**PERVIOUS CONCRETE SYSTEM AND WATER QUALITY EXPERIMENTATION
WITHIN A SOCIOLOGICAL CONTEXT**

A Thesis Submitted to the Graduate Faculty of The University of Georgia in Partial Fulfillment
of the Requirements of the Degree

MASTER OF SCIENCE

2014

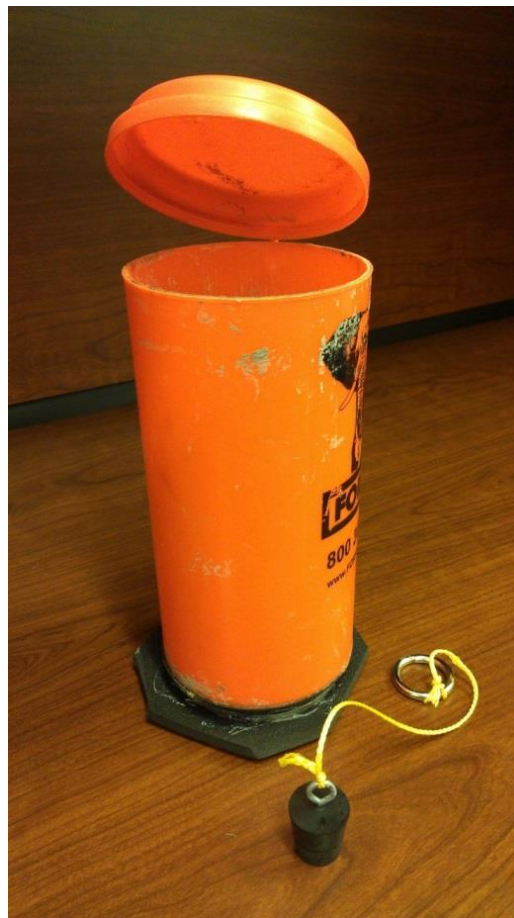
The drain test by Delatte (2007) was used to determine the internal condition of the eight PCP sites within Athens. This simple test involved draining a specified volume of water into a sample site and measuring the time required for the vessel to empty (Delatte, 2007). The apparatus consists of three main elements. The first is a 4x8 inch cylindrical concrete mold with a 7/8-inch hole drilled into the bottom to allow water to drain out. The second is a removable stopper coupled with a sealant that allow for the release of water from the vessel. The final element is a stopwatch used to time the experiment. A picture of the apparatus is displayed in Figure 2.1.

Figure 2.1 – Delatte Drain Test Apparatus

1. Drill a 7/8" hole into the bottom of the 4x8" concrete mold
2. Attach rubber ring gasket to the bottom of the mold using high strength glue
3. Attach foam rubber material to the bottom of the rubber ring gasket
4. Attach string or rod to stopper and ensure the stopper fits into the bottom hole such that no water leaks when the apparatus is left at rest.

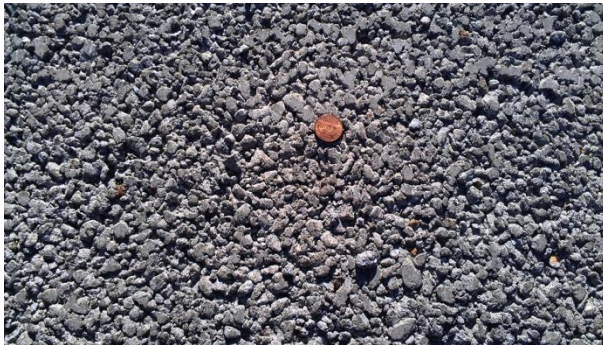
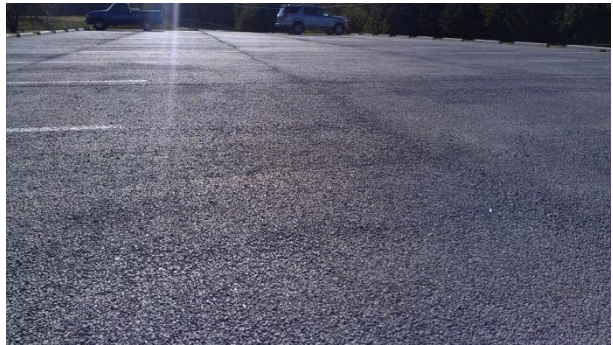
The UGA Transit Facility located at 2505 Riverbend Rd is shown in Figure 2.2. Placement of this parking lot was managed by the UGA Office of University Architects. The site is in good condition but has experienced some raveling wear since construction. The site is subjected to regular traffic from employee and visitor vehicles. In addition there are sections of the parking lot that appear clogged and ineffective.

Figure 2.2 – UGA Transit Facility Parking Lot

- *UGA Transit Facility* – This site was classified as being in good to moderate condition by Delatte test criteria throughout the two year period. Visual inspection yielded a few areas along the surface that showed signs of clogging but results were otherwise consistent with these conclusions.

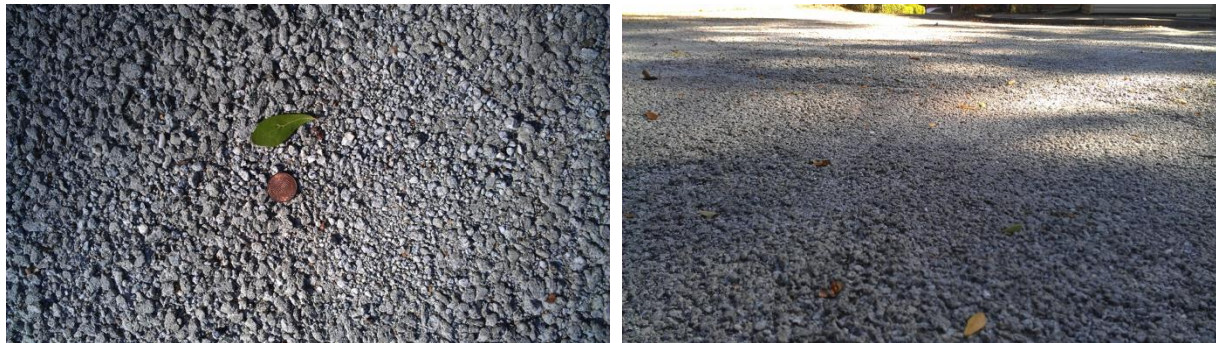
The UGA Governmental Relations Building parking lot is shown in Figure 2.4. This small parking lot is located at 198 Waddell Street. It is situated on the north side of UGA Government Relations was one of the first installations of PCP at UGA placed in 2003 (Ferguson, 2007). The site itself is in poor condition with clogging, prevalent raveling and surface irregularities. This lot experiences regular UGA employee and visitor vehicle traffic.

Figure 2.4 – UGA Government Relations Building Parking Lot

- *UGA Government Relations* – This site was classified as being very poor condition by Delatte test criteria. The site shows obvious signs of degradation and raveling. The surface provides near to no infiltration and has a very uneven surface.

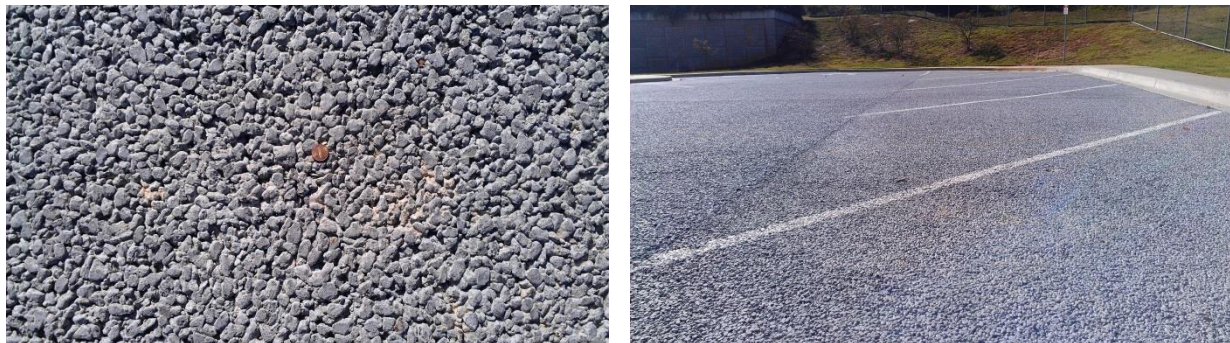
The Athens Transit Multi Modal Transfer Center parking lot is shown in Figure 2.8. The site is located at 775 East Broad Street adjacent to the main bus transfer platform and serves as a parking lot for passengers and staff. The site is a success thus far and is currently in very good condition.

Figure 2.8 – Athens Transit Multi Modal Transfer Center Parking Lot

- *Athens Transit Multi Modal Transfer Center* – This site was classified as being in good condition by Delatte test criteria. Visual inspection supports these conclusions as no signs of wear or clogging were found on site.

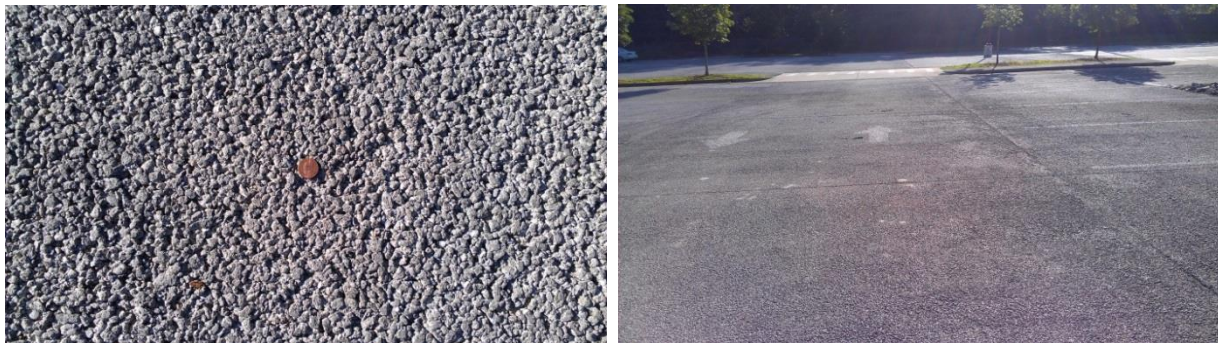
The St. James United Methodist Church parking lot is shown in Figure 2.10. The site is located at 111 West Lake Drive adjacent to the older parking lot near the main church building. This site shows multiple signs of wear with obvious raveling, clogging, and degradation of the PCP surface. The site is used by the members of the church and experiences regular light vehicular traffic. It is not in very good condition.

Figure 2.10 – St. James United Methodist Church Parking Lot

- *St. James United Methodist Church* – This site was classified as being in very poor condition by Delatte test criteria. Visual inspection found many signs of wear including excessive raveling and obvious signs of clogging.

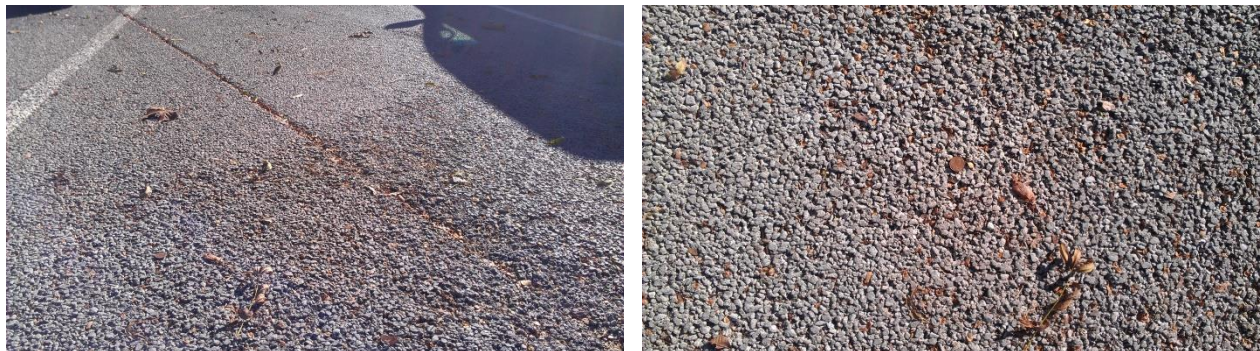
The Athens Clarke County Community Protection and Public Works department is located at the corner of North Lumpkin and W Dougherty St. Its back parking lot consists of asphalt and pervious concrete parking spaces. The site experiences regular employee and visitor vehicle traffic and has minimal visible wear. The surface, however, is visibly clogged.

Figure 2.12 – Athens Clark County Community Protection and Public Works Parking Lot

- *Athens Clarke County Public Works* – This site was classified as being in moderate to poor condition by Delatte test criteria throughout the two year period. There is visible wear and clogging. The site provides very little infiltration.
- *Rutherford Hall* – This site was classified as in good condition by Delatte test criteria. The site shows visible wear such as extensive raveling but provided sufficient infiltration.
- *Athens Transit Commuter Parking Lot* – This site is classified as being in good condition by Delatte test criteria. There is visible wear, despite the site being relatively new, with raveling and surface wear across the entire surface.

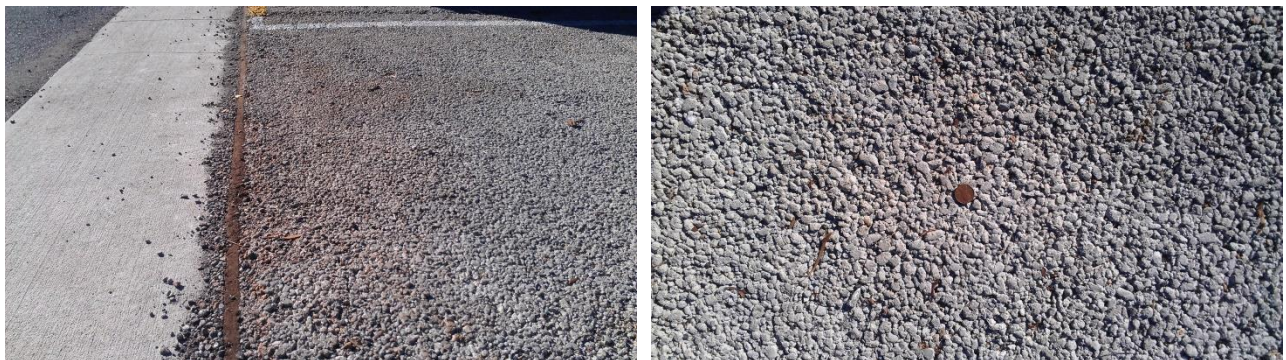
The UGA Rutherford Hall dorm is located at the corner of Cedar St. and Stanford Dr. The parking lot located adjacent to the building is relatively new and contains both asphalt and pervious concrete parking spaces. The site experiences regular student vehicle traffic and is showing visible wear with apparent raveling at its joints.

Figure 2.14 – Rutherford Hall Parking Lot

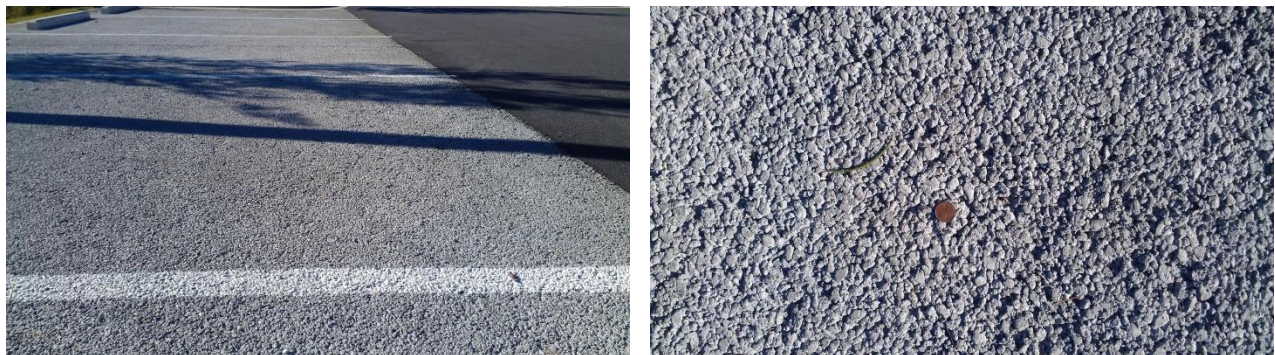
The Athens Transit commuter parking lot is located near the Lexington Highway adjacent to the Athens Perimeter highway exit in the cloverleaf. This site is relatively new and contains both asphalt and pervious concrete parking spaces. The PCP displays very apparent wear with severe raveling at its joints and uneven surfaces at high traffic areas. The site experiences regular commuter vehicle traffic.

Figure 2.16 – Athens Transit Commuter Parking Lot

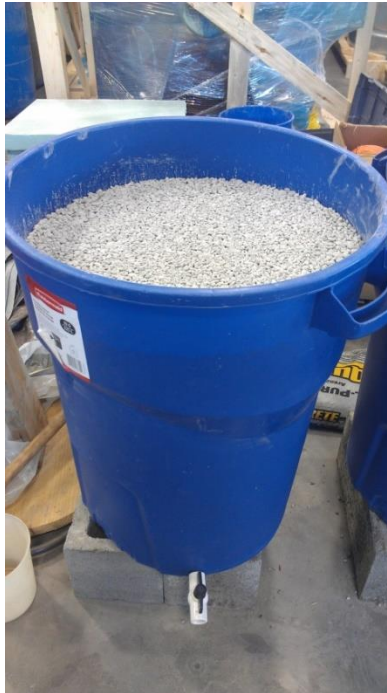
Each demonstration was comprised of three basic elements: the container, the underdrain system, and the PCP system. For this study, the container was made out of a plastic 32 gallon bin akin to the one displayed in Figure 5.2. The underdrain system was comprised of a simple valve and is pictured in Figure 5.3. An internal schematic view of a demonstration unit is displayed in Figure 5.4. Each layer within the pictured systems had a thickness of 8 in (20.3 cm). This

Figure 5.2 – Example Demonstration Unit

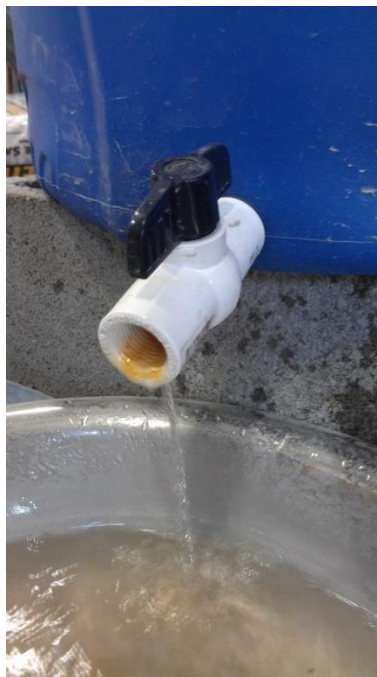
Figure 5.3 – Under-Drain Valve

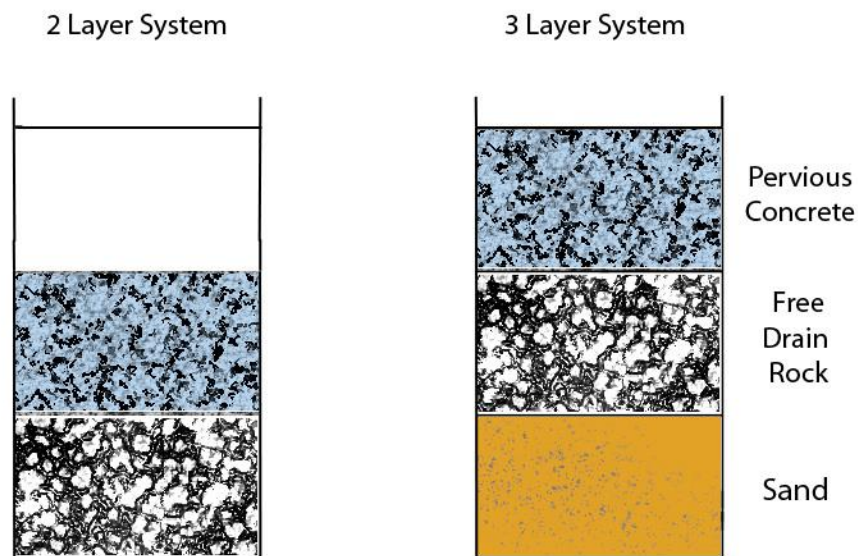
Figure 5.4 – Internal View of Example 3-Layer and 2-Layer Demo Unit

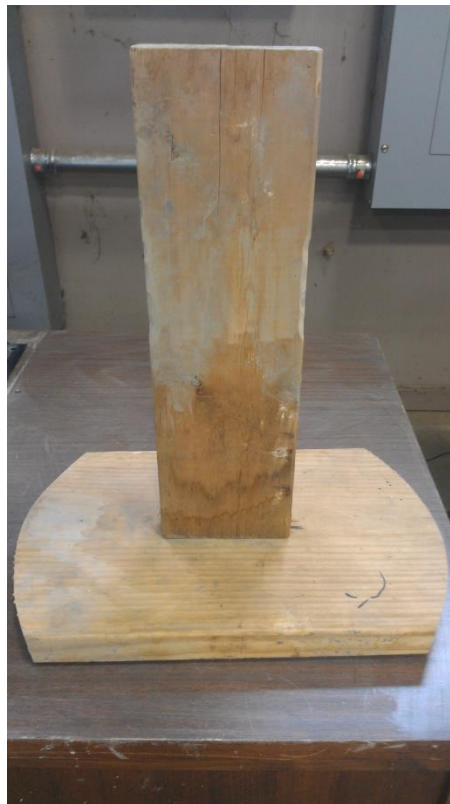
Once placed the pervious concrete layers were then compacted using a wooden compaction tool built specifically for these specimens. This compaction tool is displayed in Figure 5.5. After achieving the desired thickness and properly compacting each unit, a sheet of plastic was placed over the unit and sealed using duct tape.

Figure 5.5 – Picture of Compaction Tool used on demo units

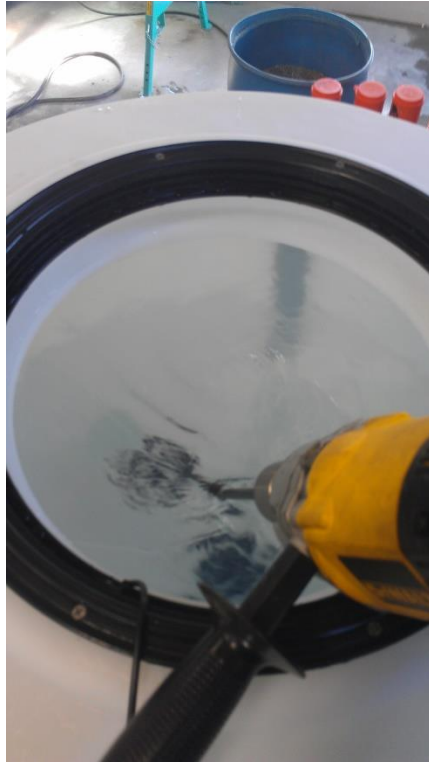
Figure 5.6 – Mixing Synthetic Stormwater using drill and paddle

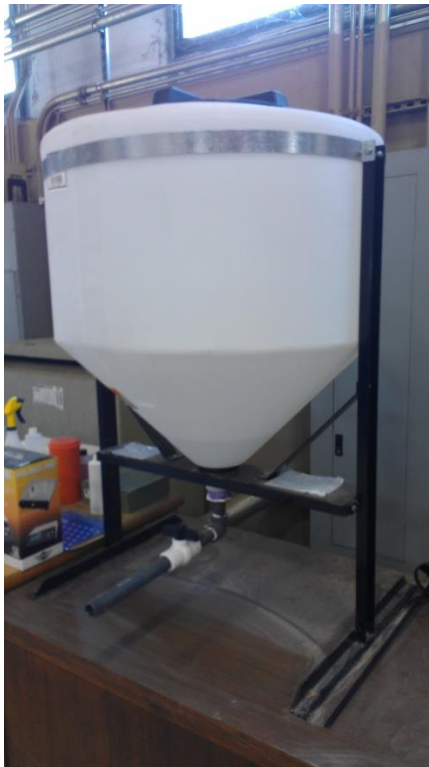
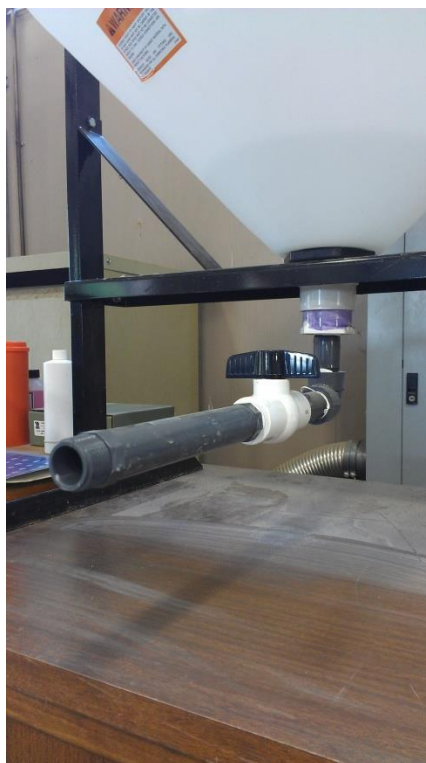
Once mixed the release valve at the bottom of the tank was opened to allow any residual water to evacuate the drain pipe. An initial sample was taken and stored after ensuring excess water had left the pipe and that the synthetic stormwater had gotten a chance to reach the outlet. An example of how each synthetic stormwater batch was mixed is shown in Figure 5.6. A picture of the tank and valve mentioned earlier is shown in Figure 5.7 and Figure 5.8.

Figure 5.7 – Picture of 50 gal tank and valve

Figure 5.8 – Picture of 50 gal tank and valve

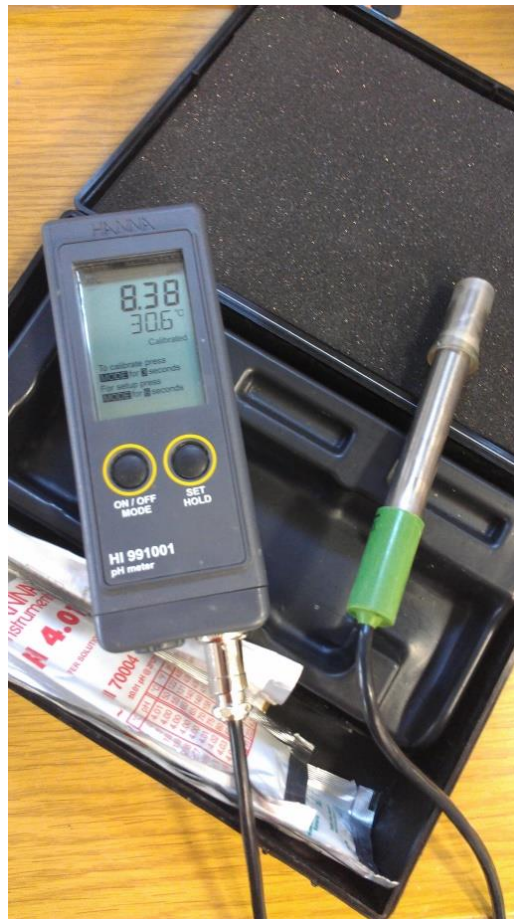
and trial for each demonstration unit. A picture of the pH meter used in these experiments is displayed in Figure 5.10.

Figure 5.10 – Picture of pH meter used for measurements

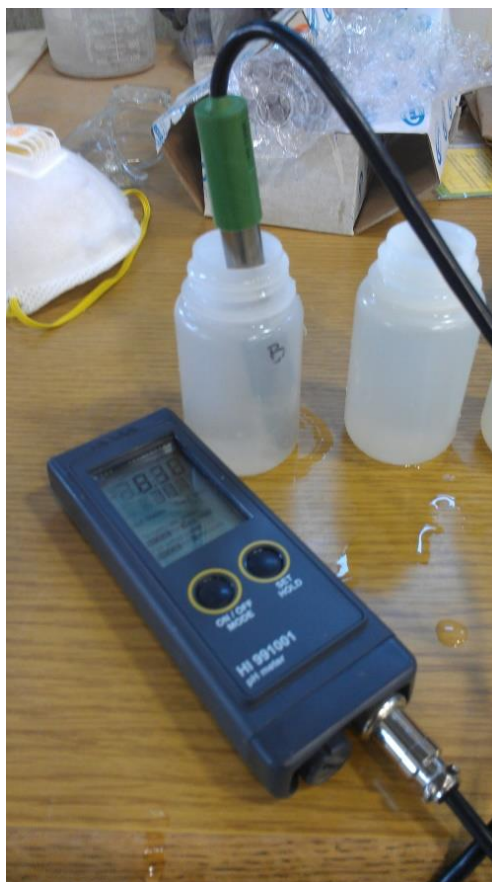
125 ml sample bottles were used for pH testing and were filled with effluent water to ensure maximum submersion of the pH meter probe. pH measurements were not recorded until the pH reading was completely stable. Stability ensured an accurate reading each time. The pH meter probe was thoroughly rinsed after each reading to ensure no cross contamination or inaccurate readings occurred from sample to sample. A picture of how the pH meter probe was used to measure pH is displayed in Figure 5.11.

Figure 5.11 – Picture of pH testing

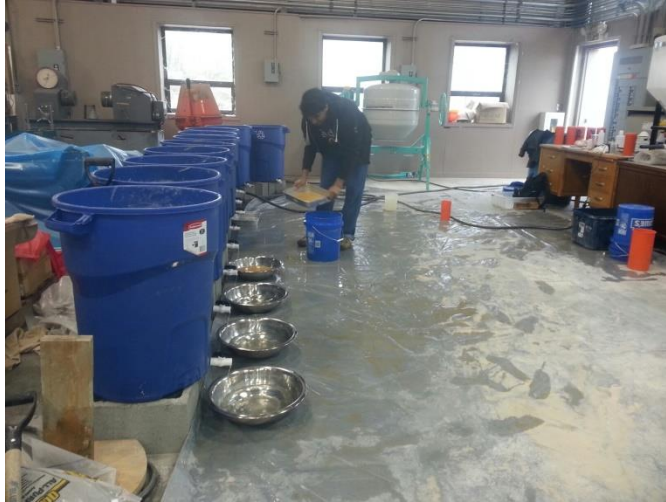
Each demonstration unit underwent full draining after each trial and off day simulated storm event. Full drainage allowed for excess test water to be removed from the PCP systems. Drainage time varied from unit to unit, and water was collected using wide pans or hoses attached to demo unit outlets. An example of the drainage conducted for each trial is shown in Figure 5.12.

Figure 5.12 – PCP Demo Unit Drainage
