HISTORY AND PRESERVATION OF DEPRESSION ERA STRUCTURAL GLASS

FACADES

A Thesis Submitted to the Graduate Faculty of The University of Georgia in Partial Fulfillment
of the Requirements for the Degree

MASTER OF HISTORIC PRESERVATION

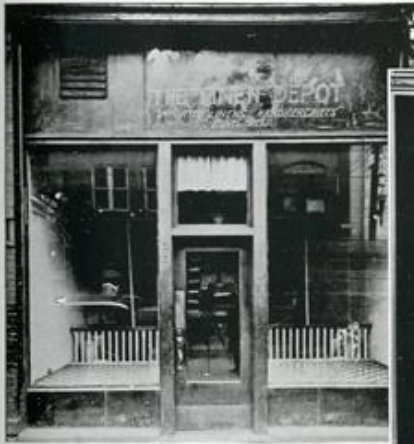
BEFORE: The site of the present Zella Alexander Shop in Roanoke, Va., as it looked before being modernized. The property stood vacant for two years prior to remodeling.

AFTER: And here's how Architect Douglas Orr of New Haven, Conn., and Martin Brothers, contractors of Roanoke, transformed the old property into a modern, productive one with a new Pittco Store Front, Black Carrara Glass, with sand-blasted, aluminum-painted inscription and decoration, combines with aluminum metal and a smartly designed, indirectly-lighted vestibule to make an outstanding installation.

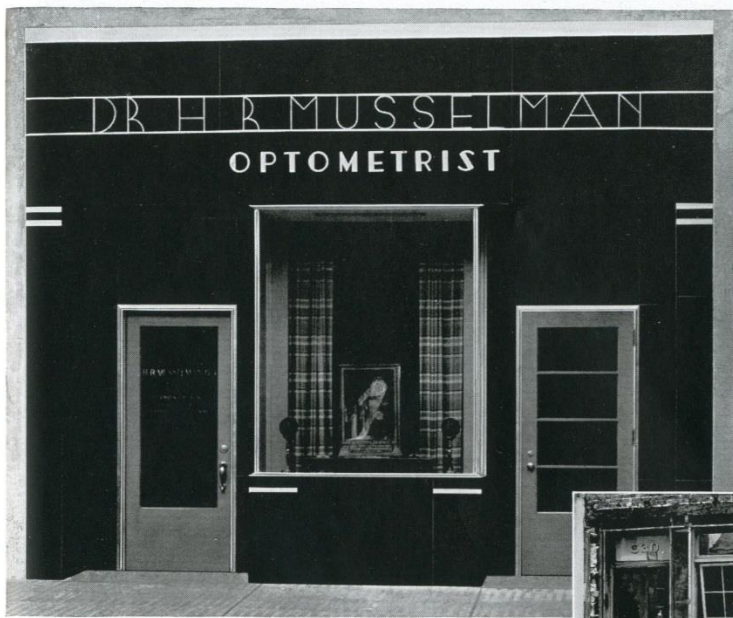
AFTER:
 Here is how Architect Karl H. Snyder and Contractor E. S. Yeager utilized Pittco Store Front Products to carry out a modern store front idea in Bethlehem, Pa.

BEFORE:
 And this is the way the store property looked before it was transformed with a new Pittco Store Front.

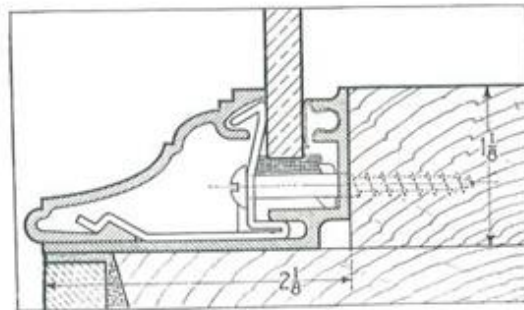
Full size cross-section

DISTINCTIVE FEATURES OF PITTCO STORE FRONT SASH

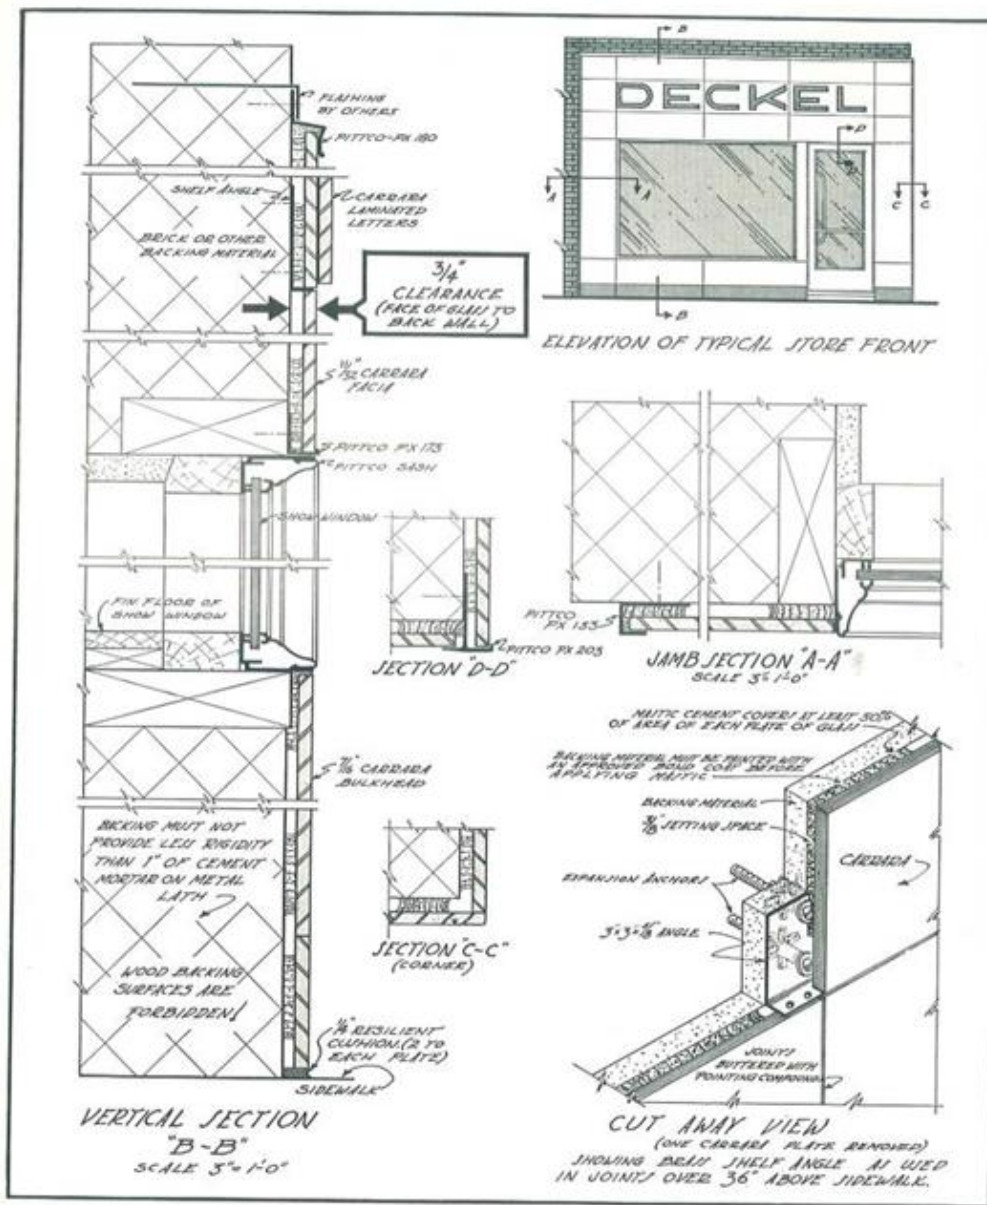
Figure 15 details of installation of Carrara glass facade

Simplicity of construction and installation is the keynote of structural glass. The typical store front details shown above can be used by the architect in almost all exterior Carrara work with the assurance that a trouble-free job will be the result. Structural glass as a veneer material can be applied with a mastic cement over almost any firm, true sub-wall. Wood as a backing surface is not recommended for all out-of-door glass construction.

with a tool known as a hot cup.⁹³ The underlying structure would require priming with a asphaltic-based primer to help the mastic adhere to the building and to prevent premature failure of the mastic due to drying. The installation of the structural glass panels required the application of the asphaltic mastic in daubs 2 to 3 inches in diameter. The manufacturer of the mastic recommended that the glass panels receive about 50 percent coverage of the mastic for best adhesion to the building. It was also recommended that detail edges and any openings or drilled holes in the panels receive a 3-inch wide band of mastic to help in application and adhesion to the building.⁹⁴

Shelf angles were used in helping to support structural glass panels on the building. These brackets were made of nonferrous metals such as brass and copper or galvanized iron to prevent corrosion. The shelf angles were made of 18 gauge metal and were generally 3 inches square with a ½ inch leg which was fastened to the masonry substrate. An illustration of this shelf angle can be seen in the cut away view in Figure 15. These angles were installed on every other vertical row of glass panels and, together with the mastic, supported the full weight of the panels. The shelf angles were installed not more than three feet apart vertically and spaced every 18 inches horizontally with at least two angles used for each individual piece of glass.⁹⁵ Structural glass generally weighs about 5 pounds per square foot and mastic alone would not be able to prevent gravity from causing the panels to slide off the building over time. Figure 15 gives illustrated details of how PPG specified the installation of Carrara glass facades in exterior applications. Essentially, the glass veneer was applied to a dry, smooth, and solid masonry or plaster-on-masonry substrate using an asphaltic masonry adhesive.

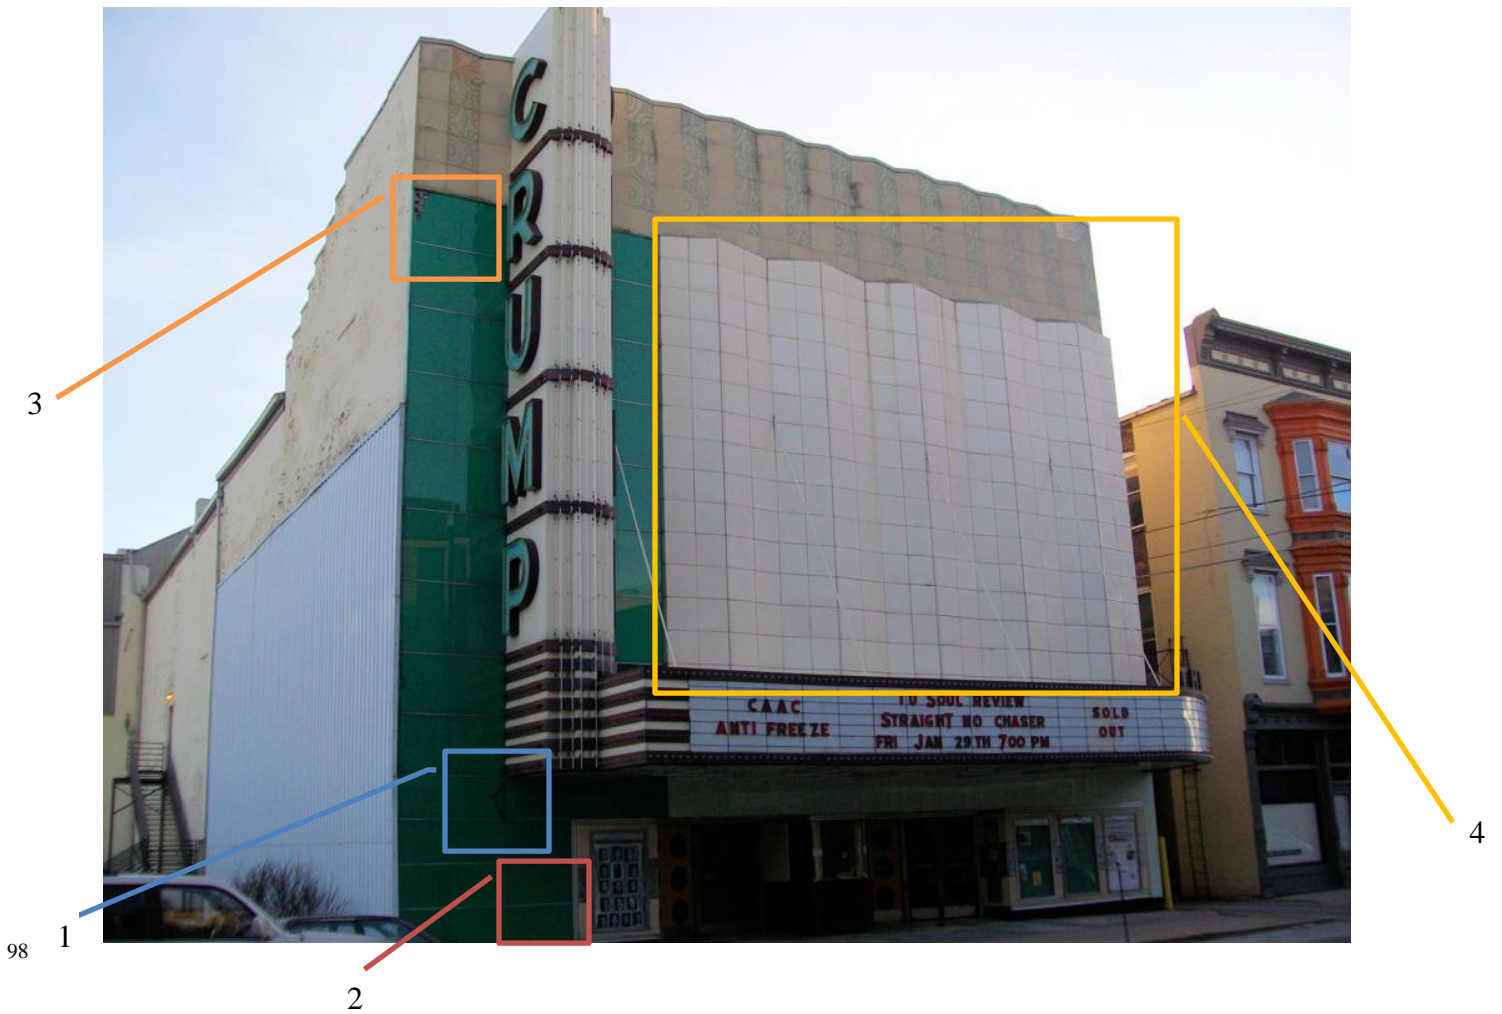
Figure 16 Crump Theatre

1. Cracked structural glass panel
2. Replicated panel using gloss-painted hardboard or plywood panel
3. Damaged structural glass panel missing a section
4. Porcelain-enameled steel panels with some evidence of rust

Most of the Vitrolite is intact, with only two panels being visibly cracked from a distance. However, as you approach the building, impact damage is evident along the lower courses of Vitrolite on the building's façade. One panel has been replaced with a substitute panel of plywood or hardboard painted in a high gloss enamel paint in a jade green, and while this substitution looks compatible from a distance, as you approach it becomes more noticeable. The cracked panel that is evident from the photograph does not show signs of having been repaired to prevent further damage from water intrusion.

Overall, the suggested repairs for the building, using guidelines developed by National Park Service Preservation Brief 12 and interviews with Timothy Dunn, are that the façade needs to be cleaned, inspected for loose and failing panels, loose panels re-adhered to the building, and damaged panels replaced with similar structural glass panels or panels from higher up on the façade replacing lower panels, with other substitutes for structural glass such as painted hardboard or back-painted glass panels on the upper façade where they would be less noticeable. Despite the evidence of the previous appearance of the building's façade from historic photographs, the condition of the building's façade in its current condition qualifies it for renovation of the current façade, and the current façade is considered to be historically significant in its own right. The current façade has been in place for 73 years of the 125 year life of the building, meaning that it has been the most dominant façade, thus the current façade is worthy to be kept rather than removed.

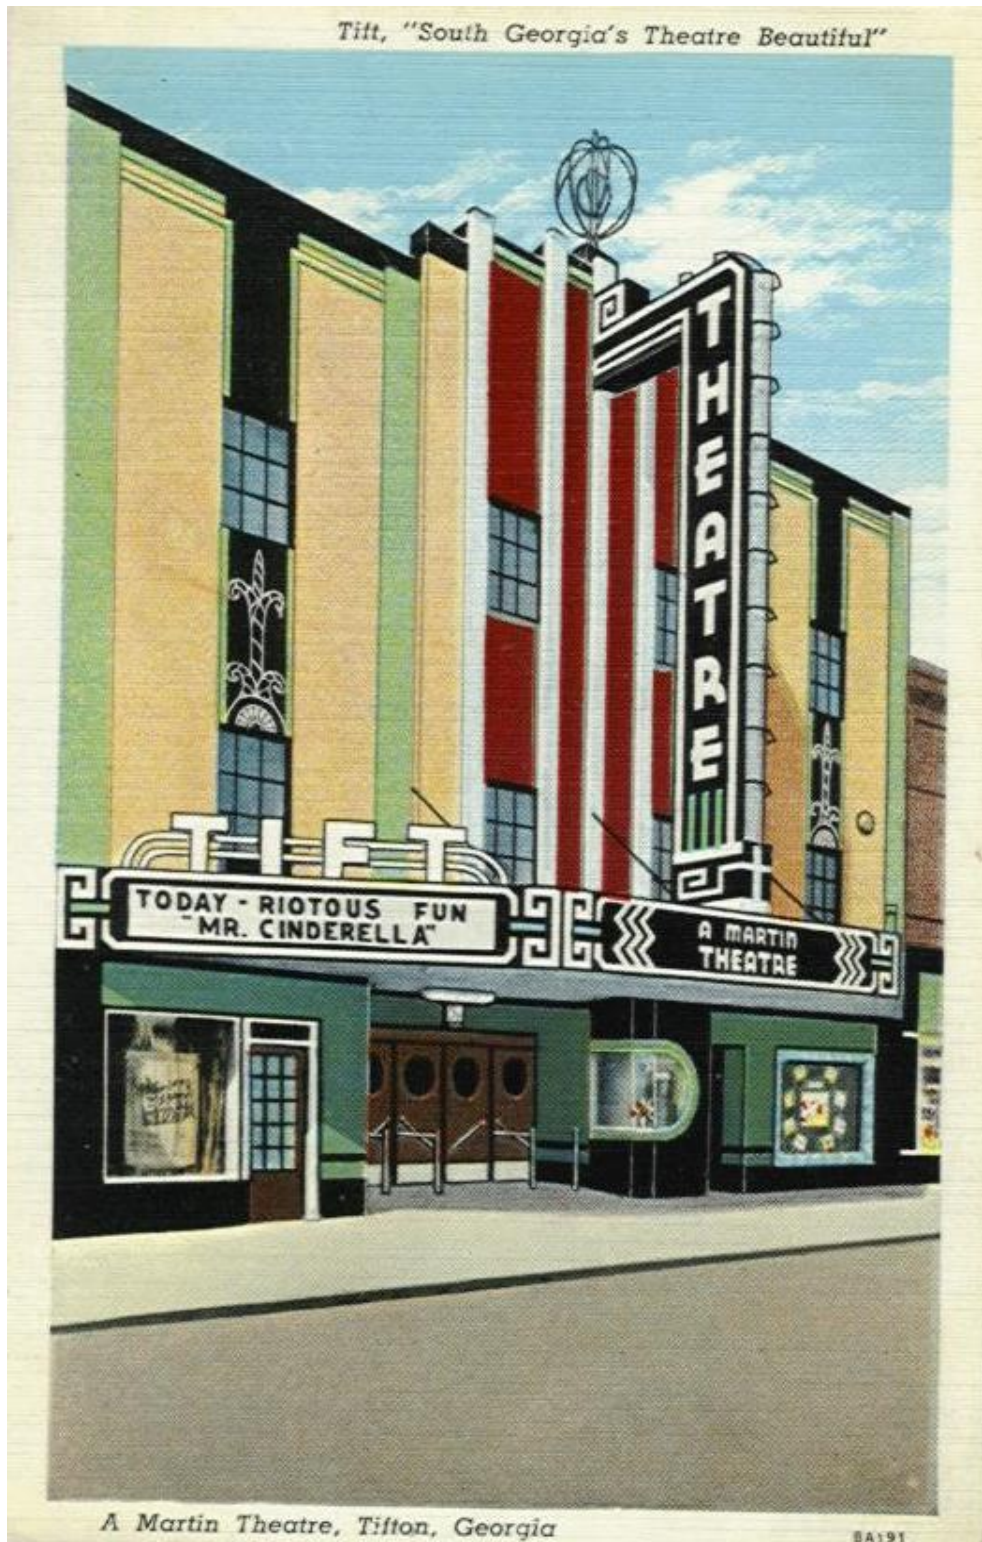
Figure 17 Tift Theatre Post card

Opening in 1937, the Tift Theatre in Tifton, Georgia retains most of its original structural glass façade.⁹⁹ The original structural glass façade was three stories tall, of which only the upper two stories remain. The façade consists of four different colors of glass which are black, red, buff and jade. The façade consists of four bays with 8 windows evenly spaced, four windows on each level. The outer two bays are mirror images of one another and the inner bay split by the sign stanchion. Originally the windows were clear, but they have since been painted to try and match the colors of the façade in the bays in which they are located. There is evidence of etching of the black glass panels on the upper façade between the second and third story windows, with the post card in figure 17 illustrating what the original detail would have looked like. The marquee on the building has lost most of its original detail and the current marquee most likely dates from the late 1950's or early 1960's. The original marquee can be seen in figure 17, and the current marquee is shown in figure 18.

The lower third of the façade has been replaced with high gloss enamel paint on rough stucco. As can be seen when comparing Figure 17, the post card from 1938, with Figure 18, a recent picture of the façade, the street level façade has seen some minor modifications that required the removal of the original structural glass. The renovation of the theatre in the late 1980's replicated the missing structural glass with patterns that are close in facsimile to the original design. This replication is effective from a distance, but closer inspection of the façade reveals the roughness of the stucco. Since the lower façade is missing its original extruded sash

Since this is the original façade to the building there are no reasons to replace it. General maintenance of the façade is recommended , including inspecting for damaged panels, re-adhering loose panels, and caulking all the joints with a modern flexible sealant to prevent water intrusion. Removing the paint from the windows would greatly enhance the appearance of the current façade. As can be seen in figure 18, the design of the panels between the second and third floor windows can still be seen but has much wear and should be replicated. If possible, replacement of the lower third of the façade with structural glass and a return to the original lower level design as seen in figure 17 would be recommended, but at the very least, if the stucco surface were to be smoothed and repainted with high gloss enamel paint the effect would be more representative of the original façade design. A complete restoration of the façade should also include a return to the original marquee as seen in Figure 17. The Tift Theatre is the best example of Art Deco architecture in Tifton, and as such is an important part of downtown architecture.

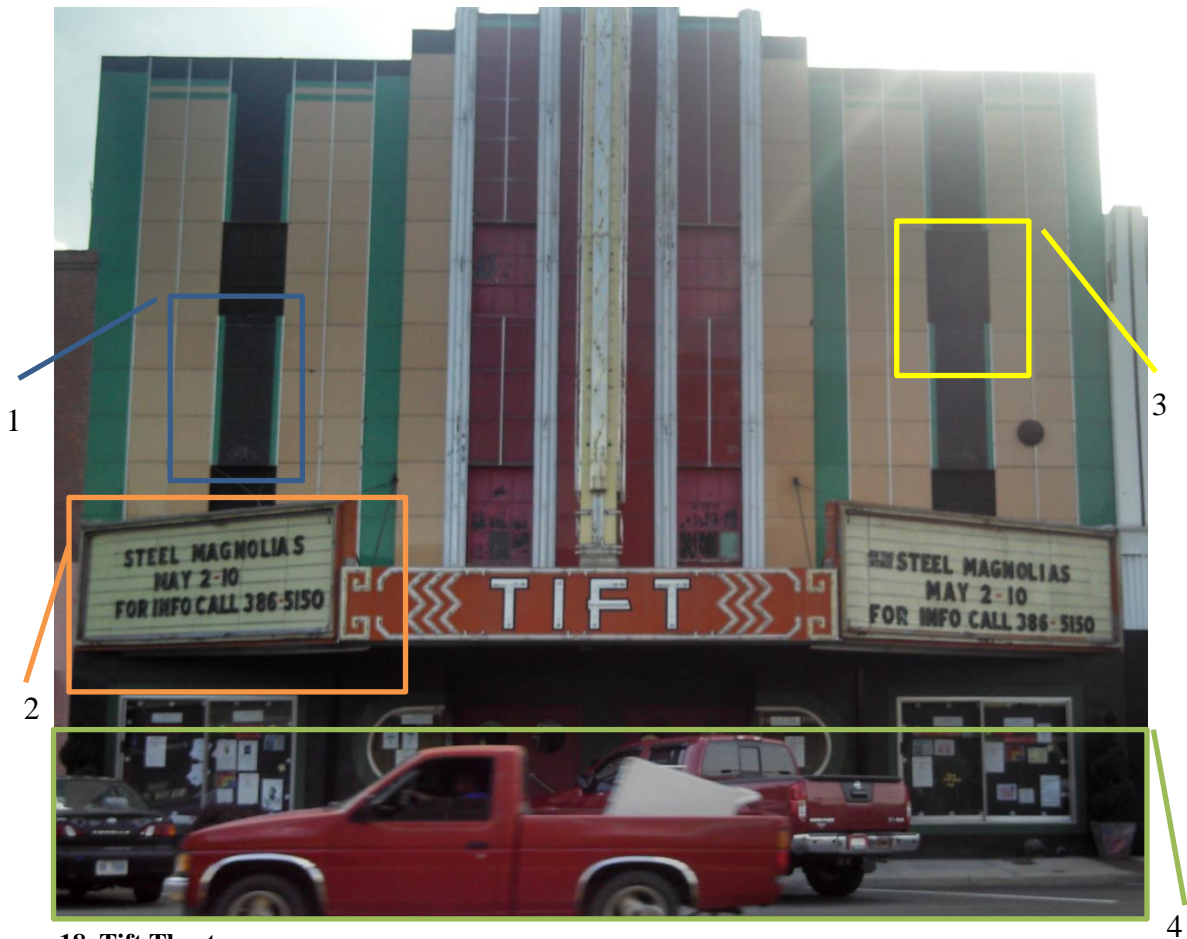
Figure 18 Tift Theatre

1. Detail etched in panel needs to be re painted to highlight detail
2. Replacement marquee
3. Original windows have been painted, paint should be removed
4. Lower façade has been changed and structural glass has been replicated in stucco painted in high gloss enamel

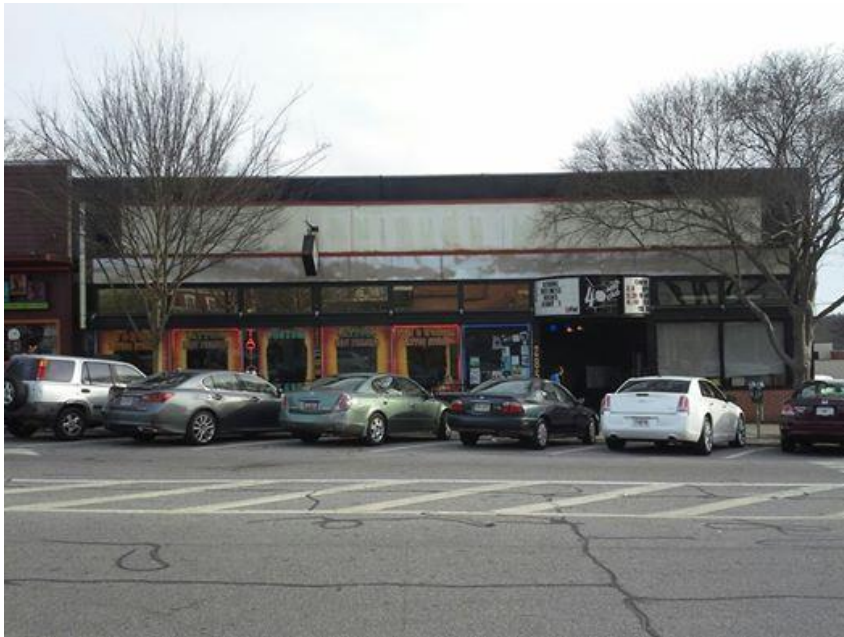
Figure 20 40 Watt Club today

1. Painted metal replacement panels in sign band, shows signs of rust and deterioration
2. Small marquee covers original transom windows over original opening
3. Original doorway into food store has been recessed into the building for two entrances.

The current building is split between two businesses and now has an entry recessed into the original store front to allow separate entrances into the two businesses. The transom windows over the original entry to the food store have been covered up and in their place a small marquee resides. Some of the original plate glass windows have been replaced and use a different sash than the remaining original windows. This façade has many missing panels and damaged panels and the storefront has been modified since the installation of the structural glass façade, as is evident in comparing the image of the Big Star Food Store on the post card to the picture of the building as it is today. In one area of the storefront it is possible to see the mounting ledgers due to a missing panel. This missing panel also brings up a question of whether the store had been originally primed in asphaltic based mastic as was suggested in most installation literature from LOF and PPG, since no evidence of a primer coat remains on the brick.

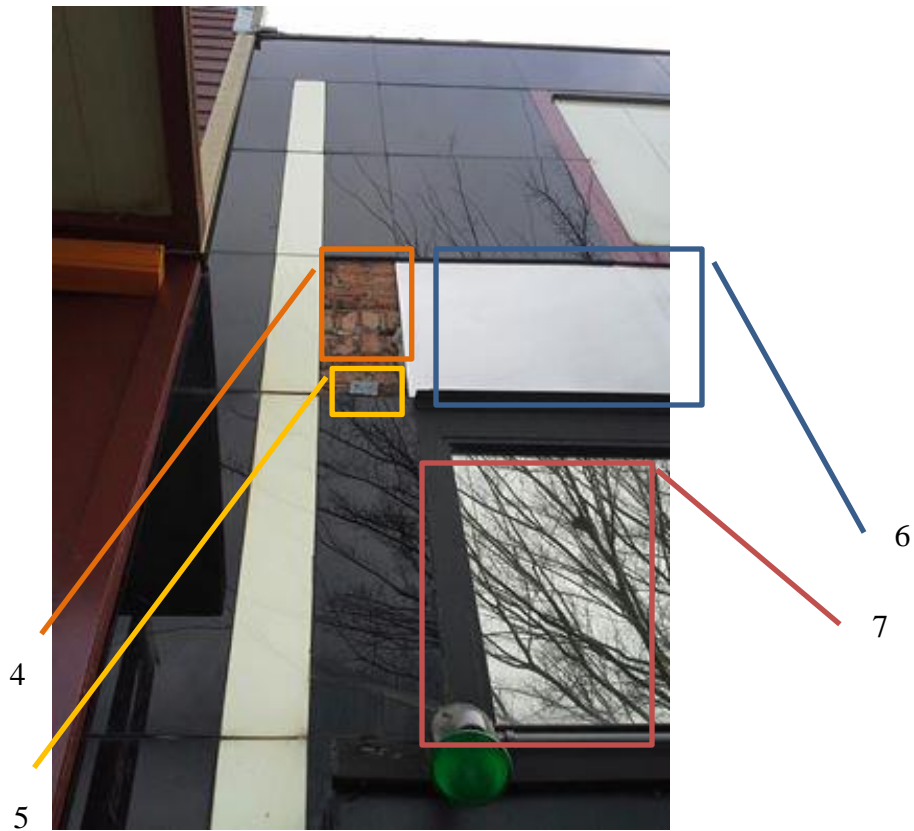
Figure 21 40 Watt Club detail

4. Substrate shows no evidence of asphaltic primer under missing panel
5. Three inch square shelf bracket used to aid in holding panels on façade
6. Part of original structural glass façade removed and replaced with sheet metal
7. Original transom windows have been replaced, new transom windows utilize non-matching sash components

The original structural glass installation also made use of integrated metal sash fittings for the transitions between the buildings and structural glass and window glazing. It appears that the sign band at the top of the building has been replaced with metal panels painted to match the green bands in the store façade. Some attempts at repair of the store front included painting the brick that was exposed by missing panels with matching paint, but no formal attempts at restoration are evident. The façade is in dire need for full restoration, and enough material is present to be salvaged for a restoration while still allowing two businesses to continue to occupy the single store front. Recommended restoration practices include a full cleaning of the storefront, replacement or replication of missing panels, resetting of loose panels, caulking of joints between panels, and protection of the lower panels from damage by vandalism and accidents, especially near the entrance/exit from the parking lot at the side of the building.

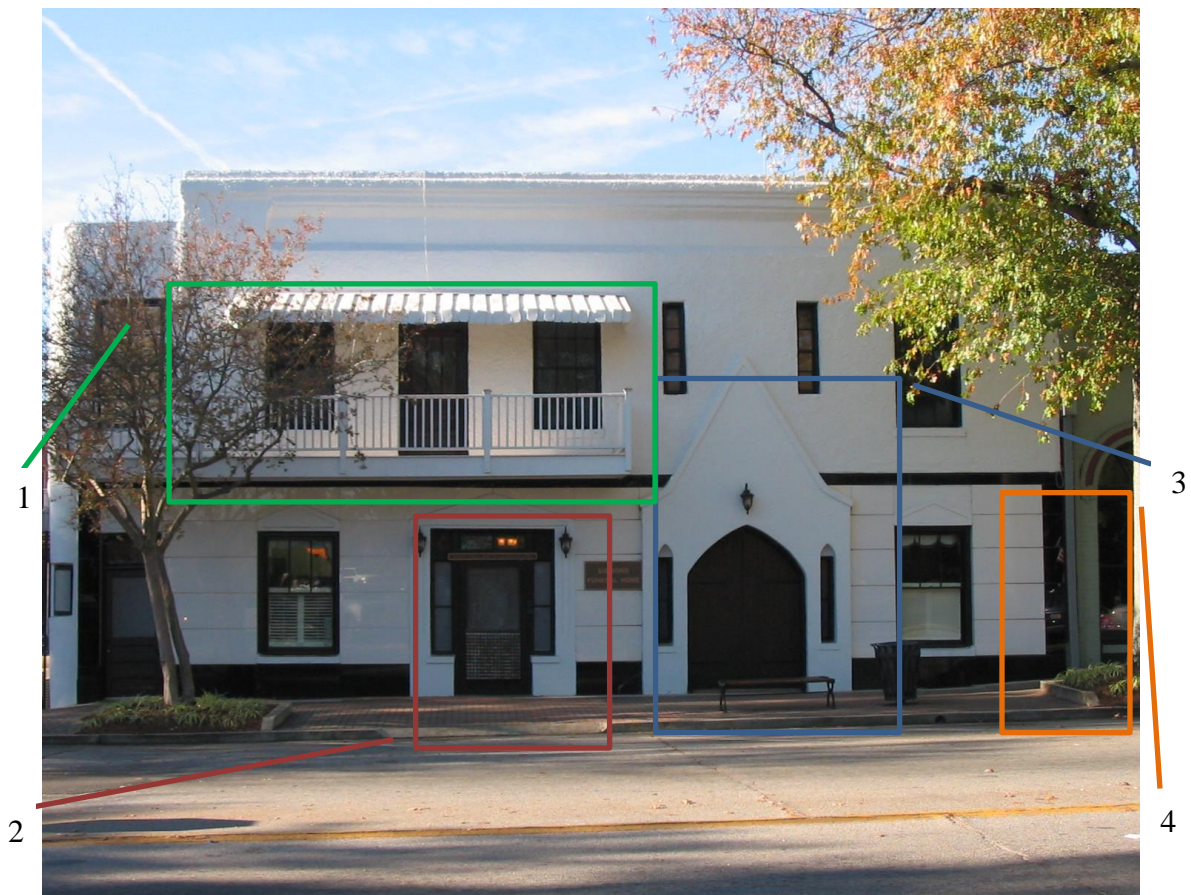
Figure 22 Simmons Funeral Home today

1. Second story porch asymmetrically set on building façade
2. Secondary entrance with pediment
3. Formal entrance with gothic arched door way set into chapel like façade
4. Structural glass façade which wraps first floor

The building uses a background of white structural glass with black as an accent. The main entrance of the building is set in such a way as to give the illusion of a chapel with a gothic style arched doorway which is set apart from the building with a white masonry façade with a pointed gable that juts from the main building by six inches. This façade that juts from the building creates a rather formal entrance to the building. A few feet away a second entrance to the building is framed in an art deco styled pediment. Structural glass is set along the face of the building around these two entrances. The windows on the lower façade also possess pediments but have the structural glass abutting directly to their frames. Unlike many other commercial storefronts, this façade does not use large plate glass windows or extruded metal sash for its installation. This use of structural glass seems rather unconventional in its nature, as structural glass was used in more flashy architecture, and the design of this façade is rather understated due

to the nature of the business. While the current façade is a mish-mash of styles, it is in relatively good shape with little damage to the structural glass. The current façade reflects strong art deco influence in its design and the materials used.

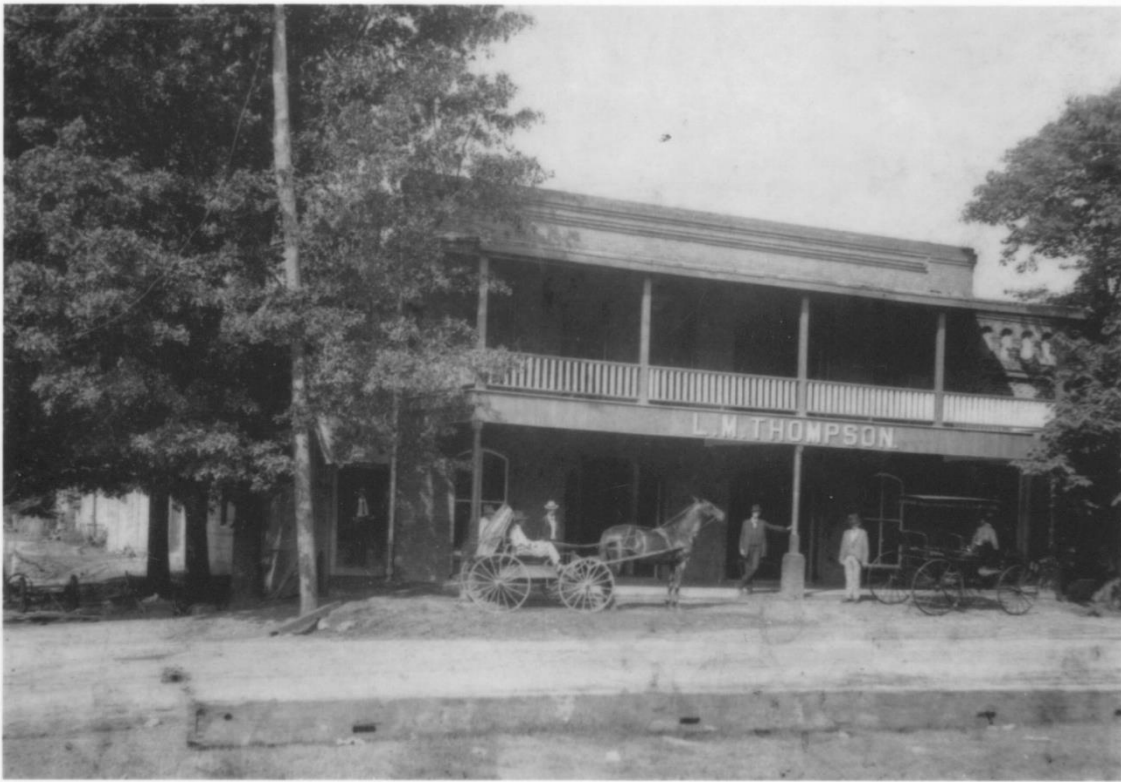
Figure 23 L.M. Thompson

The Simmons Funeral Home in Madison, Georgia, has had a long history as a funeral home. As is evidenced by the photos in Figures 22, 2,3 and 24, the building has undergone many changes over the years, with the latest renovation of the façade having occurred in the late 1940's with the lower half of the façade being covered with structural glass. The building has a two-story façade with the main and secondary entrances being in the middle of the building's lower façade. The façade is asymmetrical; the left and right most windows on the first and second story facades line up, and two small narrow windows on the second story line up with the gothic arched windows that flank either side of the gothic arched doorway that forms the formal entry into the chapel. The second floor has a small balcony, which is asymmetrically placed on the building. From the photos in figures 23 and 24, it can be seen that the building has had a second-story porch , which overhangs the lower façade since its earliest inception.
