FILL ‘ER UP: THE REHABILITATION OF EARLY TWENTIETH CENTURY  
GAS STATIONS

A Thesis Submitted to the Graduate Faculty of The University of Georgia in Partial Fulfillment  
of the Requirements for the Degree

MASTER OF HISTORIC PRESERVATION

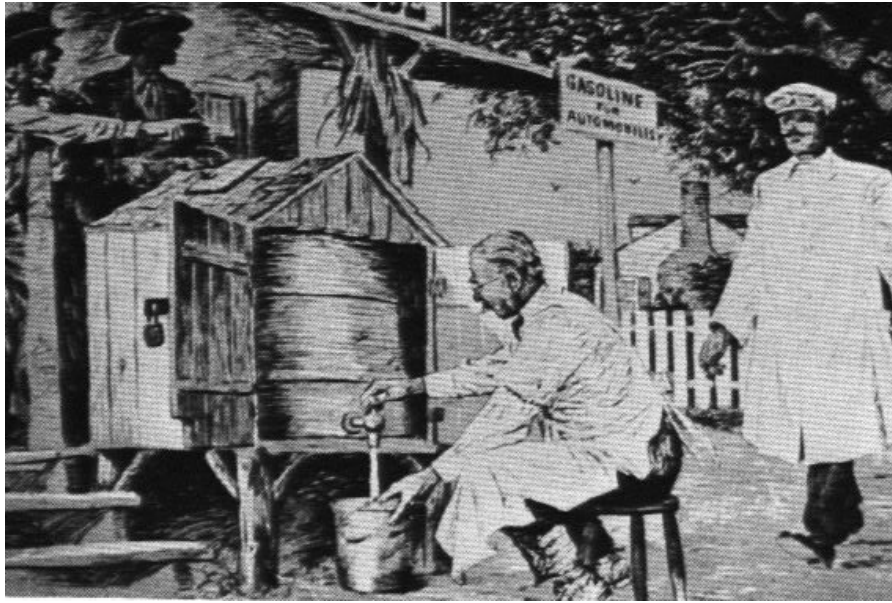
Figure 4. Early Refueling Technique

To fuel the earliest automobiles in the United States, owners had to drive to the edge of town and get their fuel from oil distributors. Initially, gasoline was distributed like kerosene, pumped into hand-held tin cans and then poured into gas tanks. In 1885, Sylvanus F. Bowser applied a lever action pump to a kerosene tank for easy dispensing.<sup>3</sup> As demand increased, specific machinery was developed for the distribution of gasoline. The first gasoline pumps were created around 1905.<sup>4</sup> In that year, Harry Grenner and Clem Laessing founded the Automobile Gasoline Company. They designed a raised cylindrical tank, oriented vertically with a glass indicator for measuring the liquid. A flexible hose then fit on the side of the pump to transfer the fuel to the car's gas tank.<sup>5</sup>

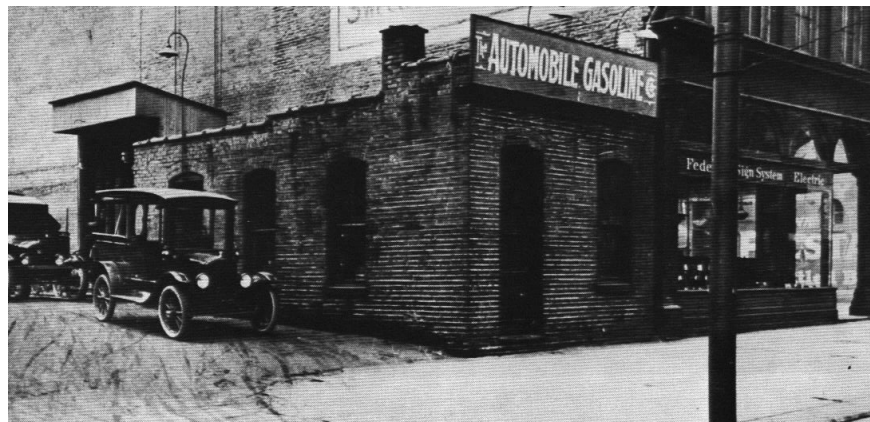
Figure 6. Early Gas Station With Off-Street Pumps

As driving became a more integral part of American life, sidewalk pumps became dangerous as long lines of cars waiting to fuel backed up into busy streets. As early as 1905, the Automobile Gasoline Company had a chain of stations specifically for gasoline in St. Louis. A few years later, the first Standard Oil gas station opened in Seattle.<sup>9</sup> In 1910, the Central Oil Company of Flint, Michigan built the first structure designed for gasoline distribution. This included a single hand-operated pump covered by a canopy.<sup>10</sup>

Gas stations designed specifically for fueling vehicles took up a large amount of room. Cars needed to pull in off of the street, pull next to a pump and then exit back onto the street. They usually also had a small shed for supplies and to shelter the attendant. In some urban areas, multi-storied buildings were demolished so that gas stations could take over prime urban real estate.<sup>11</sup> By World War I, there were 1200 or more stations added each year in America.<sup>12</sup> Before 1915, driving was a fair weather activity. Most cars were not covered or well insulated,

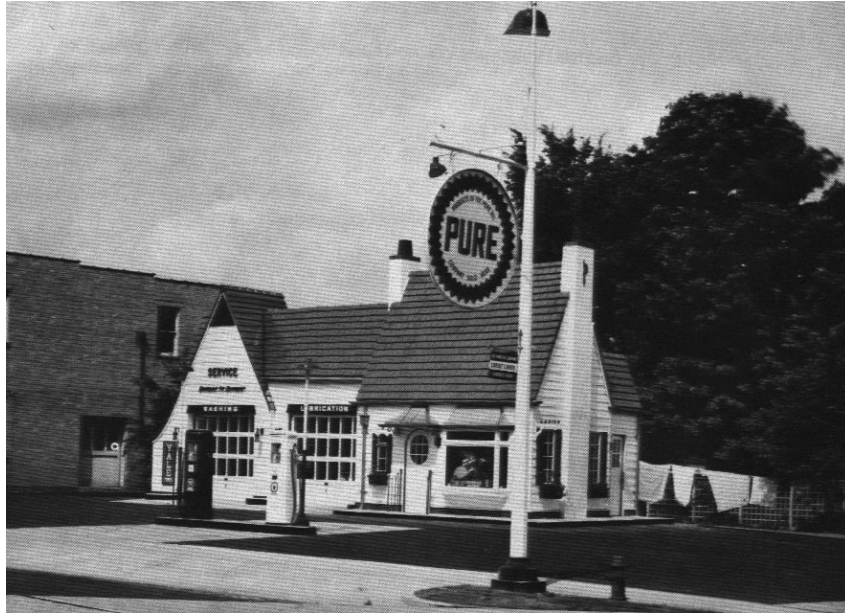
Figure 7. Traditional English Cottage Type Gas Station

By the early 1920’s, gasoline pumps were part of the American landscape. At this time there were 15,000 gas stations in the United States.<sup>15</sup> Furthermore, during this period, gas stations began to migrate into residential areas of cities. The first gas stations were built in commercial areas because they were often attached to existing commercial establishments. As the gas station moved into residential neighborhoods, owners and oil companies began to design them to look like small houses. The most recognizable of these is the English cottage-type stations built by the Pure Oil Company (Fig.7). Their unmistakable blue tile roofs are still prevalent throughout the country.<sup>16</sup>

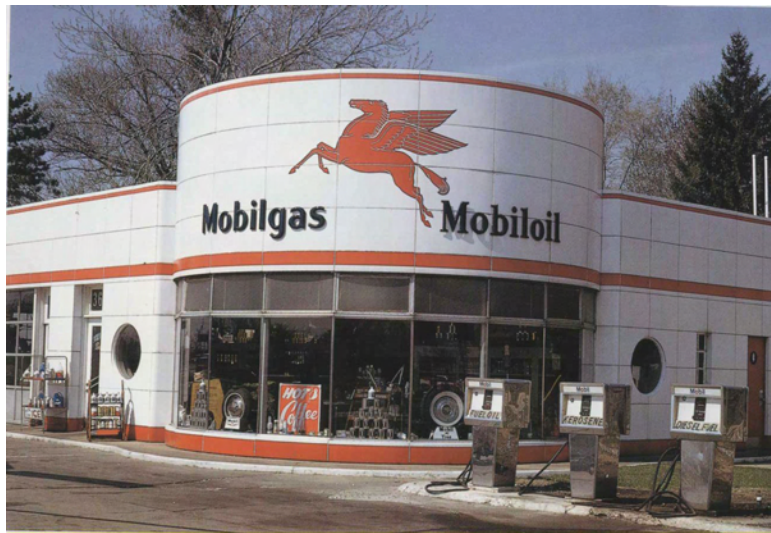
Figure 10. Form and Function of the Gas Station

Their drum design building deviated somewhat from Texaco's corporate design. In their design, the corner of the building, which housed the office, was shaped like an oil can (Fig. 10). This literal association between building form and function occurred throughout the rest of the twentieth century.<sup>24</sup> By World War II, the box had replaced the house as the archetypal gas station.

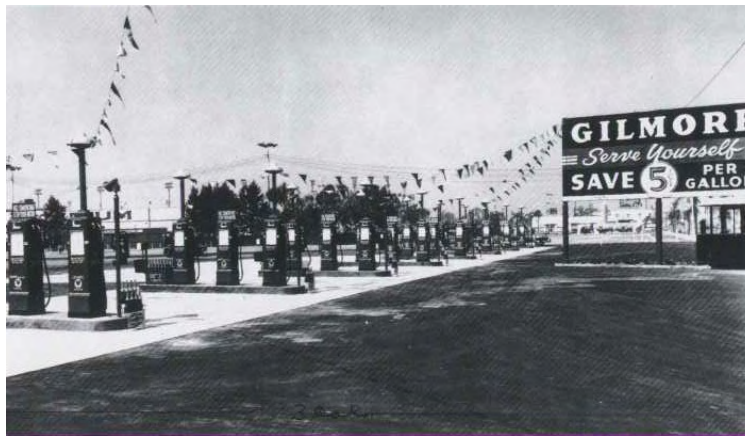
Figure 11. Early Self-Service Gas Station

The next real innovation in gas station design and operation came in California from an independent operator named George Urich. In 1947, Urich built the first self-service gas station. The self-service model accommodated more pumps because less supervision was needed. One attendant could monitor all of the pumps and make change for the customers. These self-service stations had many detractors. Several of Urich's contemporaries had windows broken at their stations and even received death threats. It seems that some people were threatened by the thought of Americans pumping their own gas. Today, this practice is the norm in gasoline sales, and full-service gas stations are much harder to find.<sup>26</sup>

The self-service gas station also altered gas station design. Because customers would be out of their cars and exposed to the elements, the gas station owners brought back the canopy to protect them. As many of the self-service stations consisted solely of pumps and a small shed for the attendant, it was easy to cover the entire operation. The canopies also allowed for eye-catching signage. While this trend occurred among the independent operators, the large oil companies believed that it was a passing fad and waited until the mid-1950's to rework their designs to catch up with the independents.<sup>27</sup>

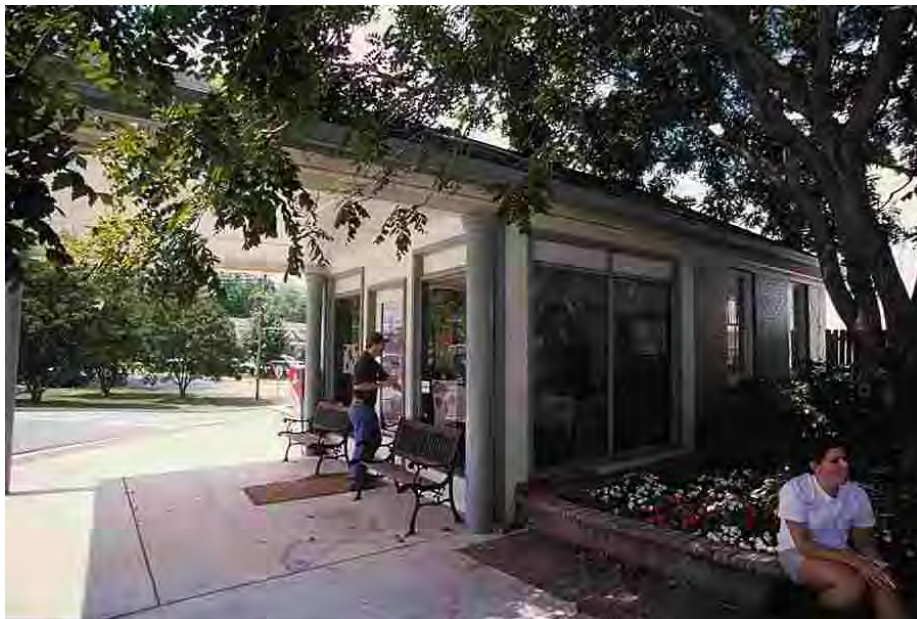
Figure 12. Downtown Development Authority Office, Commerce, Georgia

The DDA office was not an expensive or extensive project. While the dramatic changes are evident, including the enclosing of a portion of the area under the canopy, no federal funds were used in the rehabilitation. The city recognized the building's significance and decided to save it using city money. To the city's relief, the tanks could stay in the ground. To prevent corrosion, the contractors filled the tanks with sand and water. Nelson points to the thriving landscaping encircling the building as proof of the absence of contaminated soil. In addition, the city used cast iron sewer pipes that had been turned on end to support the canopy. To conserve space, the builders decided to utilize the cramped basement below the building to house the central air systems.

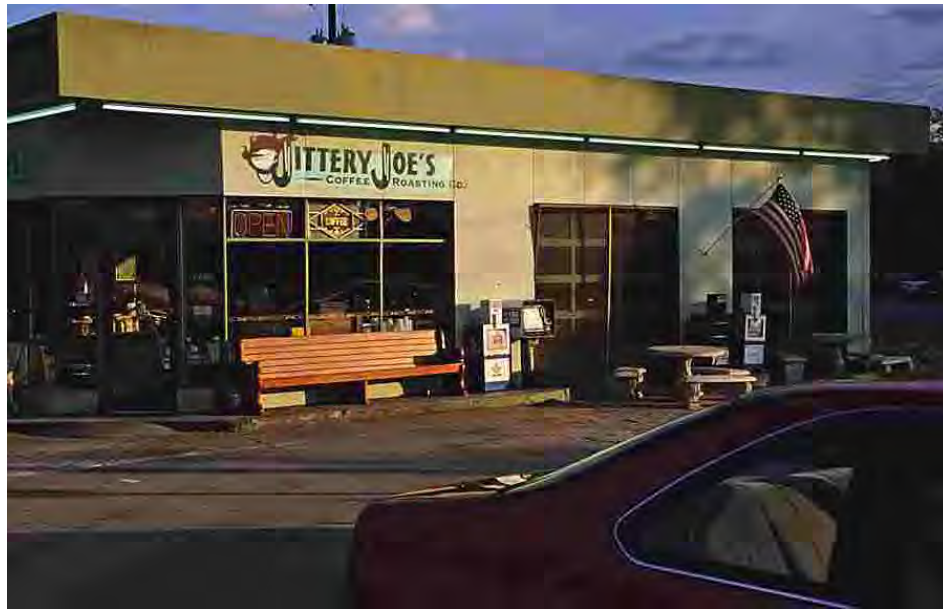
Figure 15. Jittery Joe's Café, Athens, Georgia

This building has undergone a typical progression for a gas station. From selling fuel and doing light repairs to becoming a full-service repair shop to a new use as a coffee shop, the building has remained almost constantly occupied. Keith and Karl Kortmeier followed the progression of the building, and when the auto repair shop vacated the space, decided to approach the owner and present a unique idea. The owner, Hal Hodgson, owns and runs the pharmacy known as Hodgson's directly behind the building. The Kortmeiers told Mr. Hodgson that they would clean the interior of the building if he would rent it to them for a coffee shop rather than demolish the building to create parking for the pharmacy.

Jittery Joe's is a typical oblong box much like the diagram in figure 20. The floor plan is somewhat different, however, in that the front door is on the side of the building and the men's restroom is accessed from the exterior. The office has now become the serving counter where coffee beans, coffee machines and a deli case of baked goods. The two bay areas were converted to one large sitting room with tables, chairs and bookshelves. An elaborate circular chair and billowing cloth mask the central steel structural pillar.

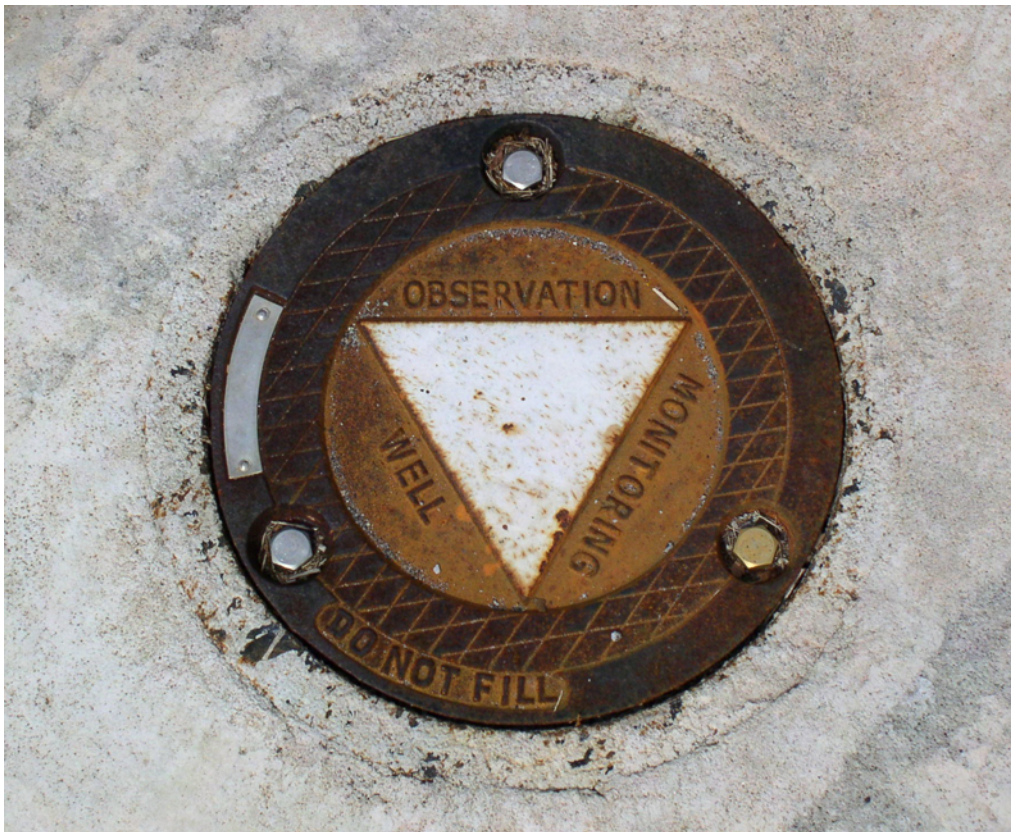
Figure 16. Monitoring Well

Hal Hodgson's father bought the building from the Standard Oil Company in the early 1970's. The elder Hodgson bought the station in anticipation of revitalizing the five points intersection. This revitalization initially included demolishing the structure, but luckily he found a tenant who sold gas and performed simple auto repairs. In 1992, the tanks came out of the ground due to possible leakage from a pumping joint.

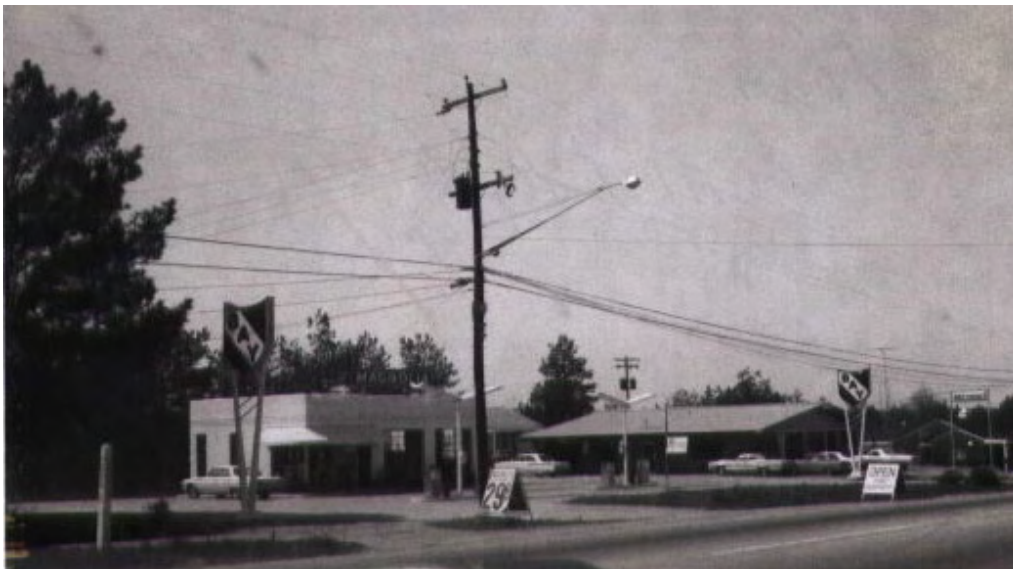
Figure 20. Last Chance Liquors

In the picture on the previous page the building was operated as a Bay gas station (Fig. 20). The building probably began its life as a Texaco gas station sometime in the 1940's (Fig. 21). The picture on the previous page is most likely from the early 1970's, right before James Moore leased the building to sell gas under the independent Magnolia brand (Fig. 20). Mr. Moore had several gas stations throughout Northeast Georgia that operated under the Magnolia

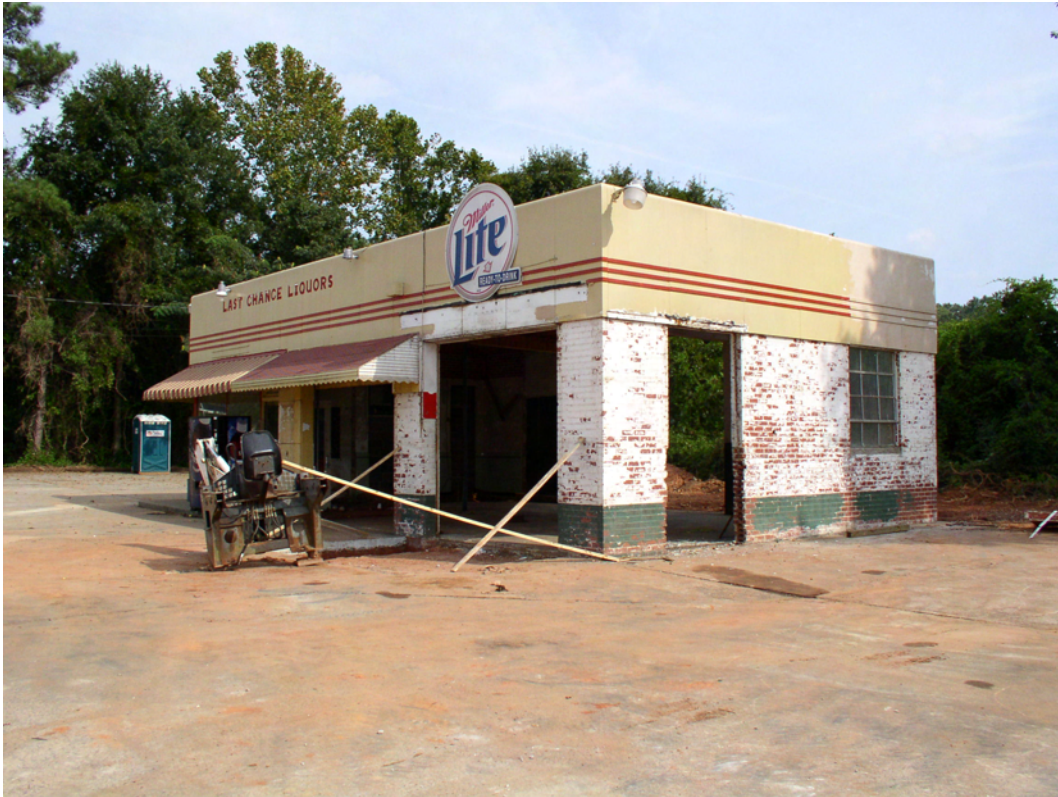
Figure 24. Last Chance Liquors, New Entrance and Drive Through

Since the property had never undergone a significant rehabilitation, the layout of the gas station was not ideal for retail sales. Horn and DeFelice are in the process of building new walls and reconfiguring the layout of the space. They have opened a portion of the back wall of the building so that they can install a new area for the beer coolers that will not take up space in the existing floor plan (Fig. 23). They have also begun adding a small addition in front of one of the garage bay doors to accommodate a larger entrance to the store (Fig. 24). Before they began renovation, the drive-through window was located in this space, but cars had to drive past the front door to reach the drive-through window. To alleviate this potential safety hazard, they have opened a portion of the sidewall so that the drive through can be moved to side of the building (Fig. 24).

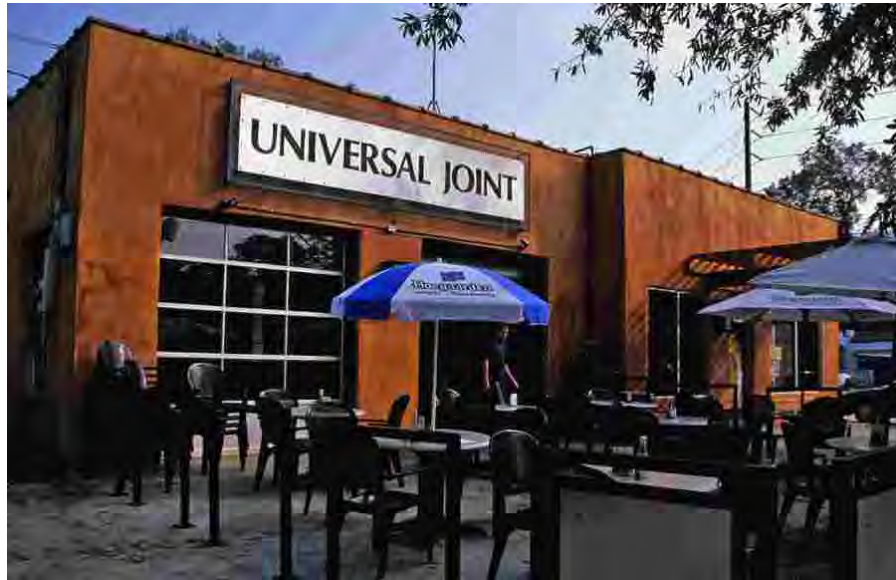
Figure 26. Universal Joint Restaurant, Oakhurst, Atlanta, Georgia

remains in the original location. Another effective treatment was the replacement of the original pump island canopy with a latticework trellis (Fig. 26).

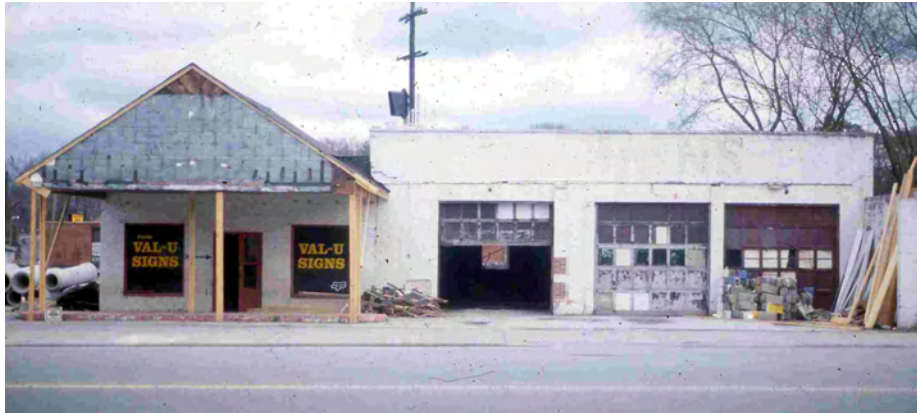
Figure 27. The Filling Station Restaurant, Dalton, Georgia (Before)

This vernacular gas station was probably built in the 1940's or 1950's as a full service station. The images of the station before and after rehabilitation are useful in identifying the appropriate and inappropriate changes to the building. First, the canopy was retained, but the brick pillars that were introduced are out of proportion and most likely bulkier than the original columns. The enclosure of the canopy area is an effective reclamation of space, but obscures the main entrance to the building. Placing the entrance in one of the original garage bays detracts from the divided light glazing that is a character-defining trait of these stations. The retention of the placement of the bays is effective for the interpretation of the building as a rehabilitated gas station, but it is unclear from the picture of the current day restaurant whether or not the divided

light glazing was retained. The current signage for the restaurant does evoke a gas station sign from the 1950's (Fig. 27 and 28).

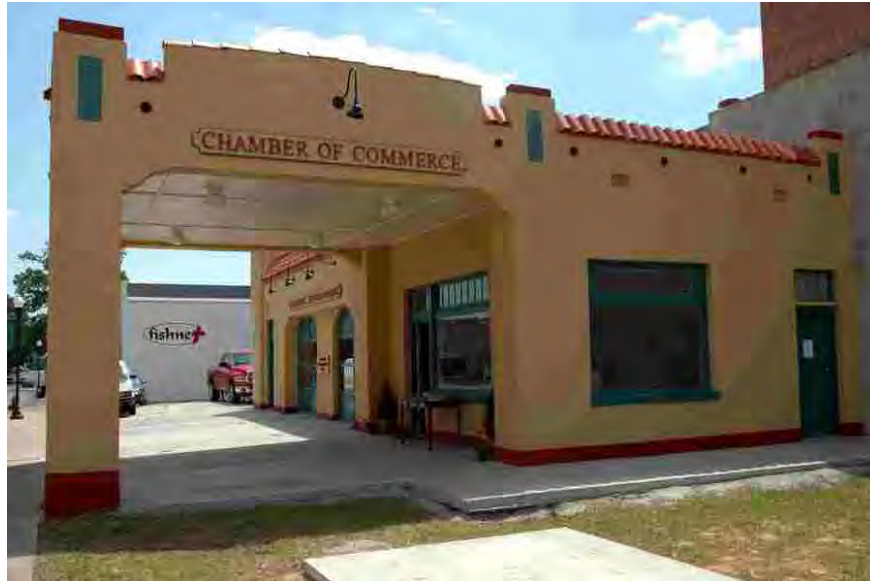
Figure 29. Elberton Chamber of Commerce, Elberton, Georgia

the origin of this building. The façade treatment and color palette are correct for the period in which this station was built. The gooseneck lights over the signage are effective recreations of the original lighting. The tile roofing on the parapet walls was well restored. In addition, no major additions to the parking area or canopy have obscured the exterior (Fig. 29 and 30).

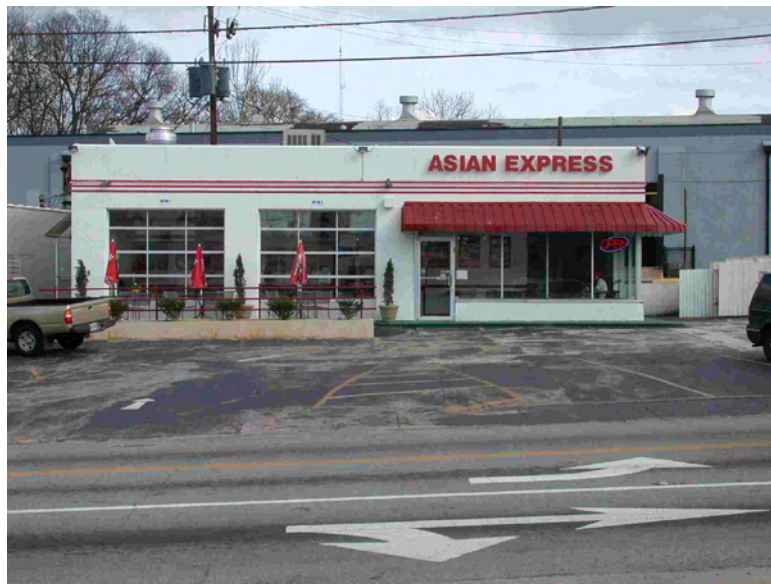
Figure 31. Asian Express Restaurant, Hapeville, Georgia

This Asian restaurant in Hapeville, Georgia was built in the 1940's as a streamlined oblong box. The current rehabilitation effectively preserved the white enamel panels and horizontal red stripes that run across the façade. It appears from the current picture that little was changed during this rehabilitation. The garage bay doors were retained and seem to remain fully functional. The patio that was created in front of the bay doors does not obscure the doors from view. The original door was retained and the red canopy that wraps around the corner of the building replicates the original canopy that would have protected customers entering the station (Fig. 31).

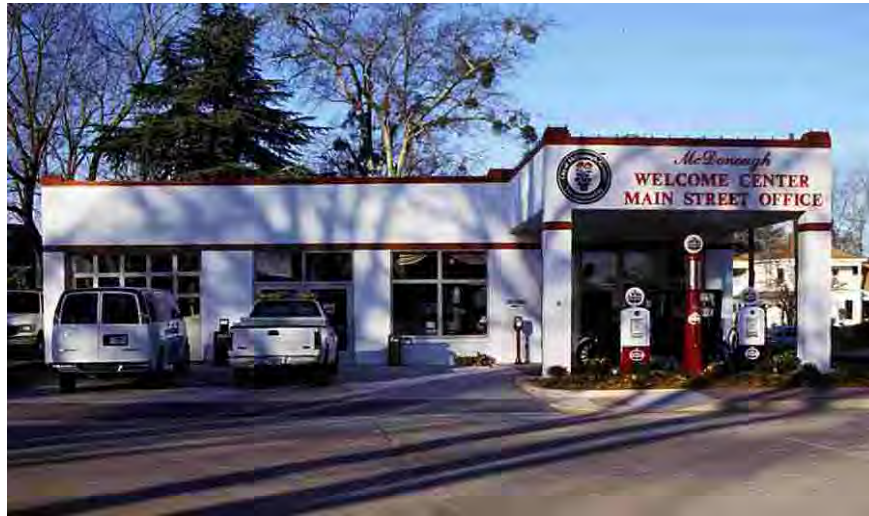
Figure 32. McDonough Welcome Center, McDonough, Georgia

This plain gas station was probably built in the 1940's or 1950's. The rehabilitation went further than many in this paper and included the installation of replicated gas pumps and other period fixtures. The retention of the left garage bay door is effective for interpreting the building

as a filling station. However, the middle garage bay door was converted to a main entrance that detracts from the original glazing. The canopy area was effectively restored and the plantings in front of the pumps adds to the landscape without obscuring the pump island or the main entrance (Fig. 32).

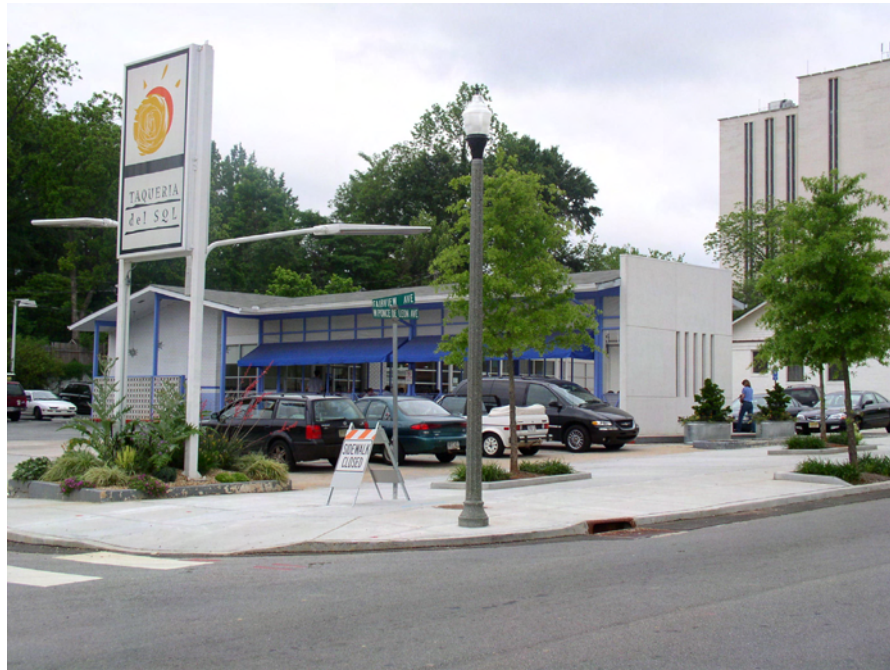
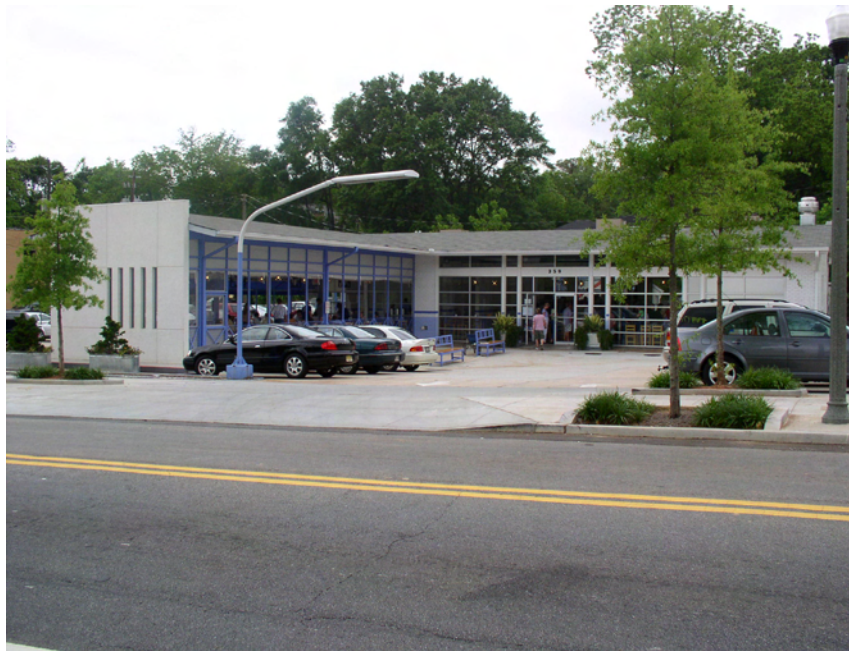
Figure 33. Taqueria del Sol, Decatur, Georgia

This gas station that has been rehabilitated to house a Mexican restaurant in Decatur, Georgia was probably built in the 1960's. This building is barely recognizable as a gas station due to the treatment of its features during rehabilitation. While the suggestion of garage bay doors remains, the glazing has been drastically altered and the main entrance now disrupts one of these doors. An oversized canopy and a large concrete wall facing the street obscure the original main entrance and canopy area. The popularity of this restaurant necessitates the large amount of parking in front of the building, but the parking arrangement does not reflect the original use of the landscape as a gas station (Fig. 33 and 34).

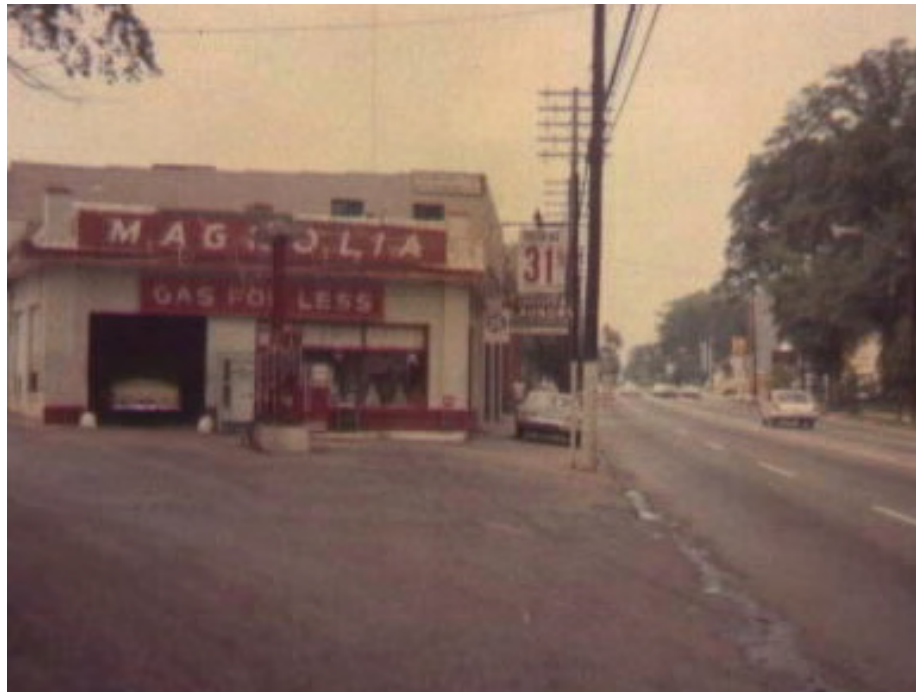
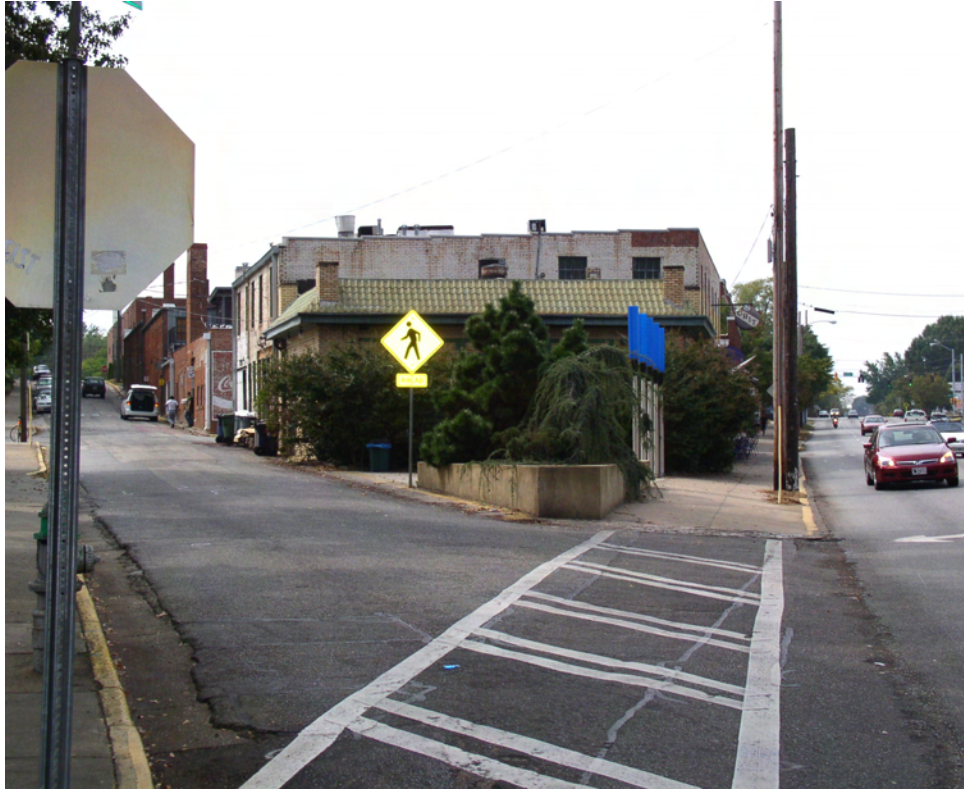
Figure 35. Go Bar, Athens, Georgia (Before)

The Go Bar, formerly a Magnolia gas station in Athens, Georgia also displays both appropriate and inappropriate treatments for rehabilitation. While the garage bay door and main entrance were retained in the rehabilitation, the diverse landscaping in front of the building now obscures these elements. The original use of this building is not evident from the street. The barrel tile roof treatment is attractive, but it is not clear from figure ? whether or not this was the original roof treatment. The rehabilitation did create a unique space and ensured the continued use of the building, but the original character is severely obscured (Fig. 35 and 36).

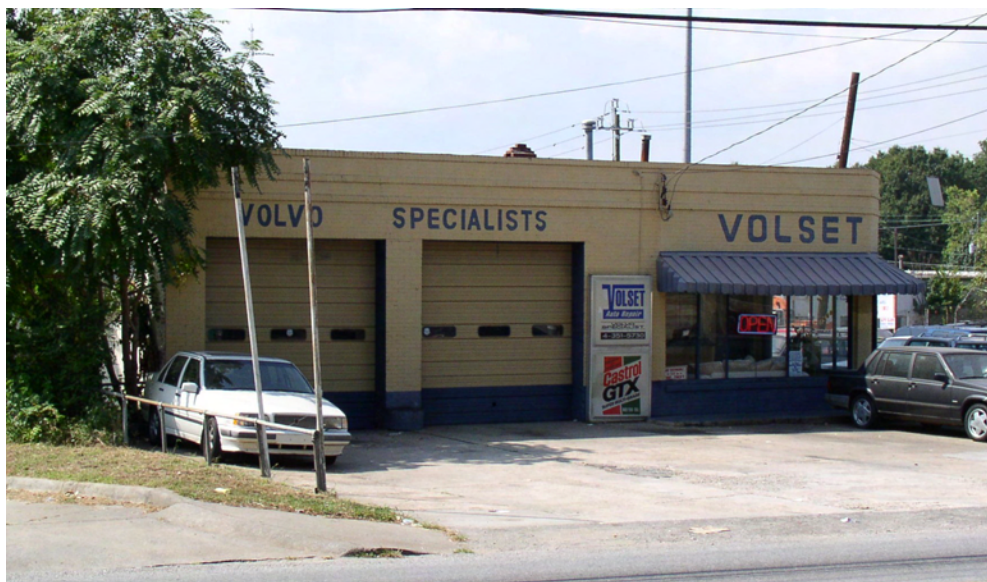
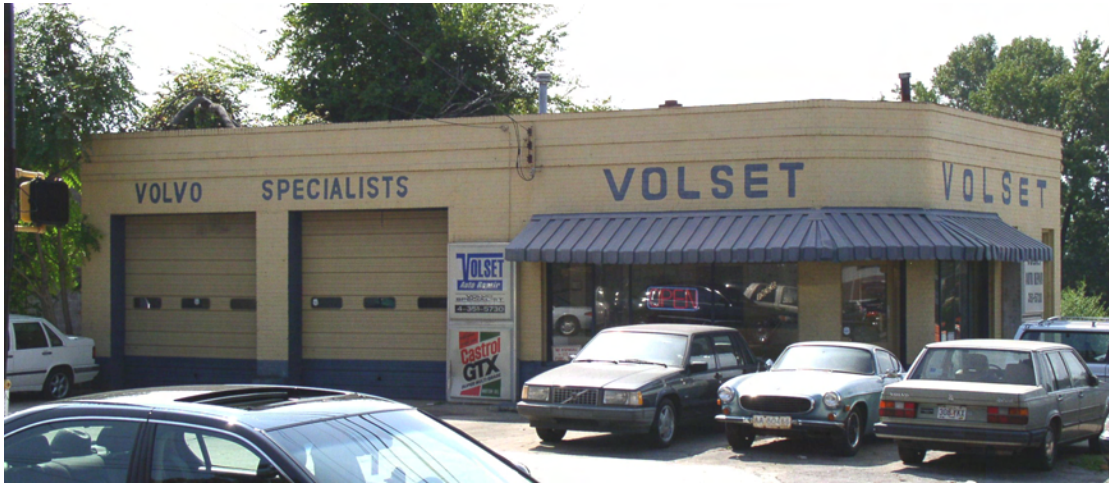
Figure 37. Volset Volvo Specialists, Atlanta, Georgia

While the owners of this building have not carried out an extensive rehabilitation, the building is in good repair and it retains its original character. The original openings and glazing remain intact and what looks to be the original canopy over the main entrance remains. Barring any severe environmental contamination, this building could easily house a small shop or restaurant (Fig. 37 and 38).

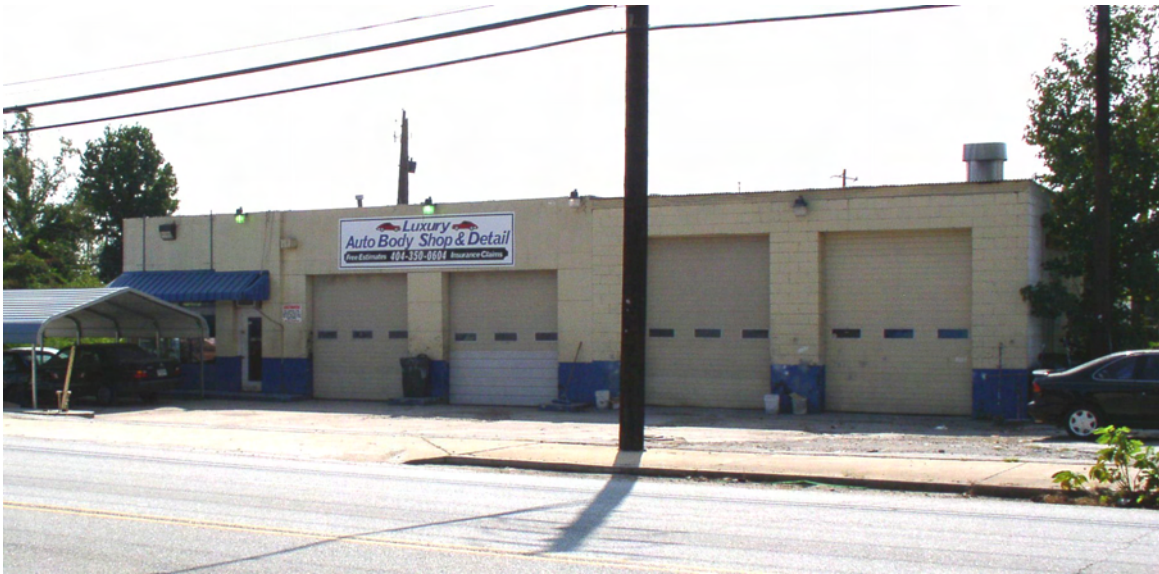
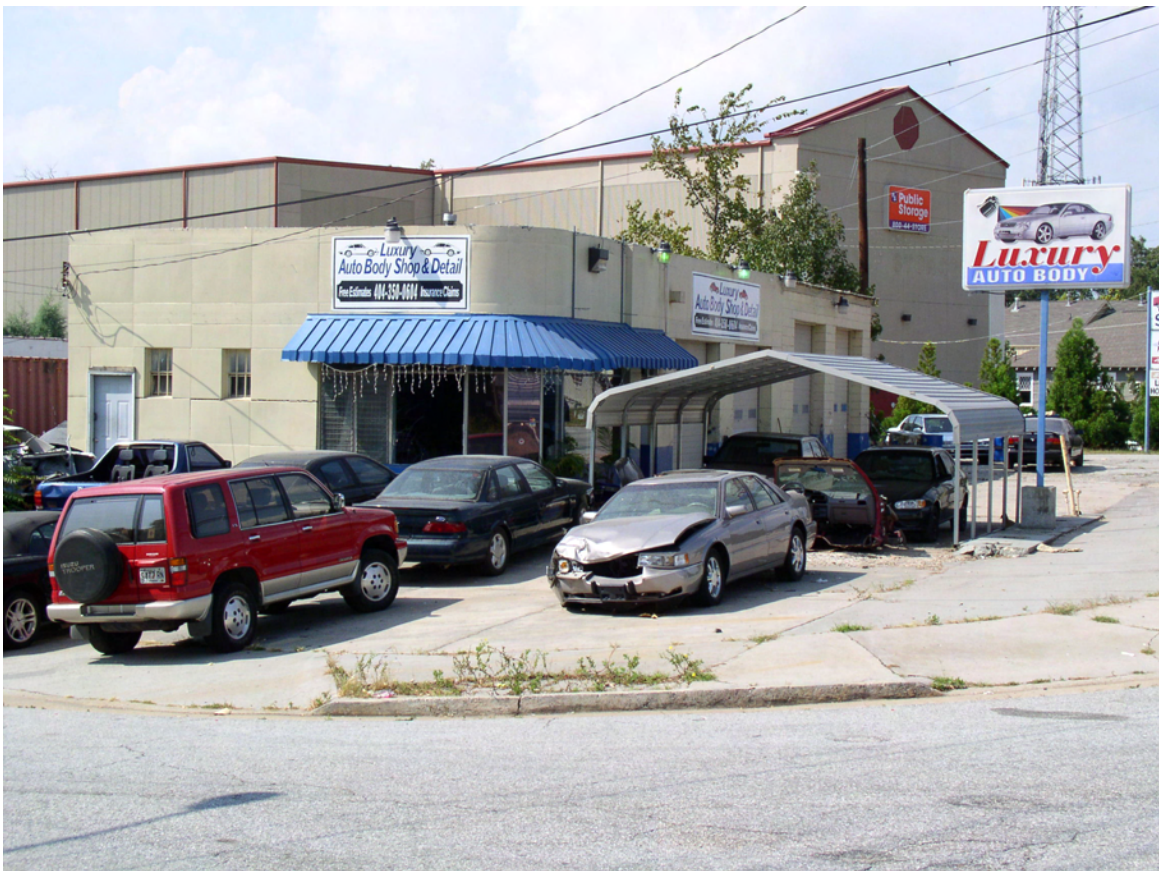
Figure 39. Luxury Auto Body Shop and Detail, Atlanta, Georgia

Much like the Volset Volvo Specialists, this building has seen little rehabilitation work. There is an addition of two large garage bays, evident from their difference in size compared to the original bay doors. The addition also has a concrete block façade, while the original gas station retains many of its original enamel panels. An effective treatment of this station would include replacing the garage bay doors with divided light glazing, and retaining the addition. This station would yield a large interior space that could easily accommodate a restaurant or possibly a flea market setup with individual stalls (Fig. 39 and 40).

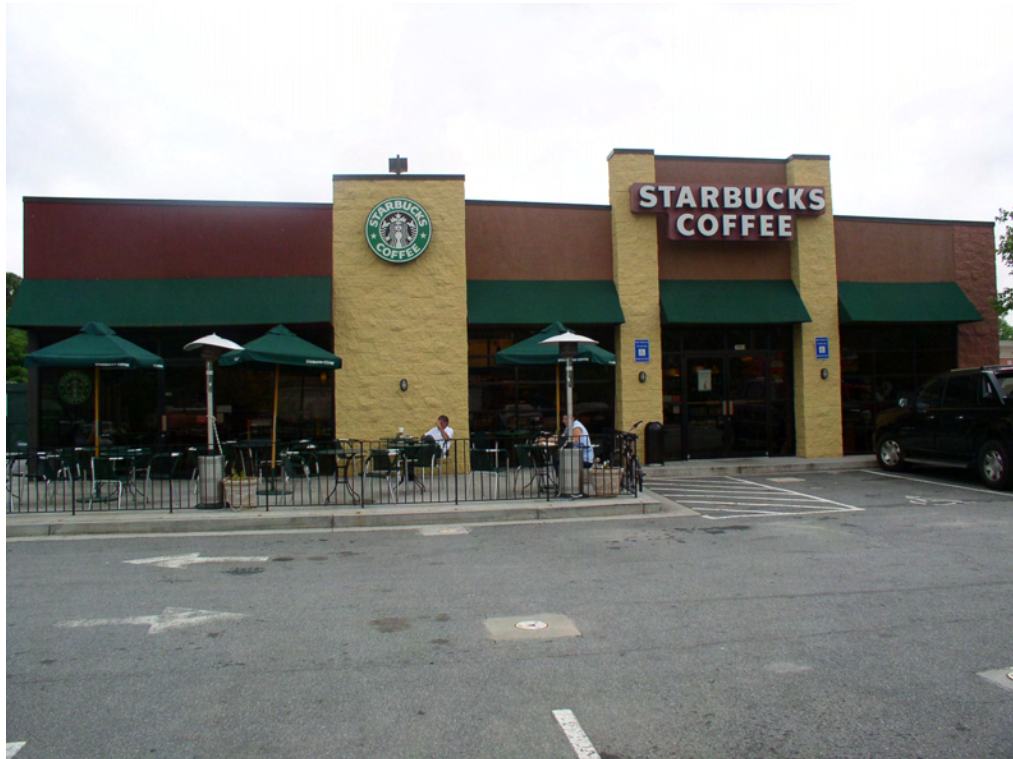
Figure 41. Starbucks, Atlanta, Georgia

The new building resembles a traditional gas station in several ways. First, the yellow piers separate the façade into four broad bays. The three on the right side of the building closely resemble garage bay doors with divided light windows. The bay to the left of the building has

larger panes of glass, much like the retail area of a traditional gas station. Functionally, they rearranged the interior to place the service area in the center of the building with seating to the sides.

The following two examples are related to the topic of this paper in that they deal with gas stations. However, they are not rehabilitation projects. The Starbucks at 3901 Peachtree Road in Atlanta, Georgia is a gas station inspired building on the site of a demolished gas station (Fig. 41). This example shows how a corporate retailer has capitalized on the design of the gas station, while irresponsibly demolishing an existing gas station. The well-known American architect Frank Lloyd Wright designed the Phillips 66 gas station in Cloquet, Minnesota (Fig. 44). While the gas station is still functioning as a gas station, it shows that even a very accomplished architect was interested in the design of gas stations during the height of his career. This gas station is significant because it is the only gas station that Wright designed that was actually built. This presents the problem of preserving and interpreting culturally or historically significant gas stations.

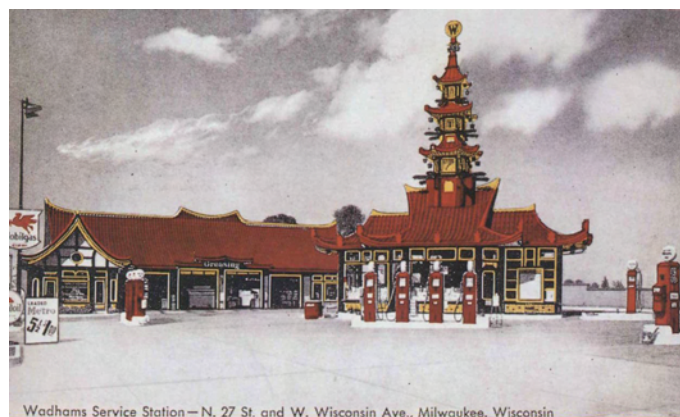
Figure 47. Chinese Pagoda Style Gas Station

Architecturally, traditional gas stations offer a wide array of architectural styles that span almost a century. They range from classically inspired temple forms to Chinese pagodas to small cottages (Fig.47 and 48). Therefore, they add to the rich mixture of styles that contribute to a location's sense of place. A small café located in a former gas station built in the art deco style is much more interesting than a rectangular box building with a flat roof and applied ornament.

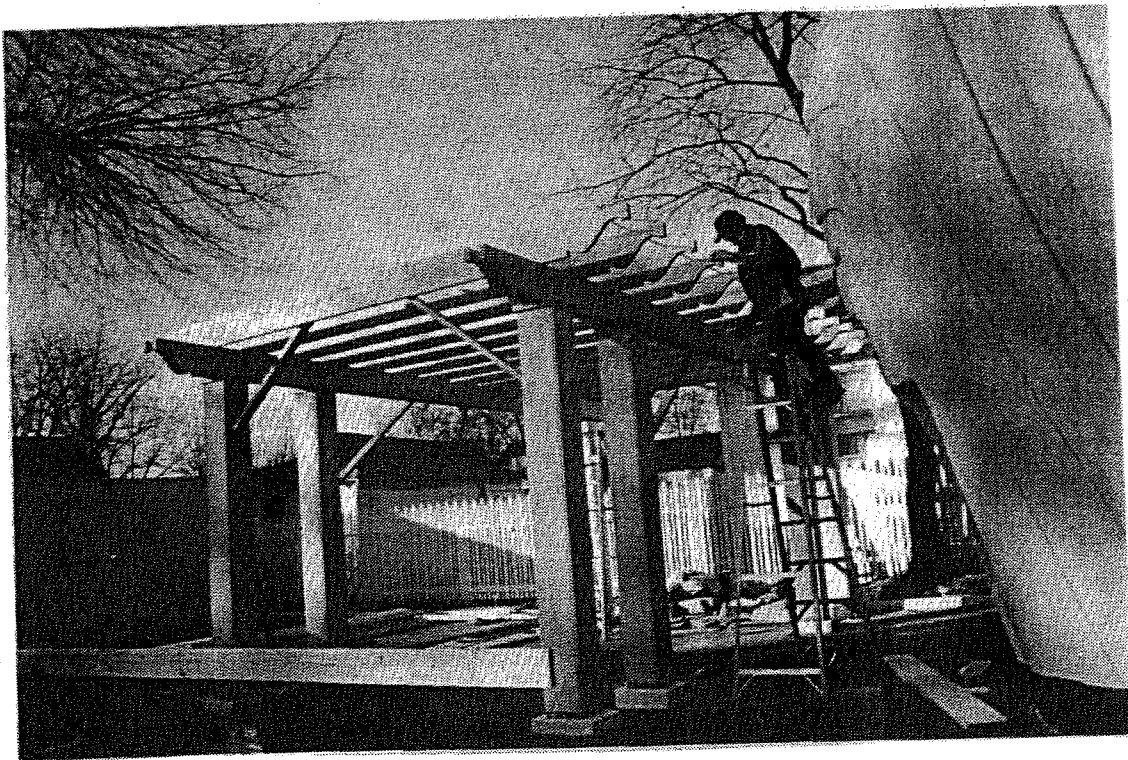
This work was done in the coldest weather of the winter, but a short break in the bad weather allowed the painters and the carpenter to finish it by mid-January. Special thanks goes to David Bergstone for designing the structure.

The carwash shelter.

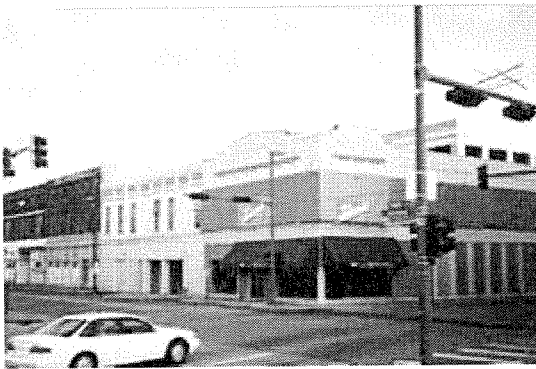
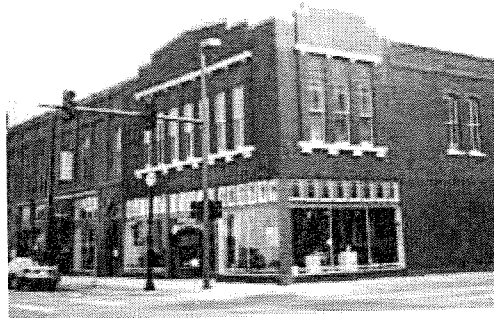
*This two-story brick commercial building--with its corner storefront--was originally constructed ca. 1876, then remodeled in 1916 in the Craftsman style and given a new, distinctive roofline. It served a number of uses, including a hotel, boarding house, saloon, restaurant, liquor store, warehouse, and office furniture showroom. The red brick walls had been painted several times over the years. Rehabilitation work included removal of multiple paint layers using a chemical stripper and thorough water rinse; spot repointing with matching mortar; and appropriate interior alterations. The building is now being used as a retail shop. Photos: NPS files.*
