GEORGIA STATE PARKS: A TECHNOLOGICAL APPROACH TO
DOCUMENTATION AND CULTURAL RESOURCES

A Thesis Submitted to the Graduate Faculty of The University of Georgia in Partial
Fulfillment of the Requirements for the Degree

MASTER OF HISTORIC PRESERVATION

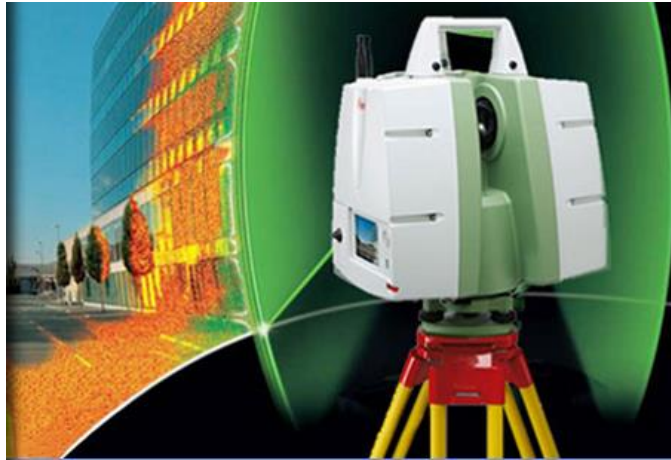
Figure 2.6 Example of 3D Terrestrial LiDAR Scanning equipment and capability (<http://transconimagingsolutions.com/>)

. 3D terrestrial LiDAR scanning is another technology that is heavily used by HABS/HAER/HALS and Direct Dimensions Inc (DDI). This technology can be used for both documentation and highly accurate measurements. “Laser Scanning is the process of shining a structured laser line over the surface of an object in order to collect 3-dimensional data. The surface data is captured by a camera sensor mounted in the laser scanner which records accurate dense 3D points in space.”⁵⁸ 3D terrestrial LiDAR scanning has been in use since 2002. The old machines were huge and had limited vision, but by 2006 the machine could spin 360° and could almost capture a complete 180° spectrum from the top of an object to the bottom.⁵⁹ 3D terrestrial LiDAR scanning is mostly used in long and medium range projects. One such project was done in 2006 to capture and record the Statue of Liberty. According to Mr. Dana Lockett, 3D terrestrial LiDAR scanning is used 99% of the time in projects because of its broad range of

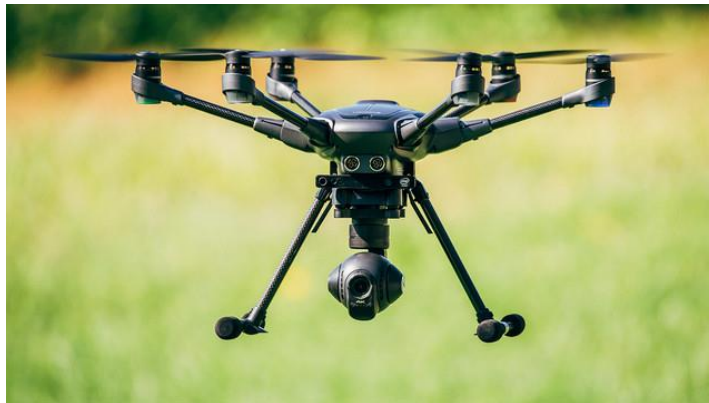
Figure 2.7 Example of an UAS (<https://www.pcmag.com/roundup/337251/the-best-drones>)

The use of unmanned aerial systems (UAS) as a technology is becoming increasingly prevalent by both the private sector and governmental entities. UAS have the potential to be integrated with both 3D terrestrial LiDAR scanning and photogrammetry, but the previously mentioned issues should be addressed. UAS are excellent at simple digital recording and documentation. They also have the benefit of recording areas and features of an object they may not be accessible to people due to height, tight quarters, or both. UAS are also highly affordable in comparison to other technologies that are currently in use. Depending on the size and capabilities desired, the price tag of a unit can vary. This technology that is also continuing to become less expensive as they are mass produced for a civilian populace. In Georgia State Parks, UAS use must be approved by DNR management and those that pilot these UAS must meet FAA regulations and be

licensed pilots. With those two caveats in mind, a UAS can serve numerous functions for a state park. They can document and record complete images of cultural resources. They can be used to map and scan entire park properties either using aerial photogrammetry, aerial LiDAR, or simple digital recording. These videos can be used for social media advertising, park interpretation videos, budgetary meetings, or any number of presentations where having full range image of a park and its cultural resources would be of value.

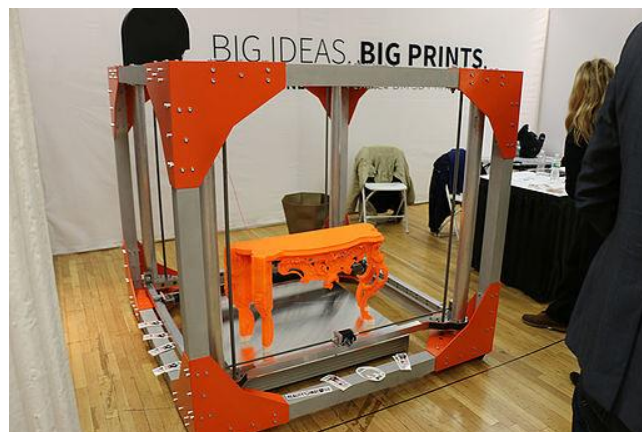
Figure 2.8 Example of a 3D Printer (<https://nursingeducationnetwork.net/2017/11/05/3d-printing-in-healthcare/>)

The final technology presented as being useful in cultural preservation management and monitoring is that provided by 3D printing. 3D printing, when used in conjunction with detailed AutoCAD® (or similar software programs) rendering derived from digital scans, can reproduce any number of features in materials such as bronze, plastic, rubber, foam, crystal, or wood.⁶⁷ A clean model scan can allow for a 3D replication of the scanned model at varying scales. A model can be used for

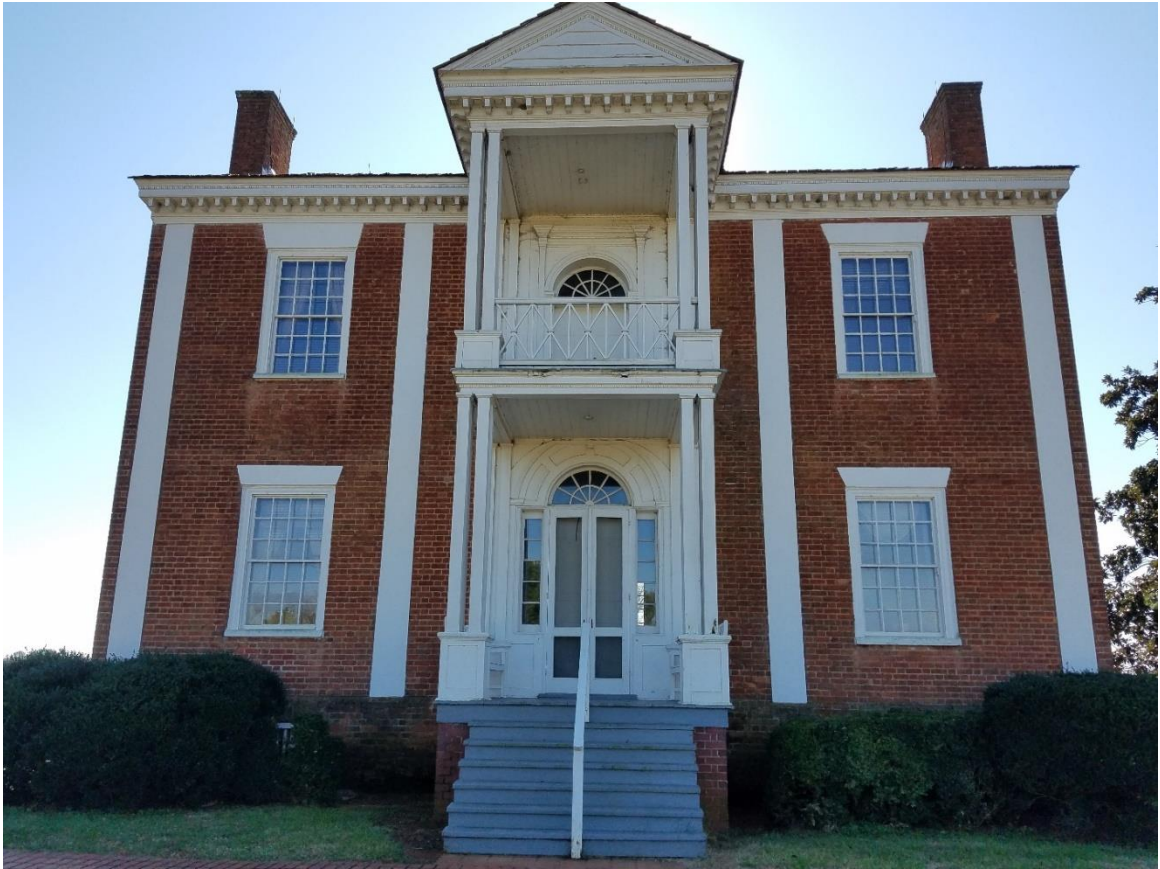
Figure 3.5: Chief Vann House-Front Exterior of the north elevation. The structure is a 2-story brick federal style building. Note the 3-bay design, the 9 over 9 double hung windows, the central entry on the first floor with fan and sidelights, as well as a 2nd story porch with pediment (Author's photo.)

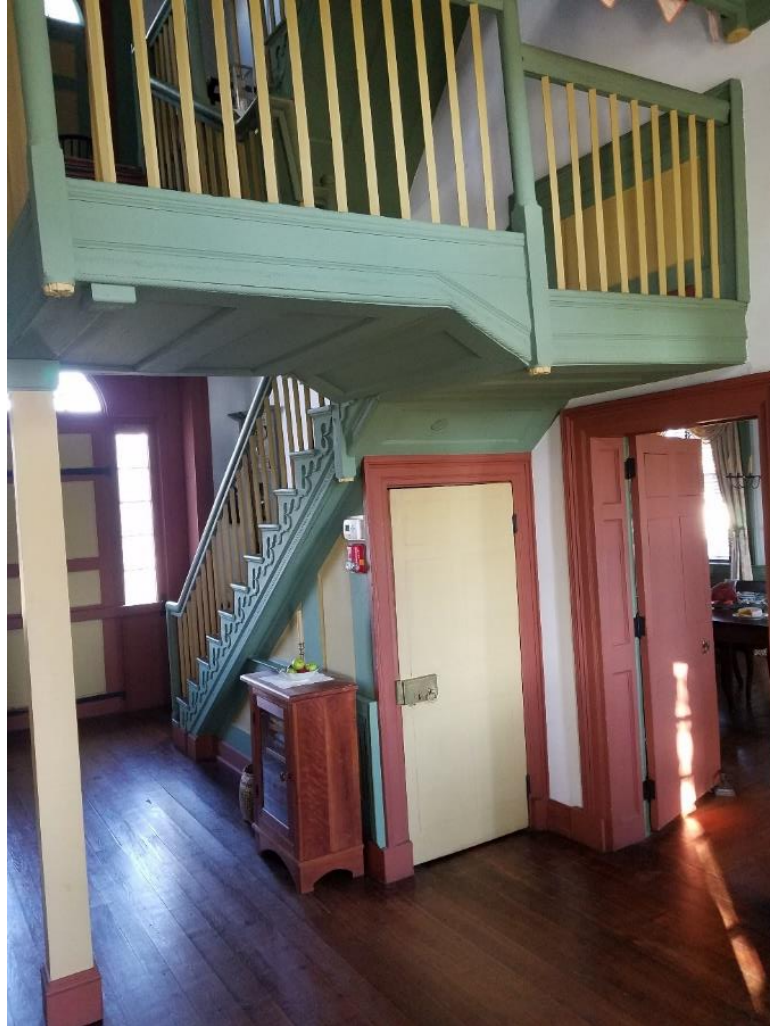
Figure 3.10: Chief Vann House- Cantilevered Stair featuring the wooden post added to support the landing to prevent further damaging stress to the structure and possible collapse. Also visible is the later addition of the basement entrance beneath the stair. (Author's Photo).

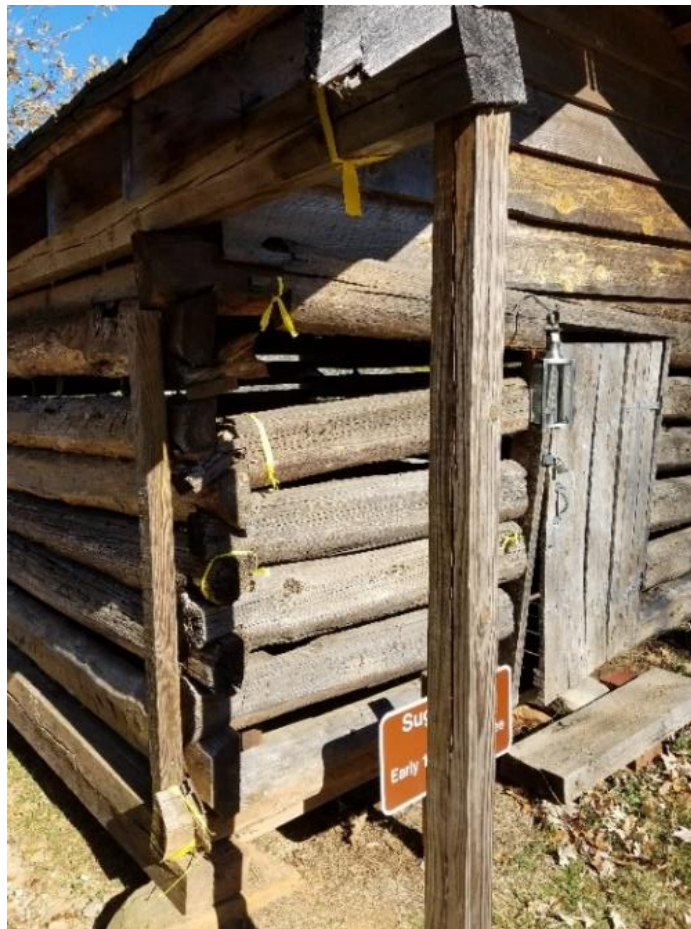
Figure 3.11: C.V.H. exterior cabin. Visible here is a structural issue where a supporting beam inside of the cabin was removed without proper consideration and as a result the wooden log twisted under the pressure cracking and separating from the corner joints causing additional damage around the door frame. (Author's Photo)

The common long-standing issues that continue to go untreated due to lack of funding are needed repair work on the Chief Vann House porch and a smattering of wood repair work needed on the cabins and other exterior structures.⁸⁸ One such example can be seen in (Figure 3.11 and Figure 3.12) where an internal support beam was removed which caused undue stress on the external wooden logs of the cabin. The shattering and separation of the wooden log from the corner joint is a result of this structural stress.

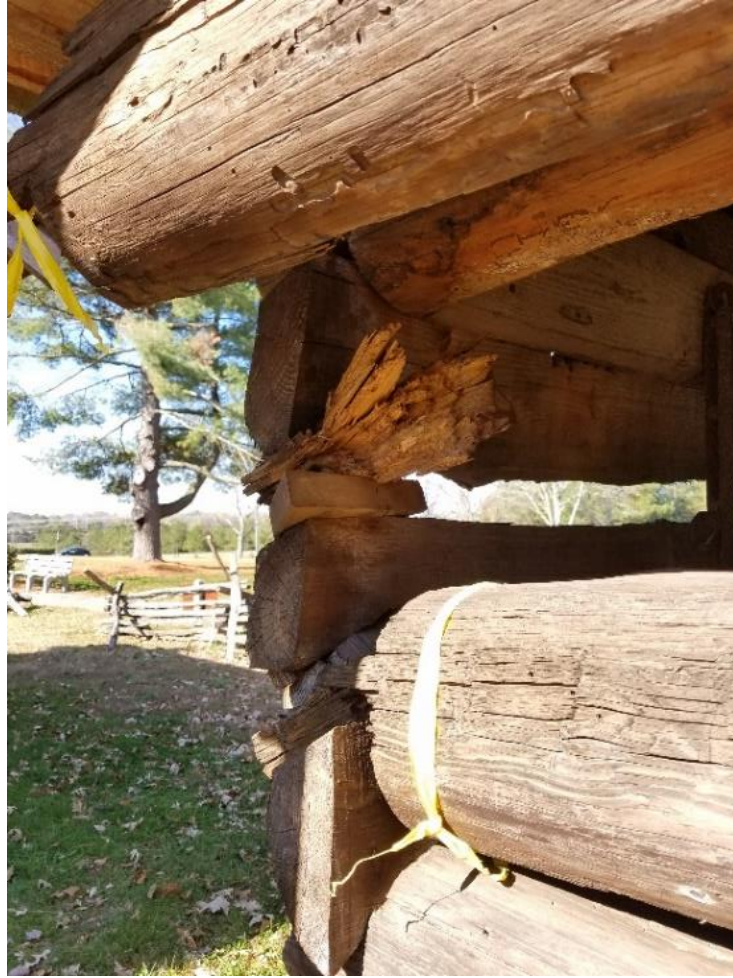
Figure 3.12 C.V.H. exterior cabin, Visible here is the point where the wooden log cracked from the pressure of the lost internal structural support and separated from the corner joint. (Author's Photo)

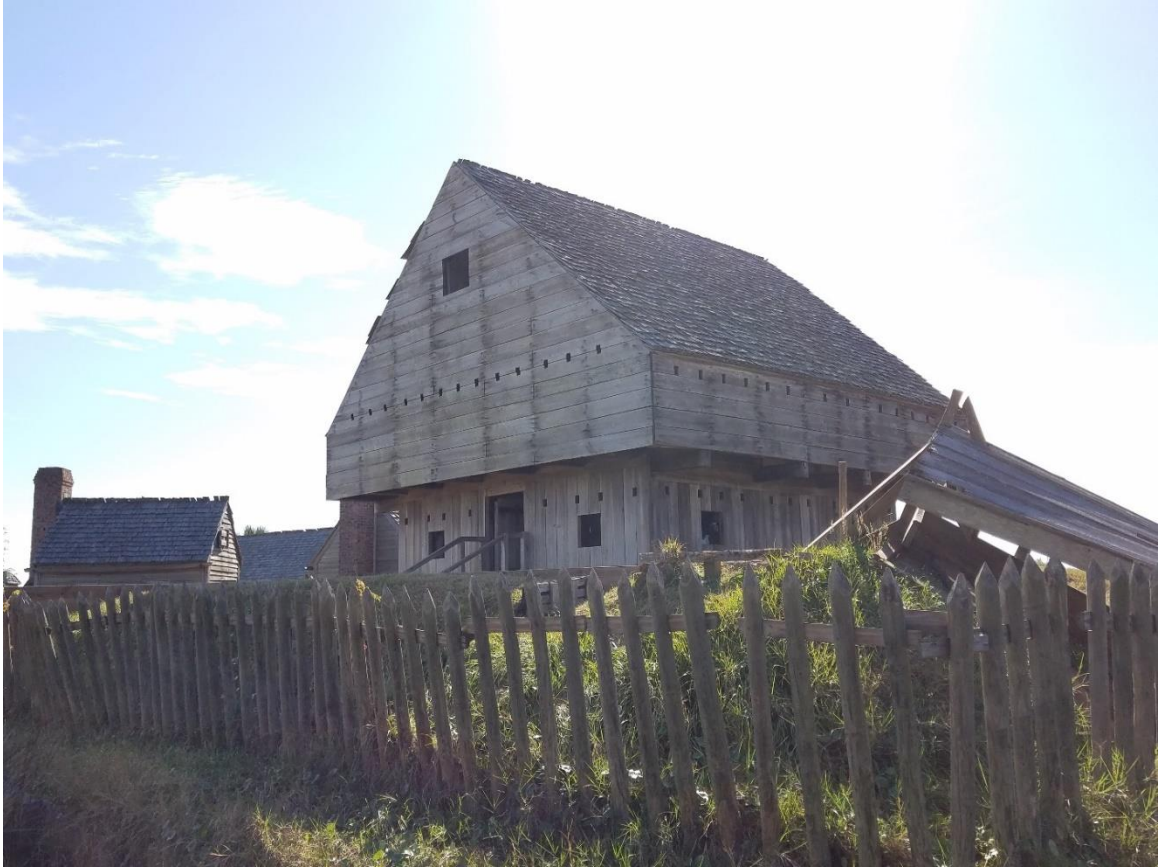
Figure 3.13: Fort King George- Pictured here is the Cedar Blockhouse which is the main cultural resource of the historic site. Also visible in the image is a tipped over and damaged guard house that was damaged during Hurricane Matthew (Author's Photo)

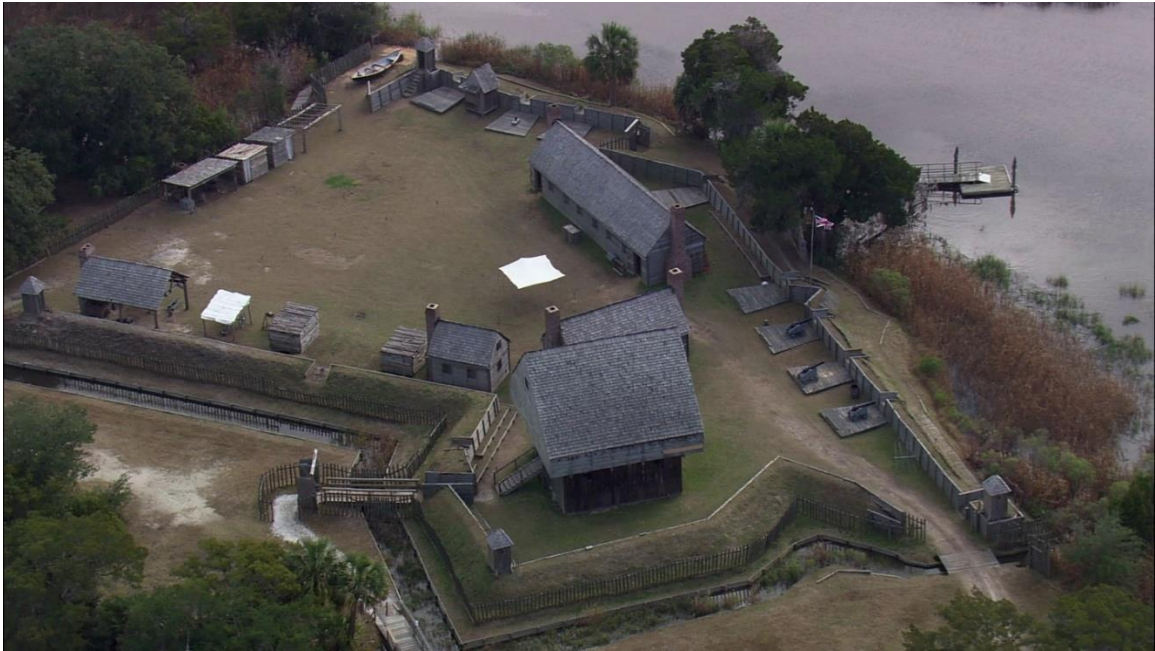
Figure 3.14-Fort King George- From the bottom center you can see the Blockhouse, above that and to the right is the officer's barracks, above that is the soldier's barracks. The right earthwork wall features the gun batteries, the top left presents two shacks and the black smith, the left corner shows the baking and brewing house. Next to those are shacks and a one room cabin. At each of the corners is a guard house. (<https://www.shutterstock.com/video/clip-29661637-stock-footage-fort-king-george.html?src=rel/17397655:8>)

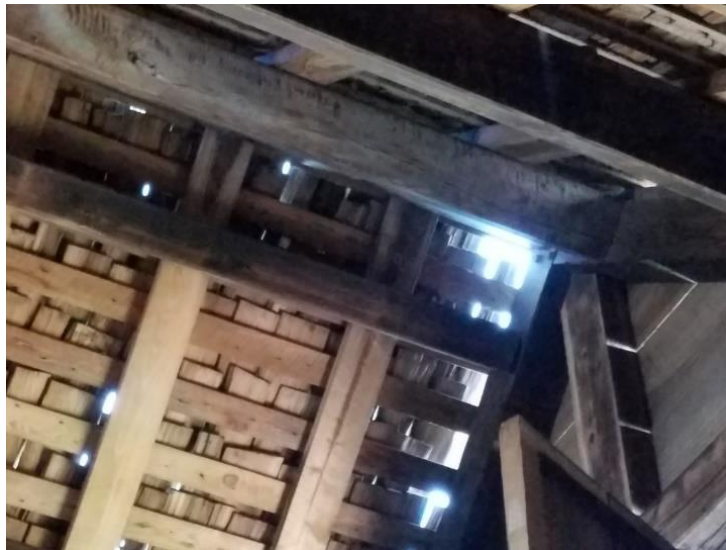
Figure 3.15 Fort King George- This image illustrates the loss of cedar shingles on the Blockhouse roof. The continued absence of these shingles leads to more water damage inside the cultural resource. (Author's Photo)

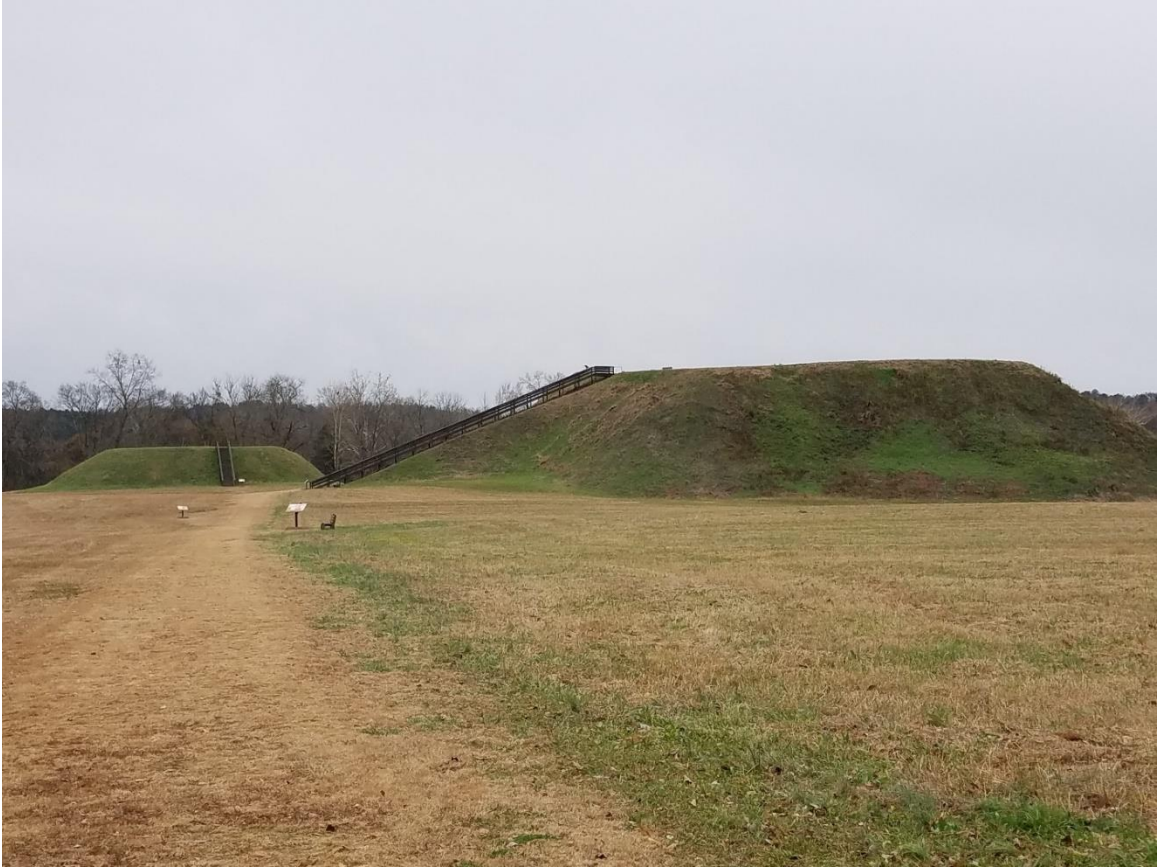
Figure 3.16: Etowah Indian Mounds- Mound A is featured in the front right of the image and Mound B is visible in the back left. (Author's Photo)

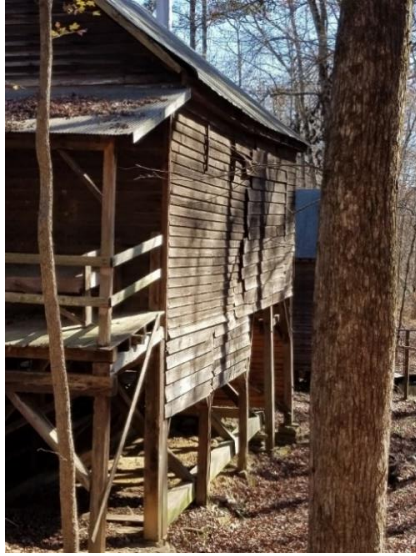
Figure 3.21: Jarrell Plantation- inferior repair work is obviously apparent in this image. The clapboards were not cut so that they would be flush with the rest of the clapboards on the structure and as a result present a visibly poor repair job. (Author's Photo)

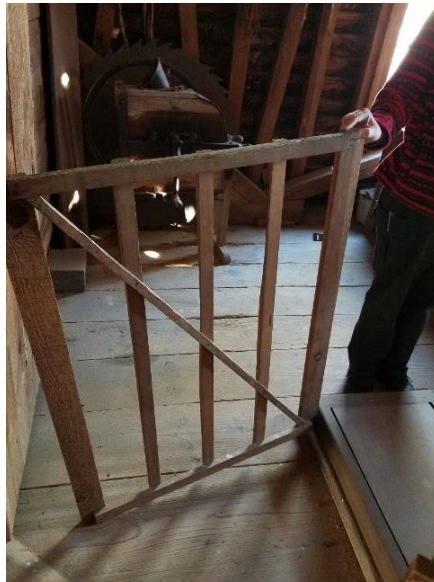
Figure 3.22: Jarrell Plantation- This is a Separation Gate placed in the doorways of each structure to control visitor traffic. (Author's Photo)

Efforts have been made to prevent visitor damage as gates have been placed in the doorways of the structures to control where visitors can go, and how much access they have to the site. (Figure 3.22)

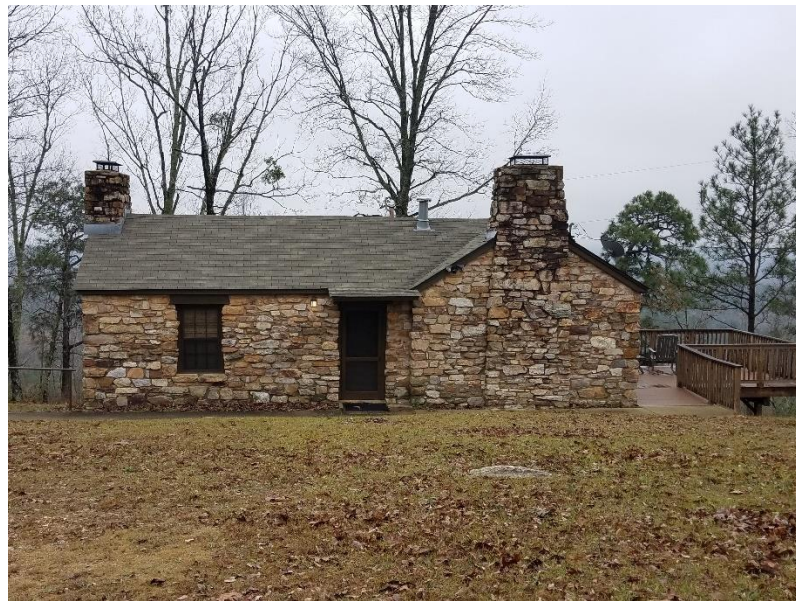
Figure 3.24 F.D. Roosevelt State Park- This is a CCC constructed cabin. It is constructed from local stones, and asphalt shingles. A chimney is visible on each end of the cabin for each of the rooms within the cabin. (Author's Photo.)

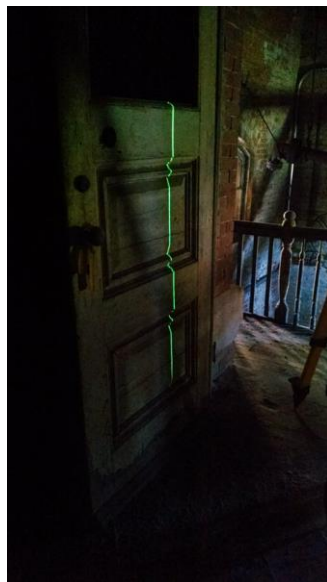
Figure 4.3 laser Scan of original paneled door at Ellis Island
(https://www.facebook.com/pg/HeritageDocumentationPrograms/photos/?tab=album&album_id=696349627095657)

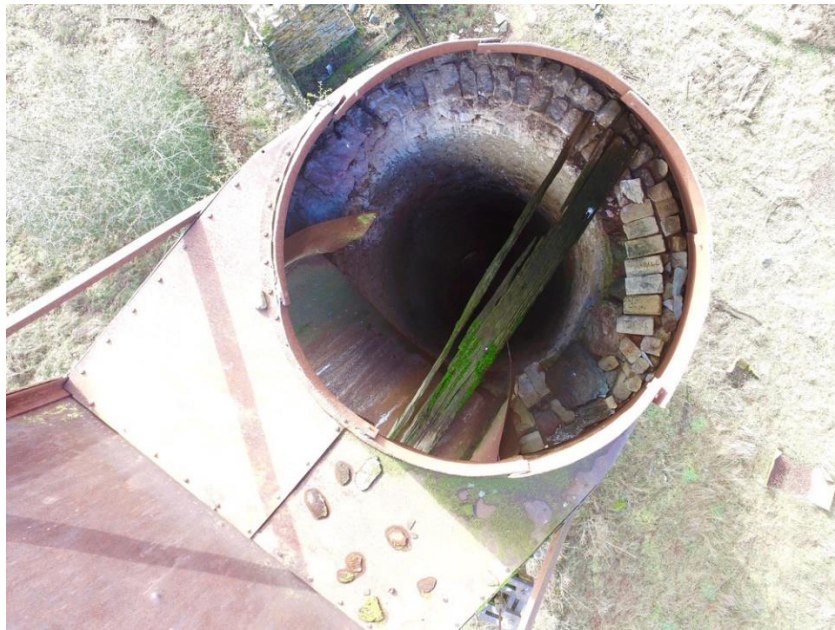
Figure 4.4 UAS aerial view of the Marble Valley Lime Kiln Chimney (<https://www.aerotas.com/cultural-survey/>)

A 3D model of the entire Marble Valley quarry complex, combining the highly detailed imagery of key features from close-up flights with the overhead imagery from the site over-flight, is an invaluable resource for future researchers and historians. They will be able to effectively walk through the site themselves, pursuing their own discoveries from before the Marble Valley Village development.¹⁷¹
