PRE-1850 PAINT IN HISTORIC PROPERTIES:
TREATMENT OPTIONS AND PROCESSES

A Thesis Submitted to the Graduate Faculty of The University of Georgia in Partial Fulfillment
of the Requirements for the Degree

MASTER OF HISTORIC PRESERVATION

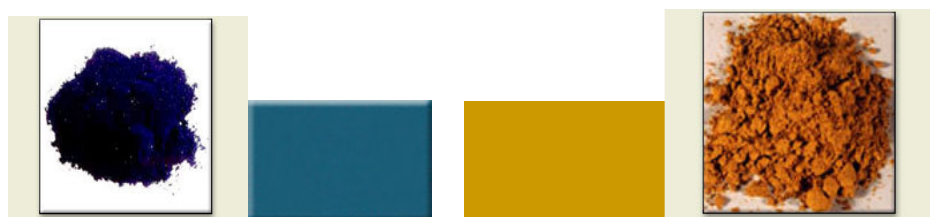
Figure 1: Prussian blue (left) and yellow ochre (right) with their respective pigments.⁴

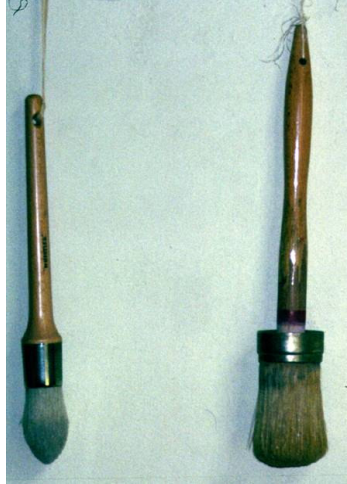
Figure 2: Round hog-hair brushes used traditionally with oil-based paints.³¹

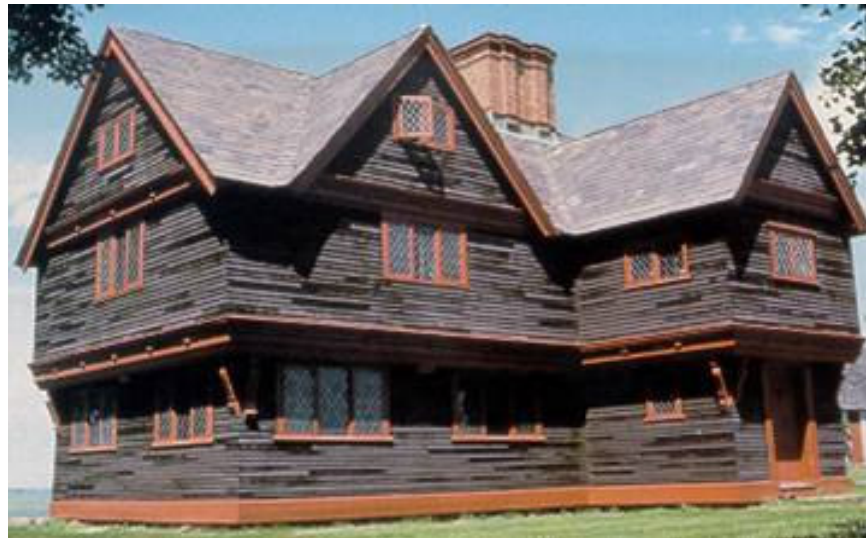
Figure 3: Ross Tavern, Ipswich, Massachusetts, with paint colors restored.⁴⁵

Exterior paint colors for Colonial houses were mostly medium to dark tones, such as reddish browns and grays (See Figure 3). According to Roger Moss, colonial buildings were rarely white on the overall exterior.⁴² Since it was a cheap and plentiful

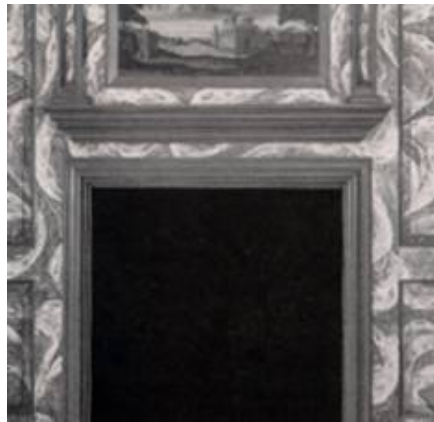
Figure 4: Stylized marbling on a mantel surround in the Pitkin House, East Hartford, Connecticut.⁵⁸

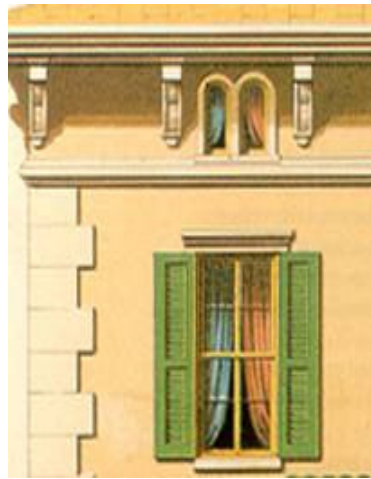
Figure 5: Example of an exterior color scheme influenced by Andrew Jackson Downing.⁶⁶

should copy the colors of building materials (See Figure 5). In his books, he suggested warm grays, similar to slate or bluestone, and brown or fawn colors similar to wood or mellow-colored stones. *Faux* stone finishes fit this ideal perfectly, and blossomed in popularity.⁶⁵

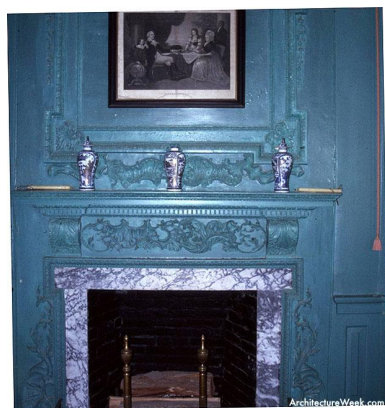
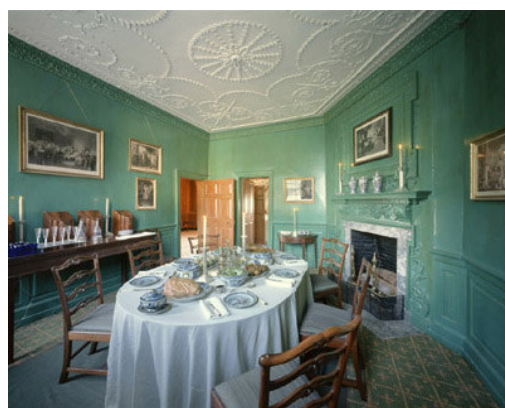
Figure 6 (left): Small dining room at Mount Vernon before 1980 paint analysis.⁸⁵

Figure 7 (right): Same room after repainting based on 1980 findings.⁸⁶

recognizing the changes historic paints are prone to undergo can lead to mistaken identification of colors and subsequent errors in restoration (See Table 3, Figure 6 & 7).⁸⁴

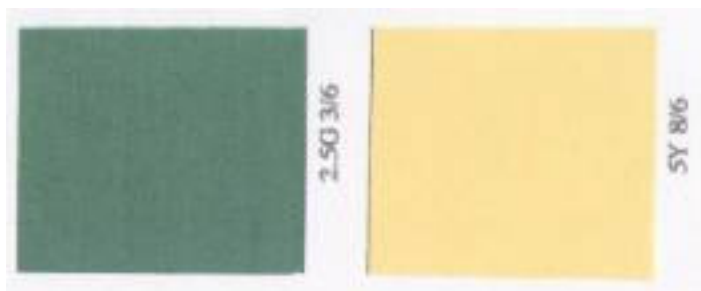
Figure 8: Two Examples of Munsell color samples.¹⁰¹

recommendations about paint removal, methods for conservation and preservation of original finishes and types of paint for restoration repainting (See Figure 8).¹⁰⁰

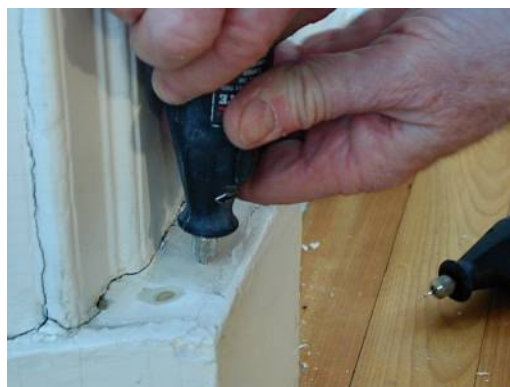
Figure 11: Sampling using a microdrill rather than a knife or scalpel.¹⁰⁹

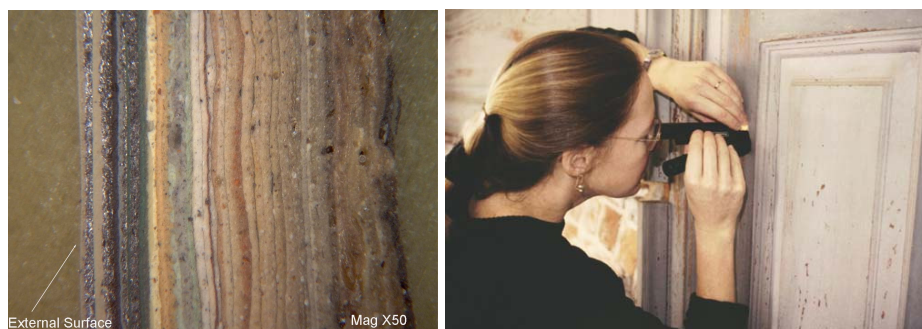
Figure 14 (left): Paint sample at 50x magnification.¹¹⁶

Figure 15 (right): Analyst doing *in situ* examination of a sample using a hand-held microscope.¹¹⁷

discerned by the naked eye or with a hand held magnifier (5x-8x). An inexpensive stereomicroscope (15x-30x) is usually taken along for on-site investigation to allow immediate examination of all removed samples to determine whether they have good paint evidence on them (See Figure 15). A complete microanalysis with a high quality binocular stereo zoom microscope (10x-70x) is done back in the laboratory (See Figure 14).¹¹⁵

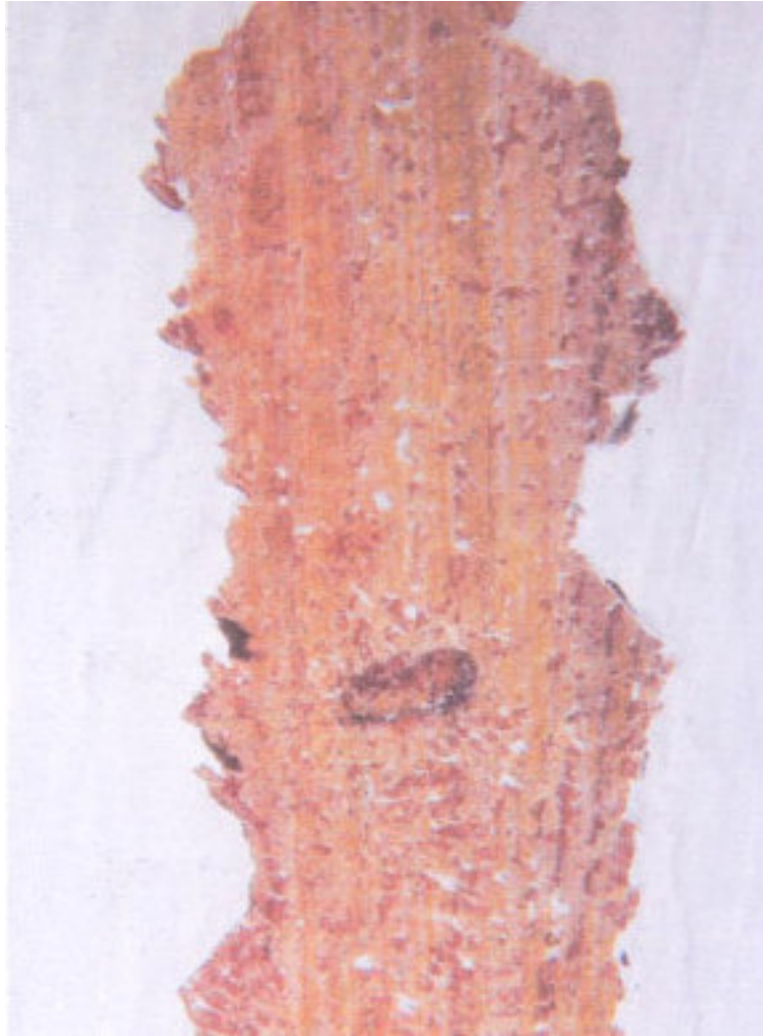
Figure 18: Example of a paint sample showing *faux* graining.¹²⁵

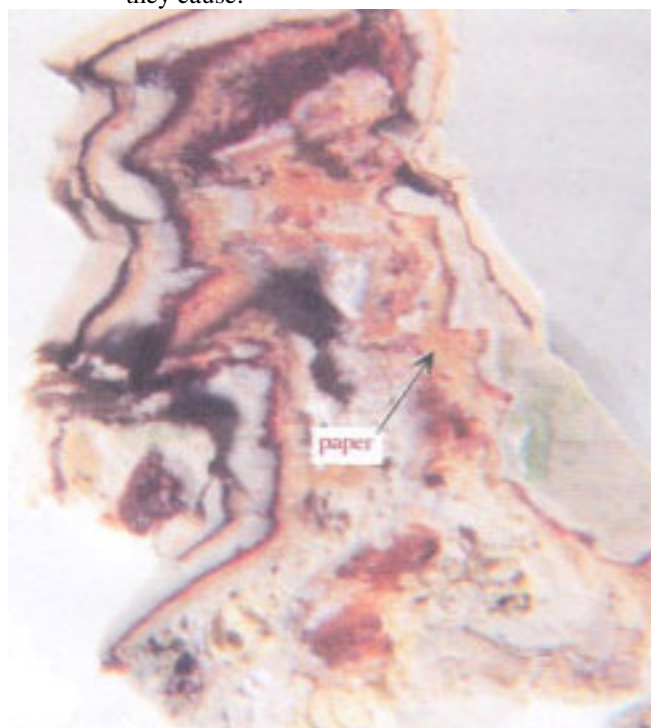
Figure 20: Example of a paint sample showing wallpaper remnants.¹²⁷

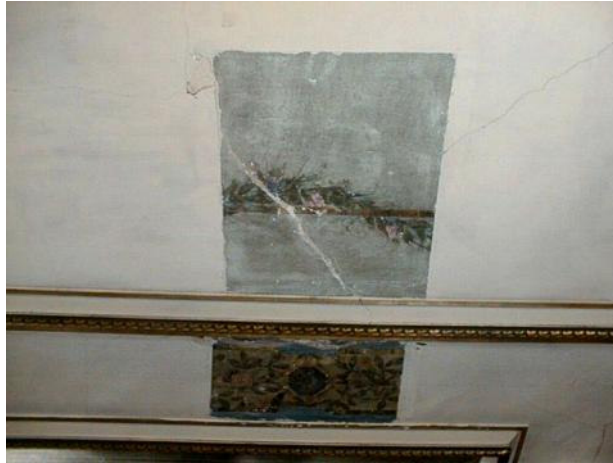
Figure 21: Remnants of historic paint finish being preserved for later research.¹³⁸

plaster, create dangerous fumes if lead is present, and pose a fire hazard. If all of the paint is to be removed, cover a part of the original paint with sturdy, protective tape, then paint over the tape. This leaves evidence for future research (See Figure 21).¹³⁷

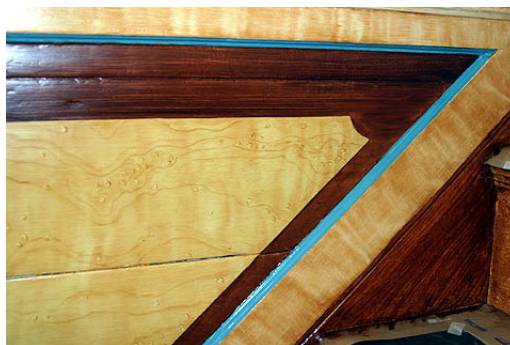
Figure 25: Interior faux finishes found in main hall of Joseph Bell House.¹⁶⁵

The graining process used two types of glazes. The first type is a water-based glaze that uses beer as a medium, mixed with dry pigments. This type of glaze is traditional; especially for maple and bird’s eye maple graining. Oil glazes, made from an

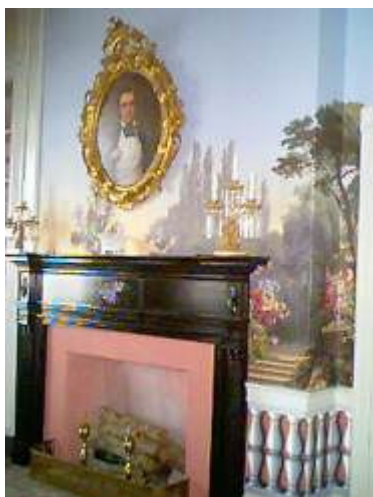
Figure 27: Formal parlor of Carnton Plantation.¹⁶⁹

The front parlor contained a Greek Revival mantel, a later replacement of the Federal style mantel still extant in the connecting rear parlor (See Figure 27). It was recommended that it be kept as an example of a legitimate taste change and point of interest in the house's interpretation. The analysis showed that after restoration of the fireplace, the hearth should be painted red and the mantel black to match the original fireplace found in the second floor front bedroom.
