# THE SOD HOUSES OF CUSTER COUNTY, NEBRASKA

A Thesis Submitted to the Graduate Faculty of The University of Georgia in Partial  
Fulfillment of the Requirements for the Degree

MASTERS OF HISTORIC PRESERVATION

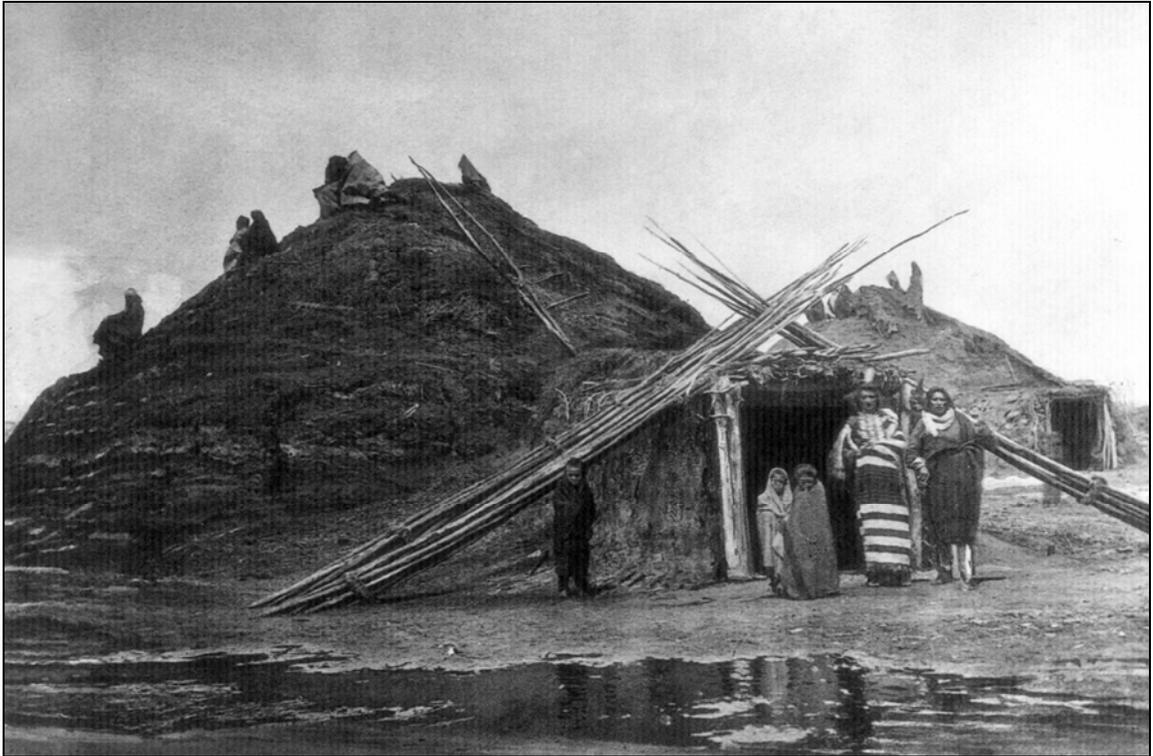
**Figure 6. Pawnee Earth Lodge**

During the cold winters of the Plains, the thick earth covering of the lodges prevented heat loss, and in the summers the earthen walls kept the interior relatively cool. Generally built as clustered communities, these dwellings were typical of the Pawnee as well as other tribes including the Ponca and the Osage. It is known that there were American missionaries sent to the Pawnee as early as 1834.<sup>29</sup> Although there are clear differences between the earth lodge and the sod house, there are enough similarities to suggest that some venturing pioneer, possibly a missionary, attained the idea by observing the Pawnee lodges and adapting the technique.

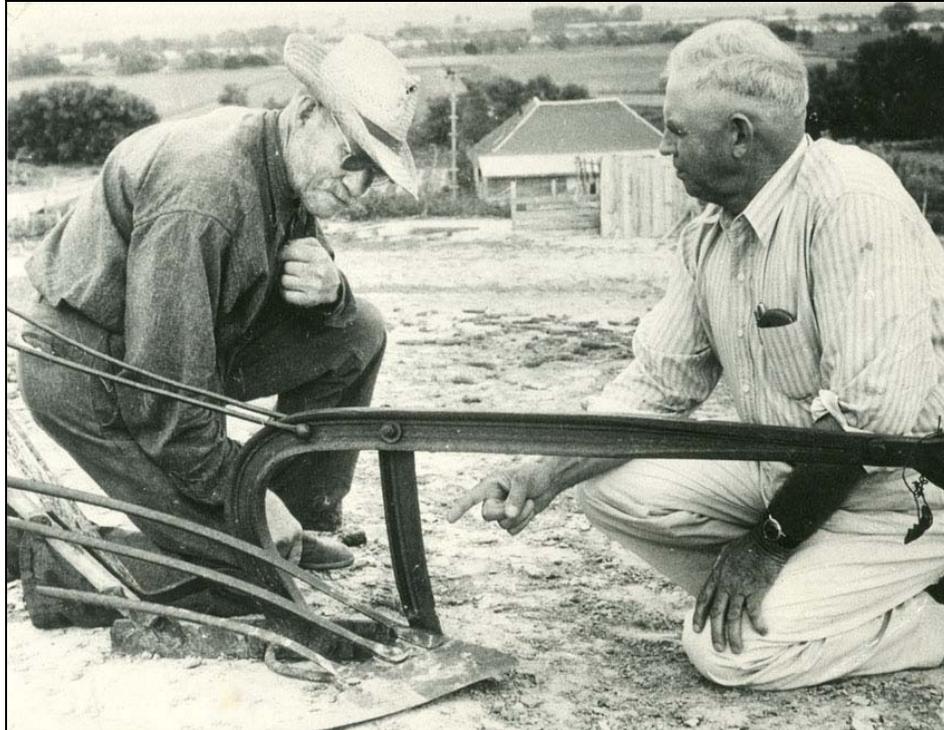
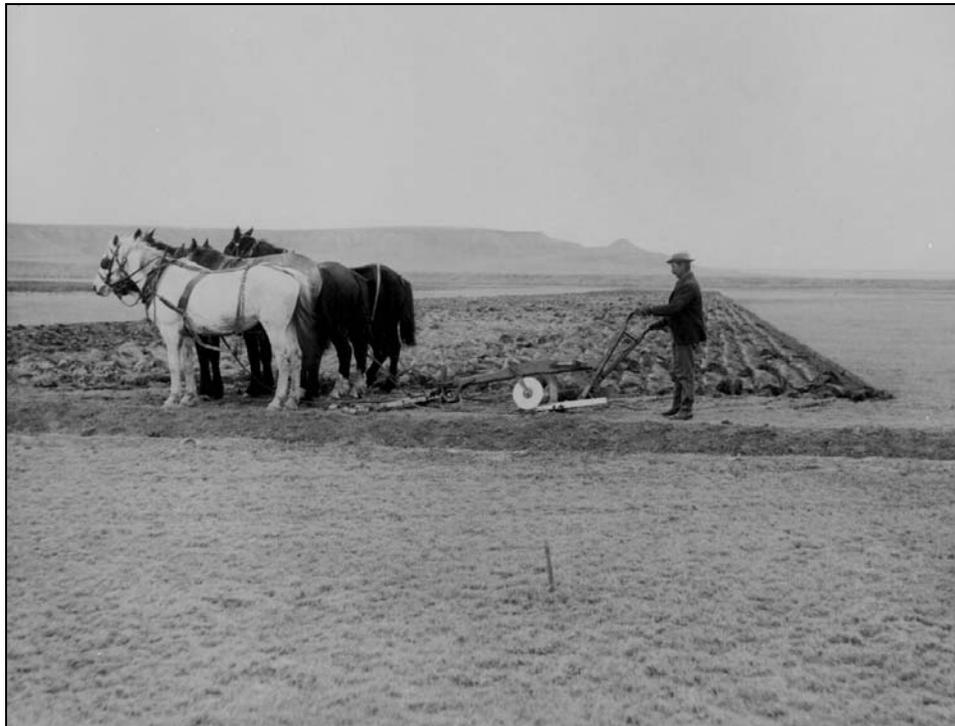
**Figure 9. Material preparation: grasshopper plow and its use in cutting the sod by a team of horses**

The prolific building of sod houses prompted the development of a new plow specially designed for the purpose of cutting sod blocks. Sometime in the late nineteenth century, the “grasshopper” plow, also known as a rod-plow or cutting plow, emerged on the Plains and rapidly spread throughout the region as the ideal tool for builders. In place of the breaking plow’s mould board, the grasshopper plow was lighter and had a set of adjustable rods that allowed the sod to be carefully cut into long ribbons three to six inches deep and one to one-and-one-half feet wide.<sup>56</sup> With a team of horses, the capacity of a day’s breaking could be doubled, but oxen were preferred because their slow pace permitted straight furrows, which produced the most uniform blocks (Figure 9). After the sod was plowed, a sharp spade was used to cut the strips into blocks of varying lengths depending on the preference of the builder. Sod blocks cut by the plow are significantly more uniform and slightly thinner with cleaner edges than those cut with just a spade.

until the 1870s and there has yet to be any recorded evidence of the plow as early as that time. An 1874 *Knight's American Mechanical Dictionary* published in New York lists a sod plow as, "a plow long in the share and mold-board, adapted to cut and overturn sod." This definition is too vague to determine which type of plow it is referring to, but it seems to better describe the common breaking plow rather than the grasshopper plow. By 1897, a grasshopper plow with a sharp blade that would cut a twelve-inch strop of sod was advertised in a Sears, Roebuck, and Company catalog for \$6.50.<sup>57</sup> Other personal accounts speak of builders who made their own grasshopper plows that were patterned on commercial models.

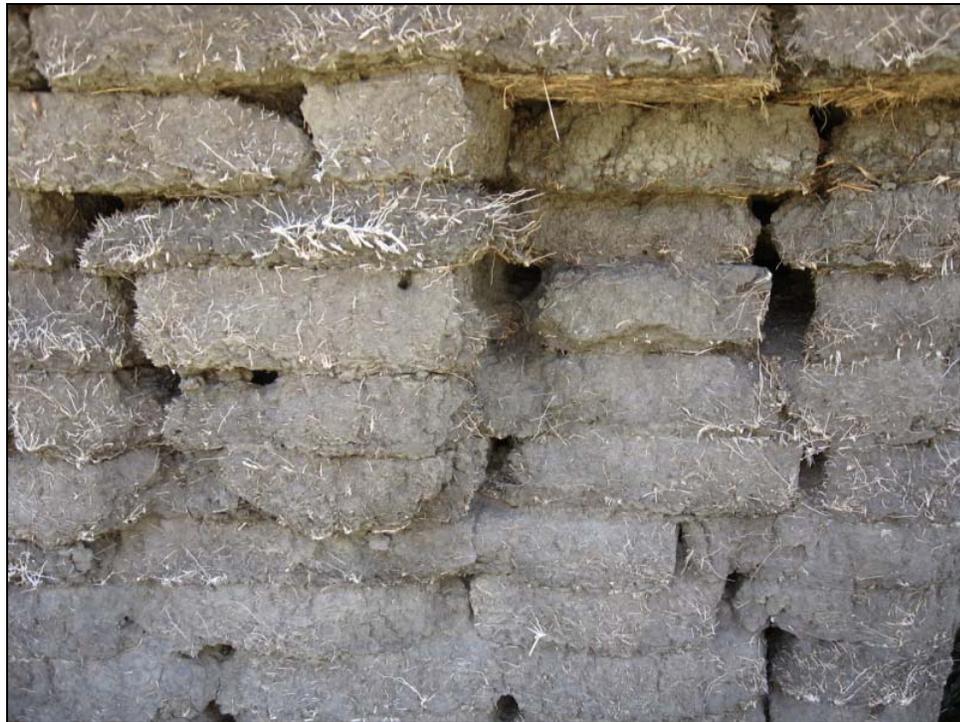
**Figure 10. Wall construction: blocks laid two wythes deep with alternating headers and stretchers**

of stretchers were laid at least two wythes deep with a one course or three course common bond (Figure 10).<sup>59</sup> It is possible that a bond higher than a three course common bond was employed; however, if the height of the stretcher courses was raised too high without a binding header course, the stability of the wall would be at risk. English bonds were also used.

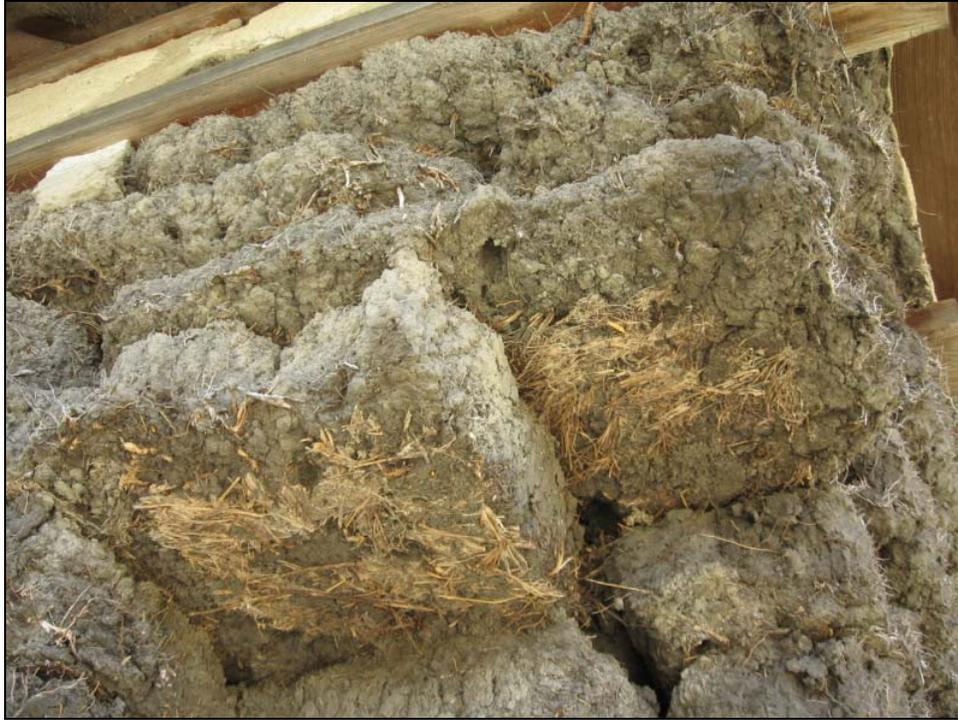
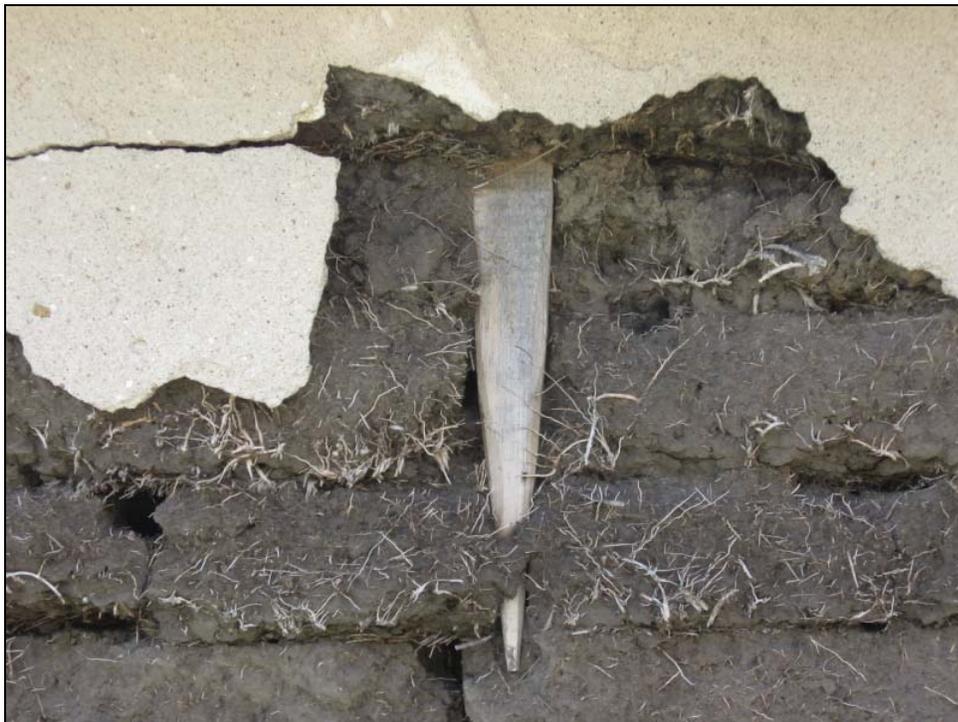
**Figure 11. Wall construction: blocks laid grass side down, and sometimes included wooden stakes driven through the blocks**

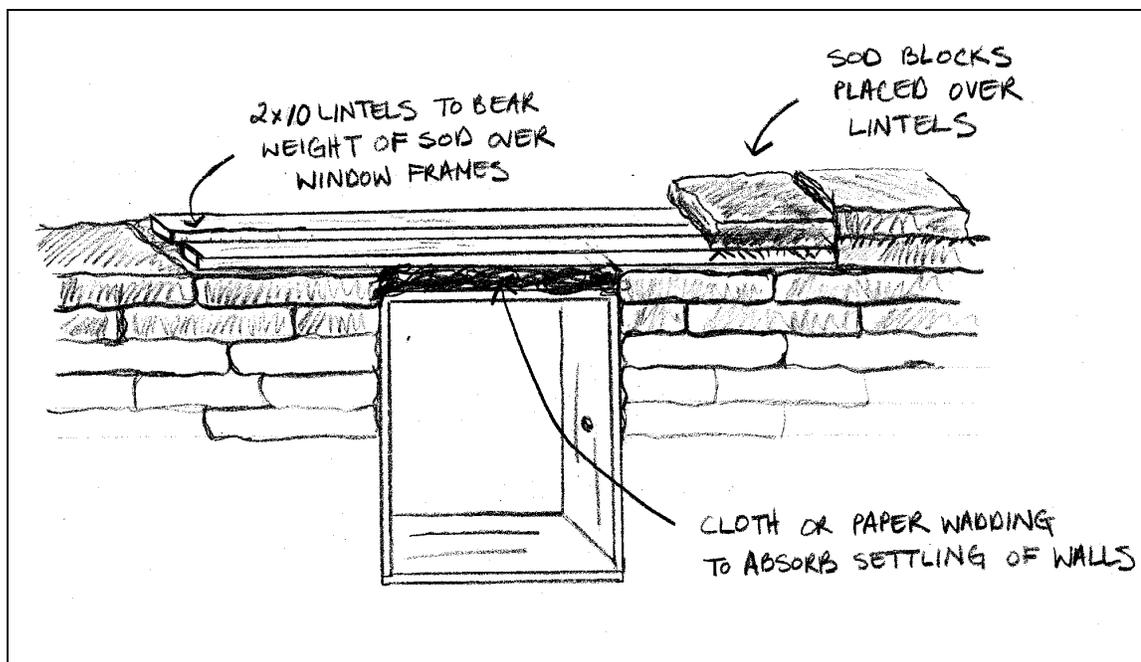
Figure 12. Windows: Sketch illustrating window construction

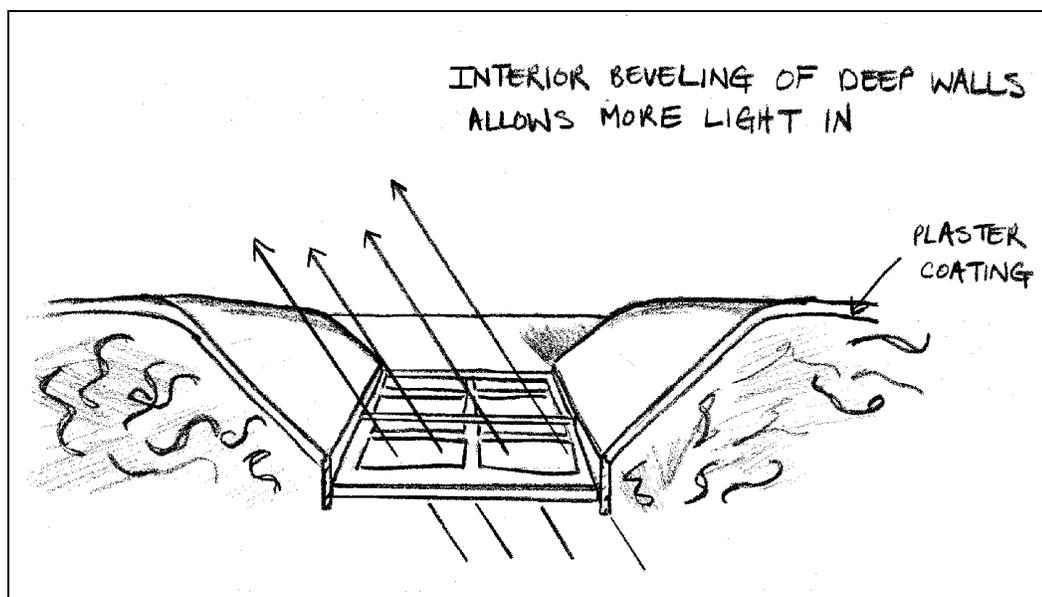
Figure 13. Windows: Sketch illustrating the beveled walls on the interior to allow more light

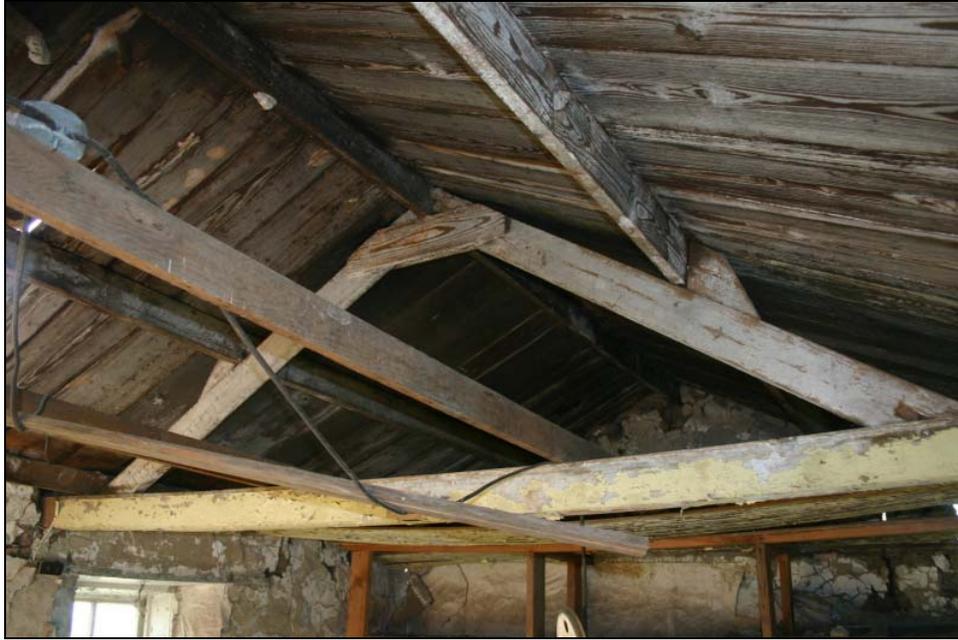
Five beam gable roof with frameless sheathing and later supported with principle rafter roof

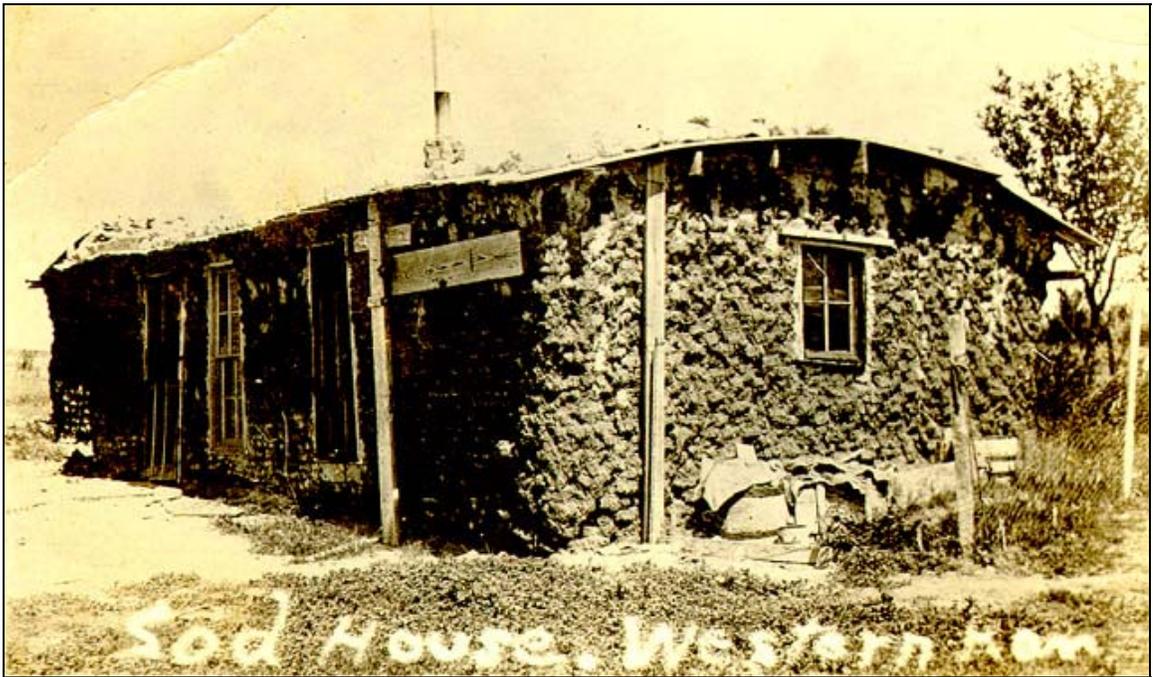
**Figure 15. Roofs: Rounded roof example in Kansas**

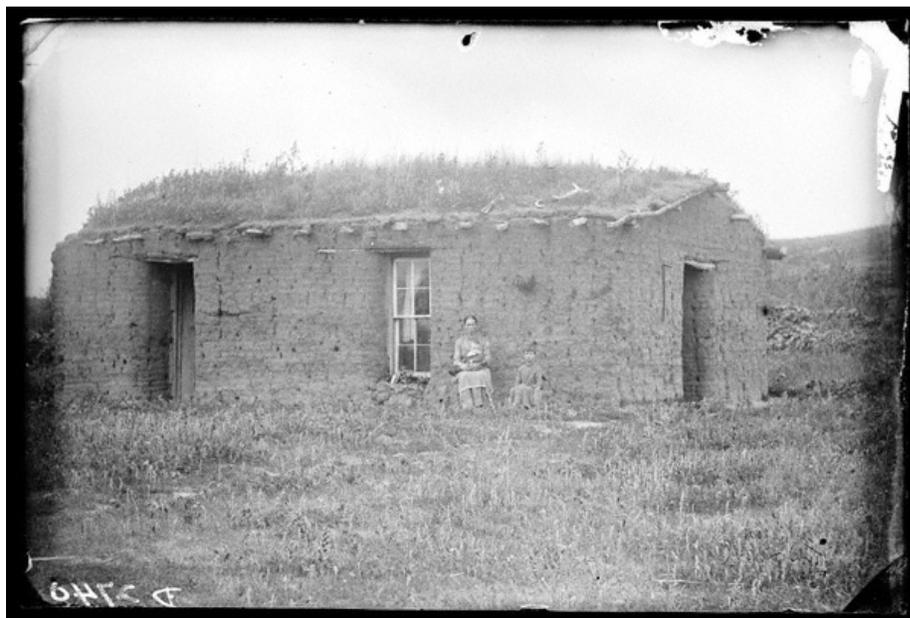
**Figure 16. Roofs: Early brush and pole construction method**

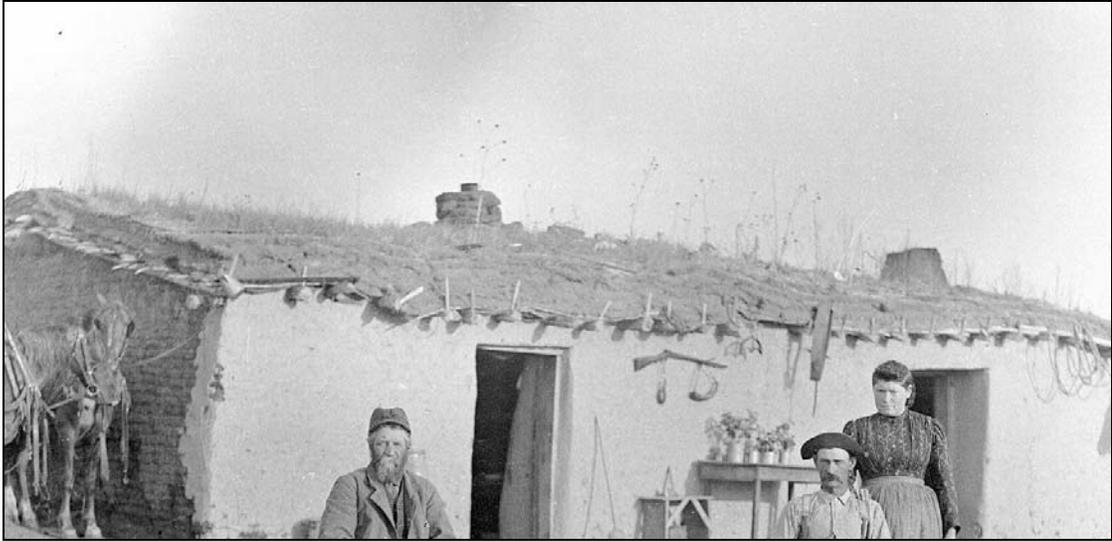
**Figure 17. Roofs: To keep sod from slipping off roof, pegs were sometimes inserted into the ends of rafters**

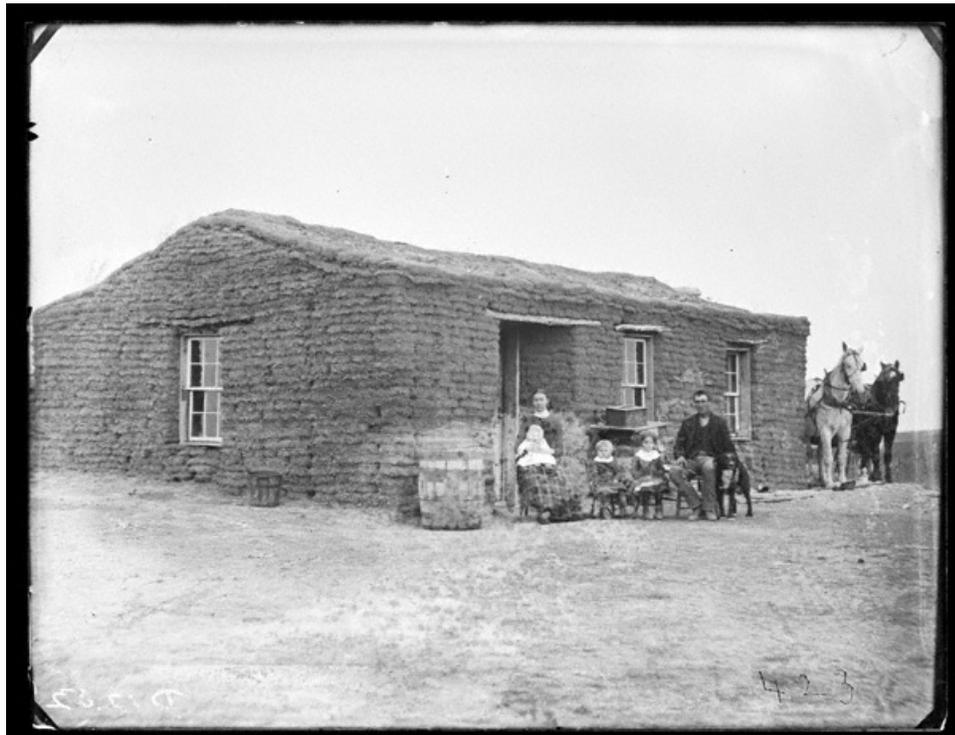
**Figure 18. Roofs: Eaves eliminated and walls rounded up to the plane of the roof**

ground with ropes or wires, or drove stakes down through the roof and into the sod walls (Figure 18).<sup>74</sup>

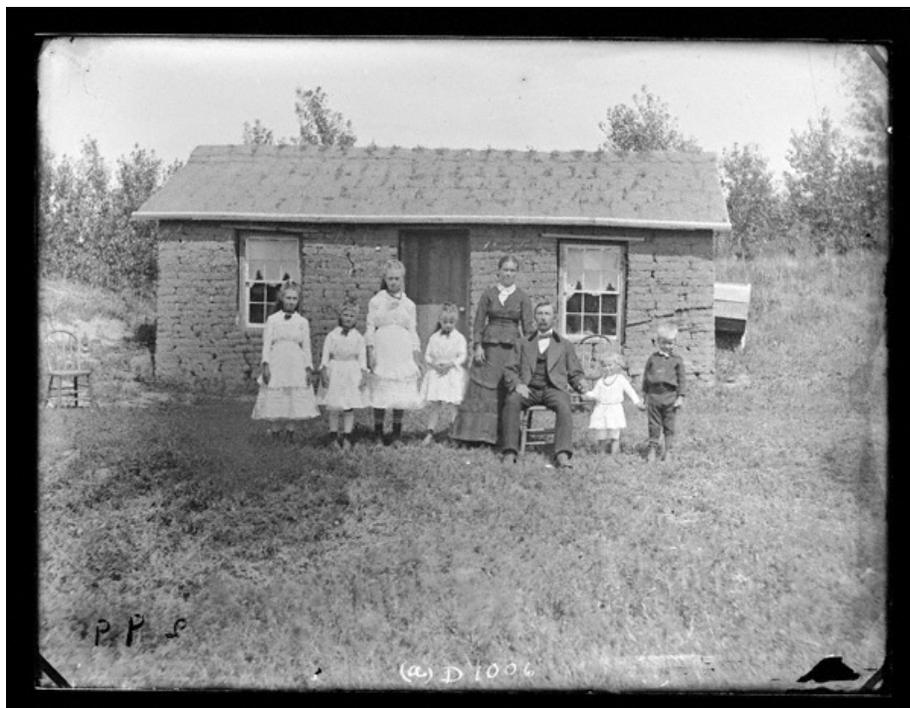
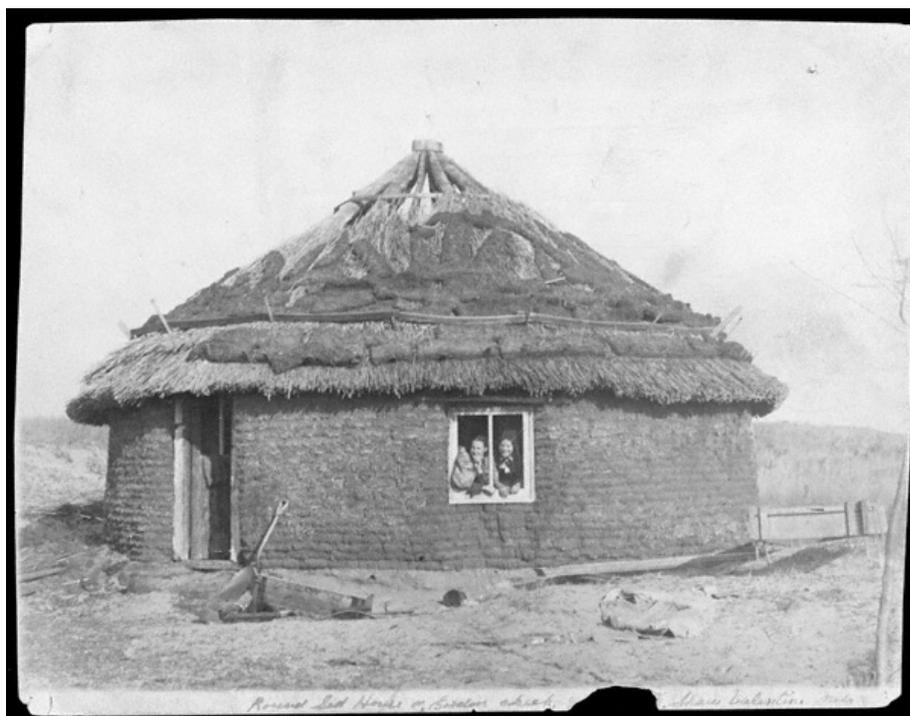
Common rectangular plan, circa 1888

Rare example of a round plan sod house in Cherry County, circa 1904

**Figure 24. Various plans found in Butcher Collection**

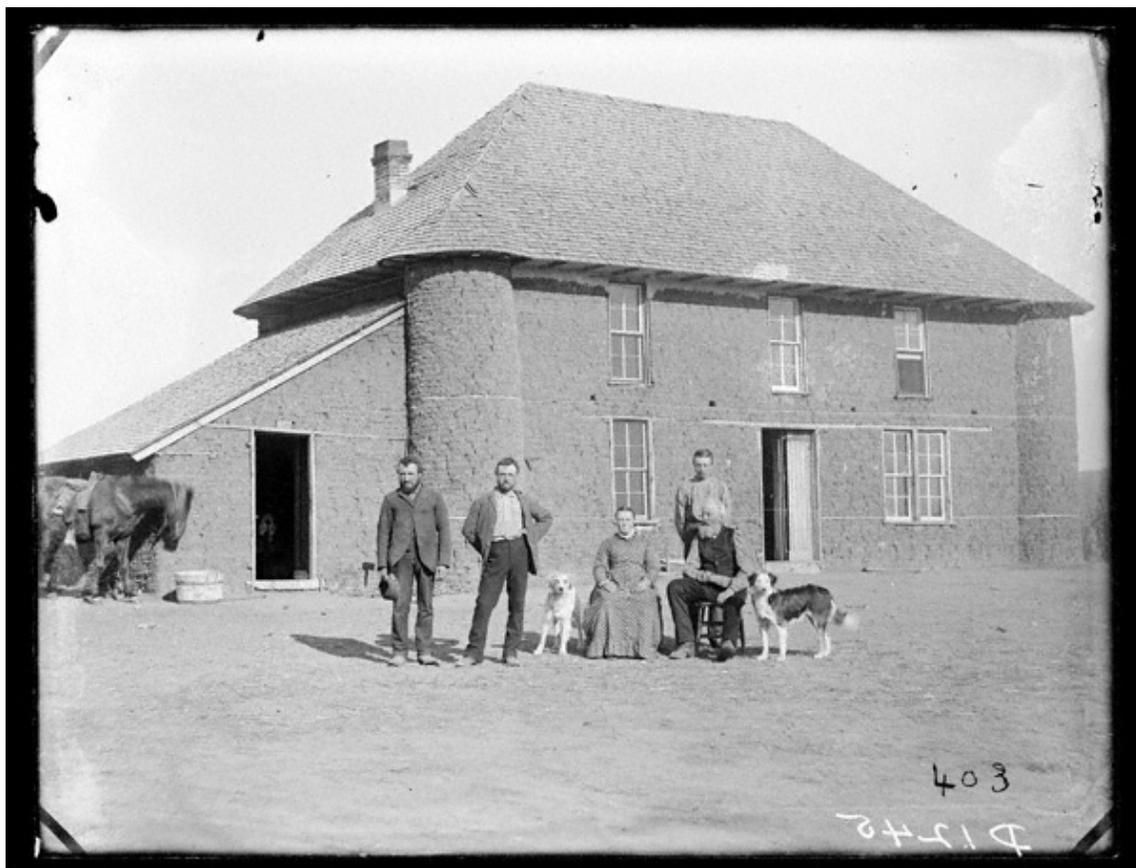
Figure 25. Rare example of a two-story sod house, circa 1886

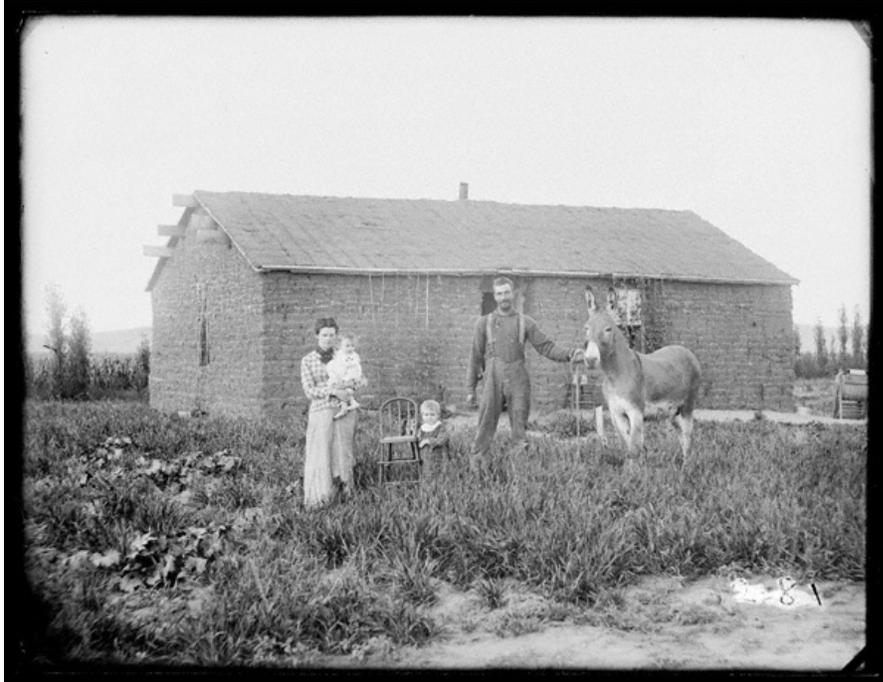
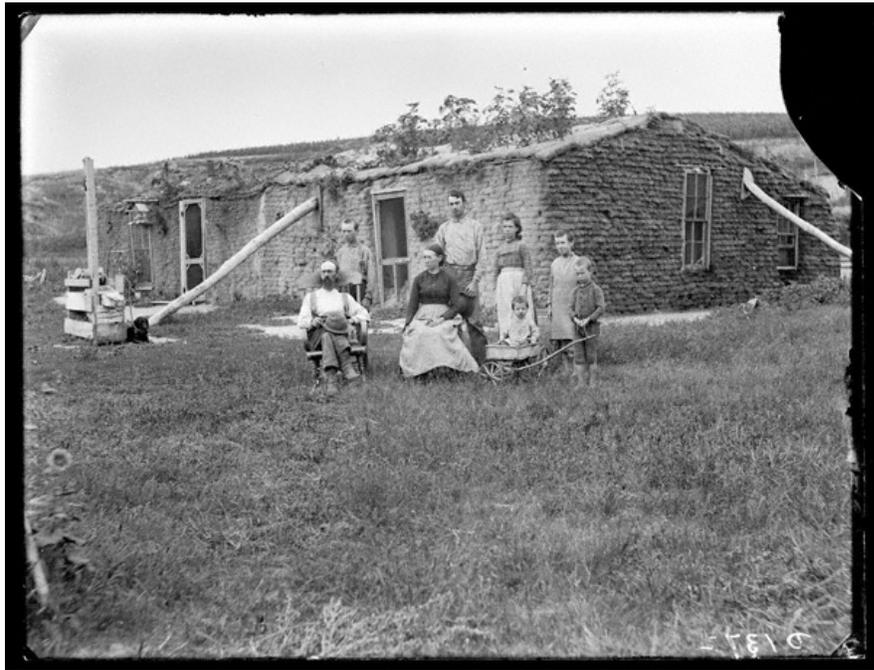
**Figure 26. Spectrum of craftsmanship displayed in photograph collection, circa 1886 and 1888 respectively**

prairie and were in desperate need of shelter, but a few either came with building skills, such as Isadore Haumont, received assistance from neighbors who had already learned the methods, or merely possessed the talent for building with earth. Butcher's pictures show the spectrum of difficulty in laying sod blocks. Some houses show sharply cut blocks laid evenly with clean pointed corners and no evidence of any bowing or warping. This characteristic, however, may be attributed to a spade that was often used to shave down the exterior walls to get them clean and sharp looking. Other houses show blocks that are evenly laid, but the corners are slightly rounded, the long grass is exposed beneath each sod block, and there are slight cracks beginning to develop in parts of the wall. At the furthest end of the spectrum are the houses that appear to be rather poorly constructed. Settling was a major problem when laying sod walls, and a builder could never predict which way the ground might move. Many houses in Butcher's Collection show unevenly laid rows, projecting sod blocks that have shifted, large cracks and bulges, especially above window and door openings, and bowing walls. In one example from 1888, a family is using logs to brace the walls like a buttress (Figure 26).

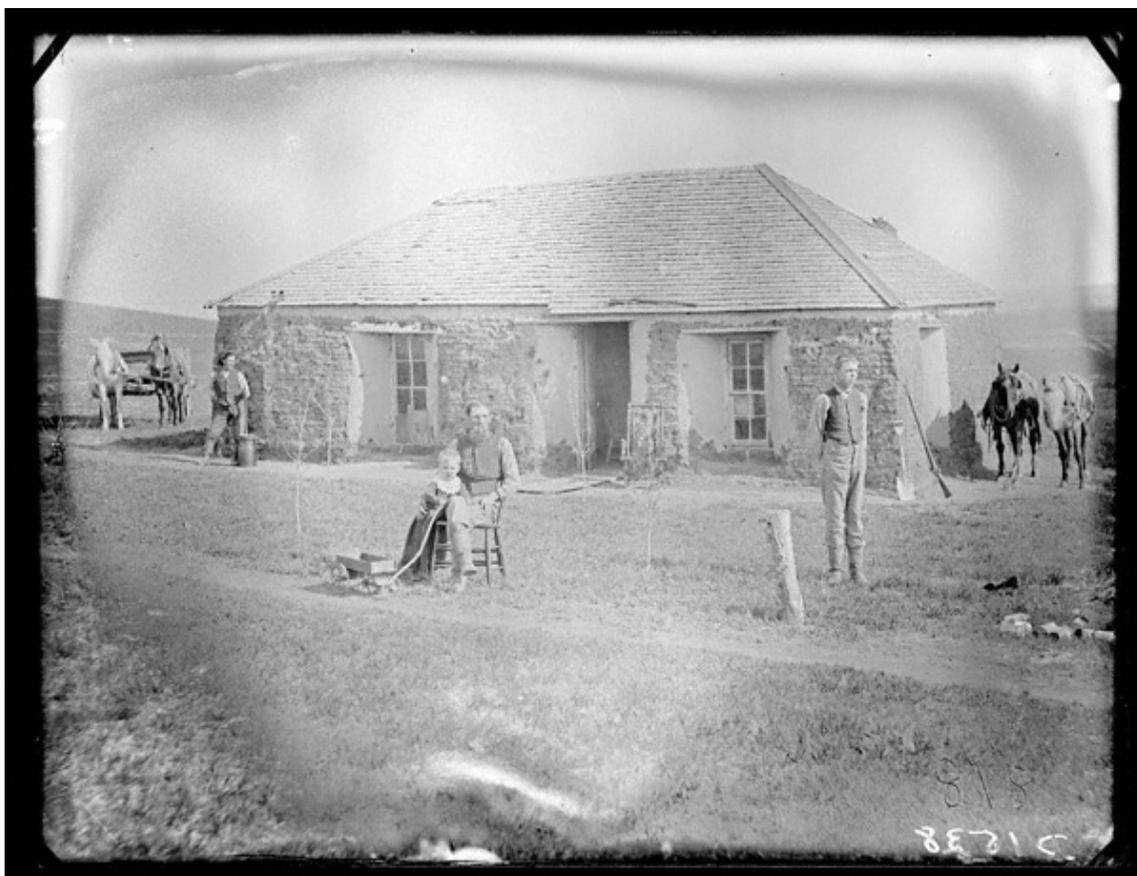
Figure 27. Photograph showing plaster on portions of exterior walls, circa 1890

in Custer County.<sup>99</sup> Exterior plastering was another feature found in the Butcher Collection. Builders frequently used interior plastering but exterior plastering was a feature more common in later generations of sod houses. Butcher's photographs show that this practice was used as early as the mid-1880s. Fully plastered walls were found in only a few photos, and each showed large portions that had eroded away. Most of the examples showed only small sections of the house that had been plastered such as a thin strip below the eaves, the corner of the house, or the exterior beveling of the window openings if the windows were recessed into the wall (Figure 27). The plaster helped hold the sod in place and it can be inferred that these selective parts of the house were chosen because they were either the most unstable or most drafty. Welsch does not quantify the number of photos with exterior plastering. He only notes that 265 houses show evidence of interior plaster.<sup>100</sup>

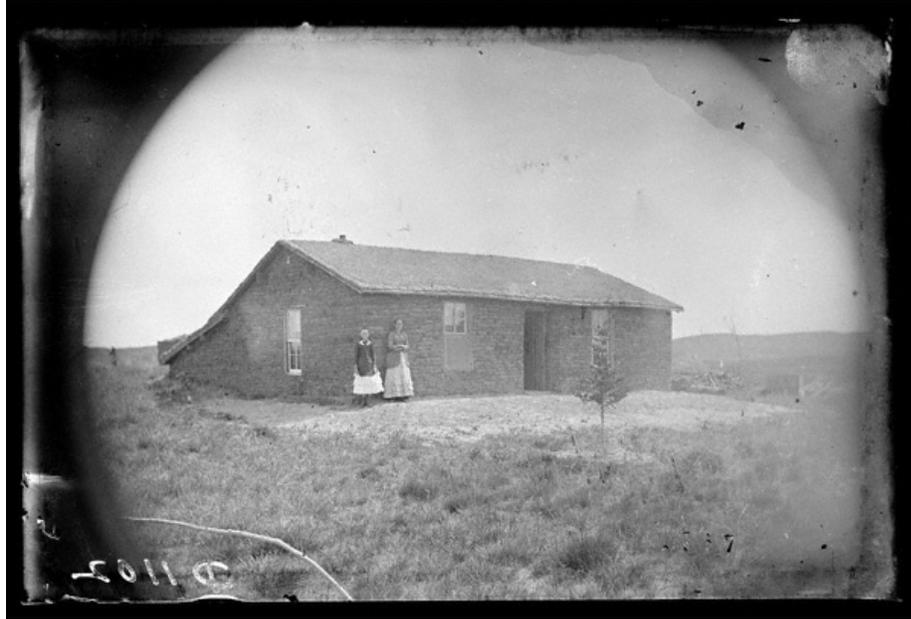
**Figure 28. Single-pen or hall and parlor plan, circa 1886**

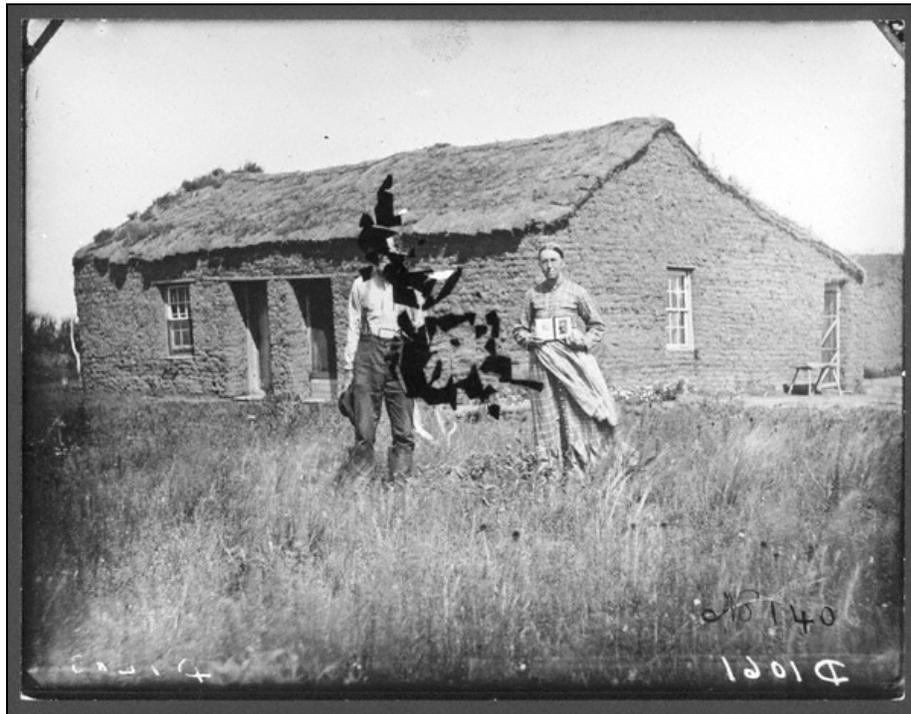
**Figure 29. Possible double-pen plan, circa 1886**

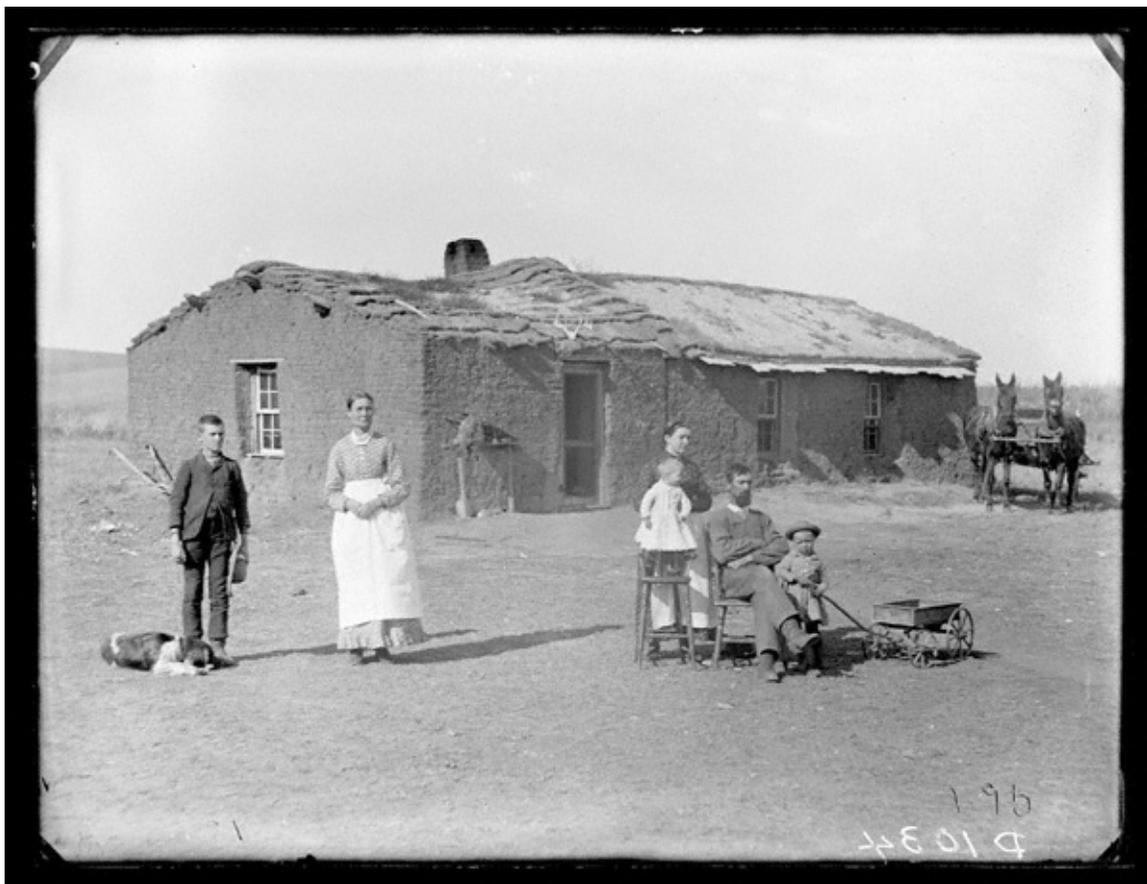
**Figure 30. Three beam gable roof using a brush and pole method on the left and using vertically placed wood planks on the right, circa 1886**

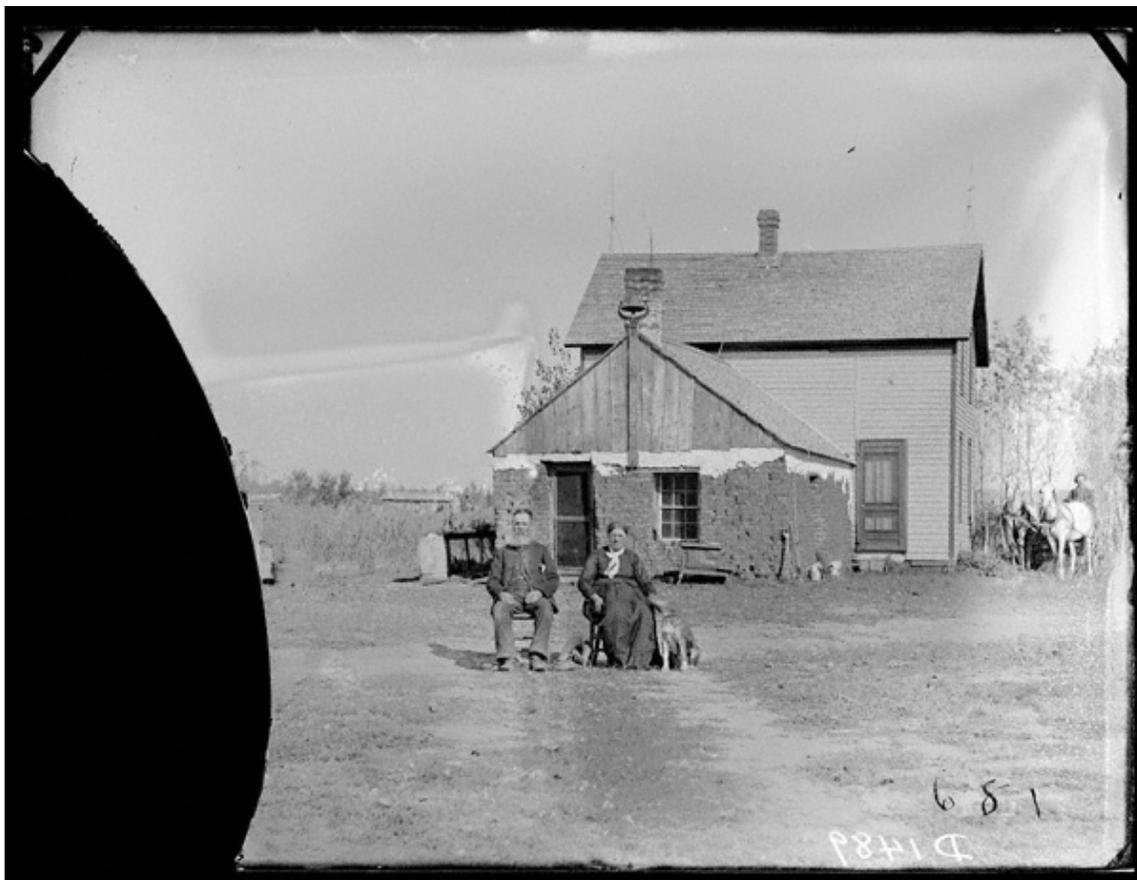
**Figure 31. Two-story frame dwelling added to initial sod house, circa 1888**

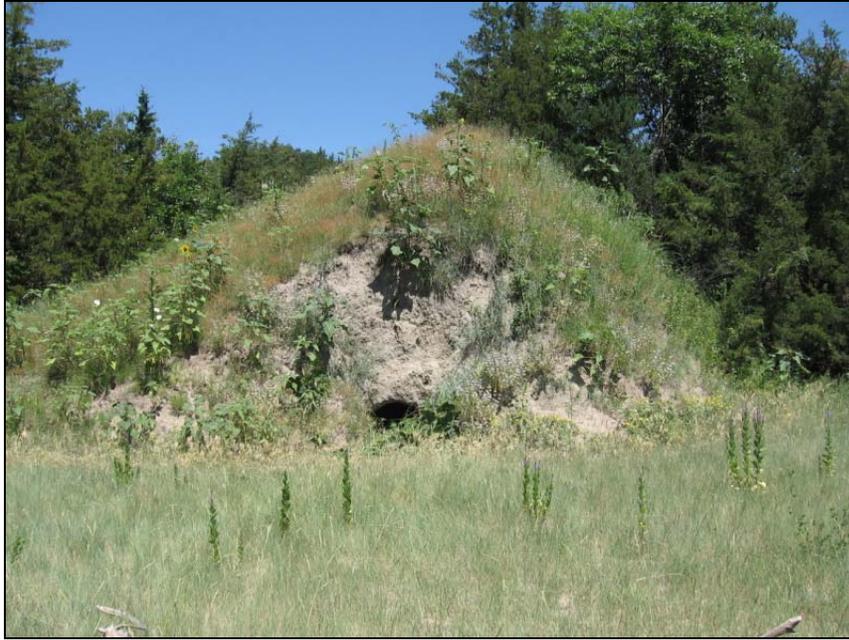
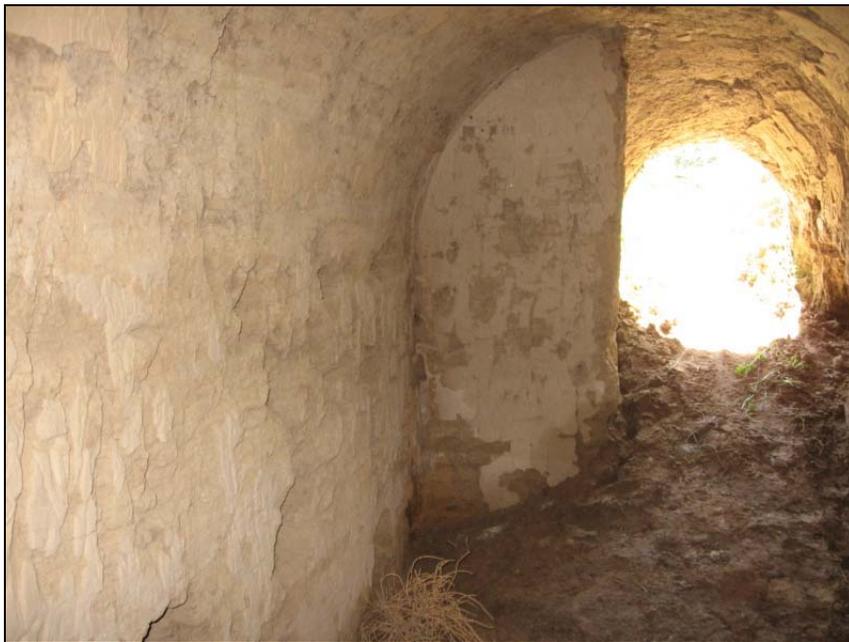
View looking west

Interior view looking east towards the entrance

**Figure 32. Sod – 02: Dugout, ca. 1887**

One potential dugout was identified approximately six miles northeast of Arnold in the northwest quarter of Section 8, Township 17 North, Range 24 West.<sup>110</sup> The site's exact location is questionable since the local guide was unsure as to where it was precisely located on the map. Positioned roughly 1.5 miles northeast of Powell Canyon, the site is only accessible by foot since it is surrounded by large grass covered Sand Hills and waist high prairie grass. The vacant dugout is excavated out of the side of a sandy hill and is roughly 10'-4" tall and 13'-6" long. Serving as the entrance to the dugout, a small arched tunnel opening faces east and measures 2'-8" tall by 4'-6" wide (Figure 32). One has to slide down a mound of eroded dirt about three feet to enter the cavity.

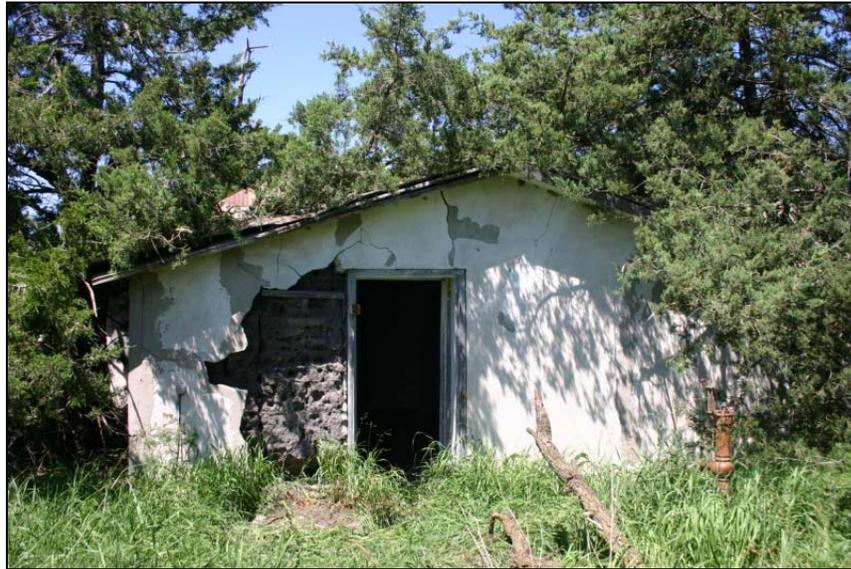
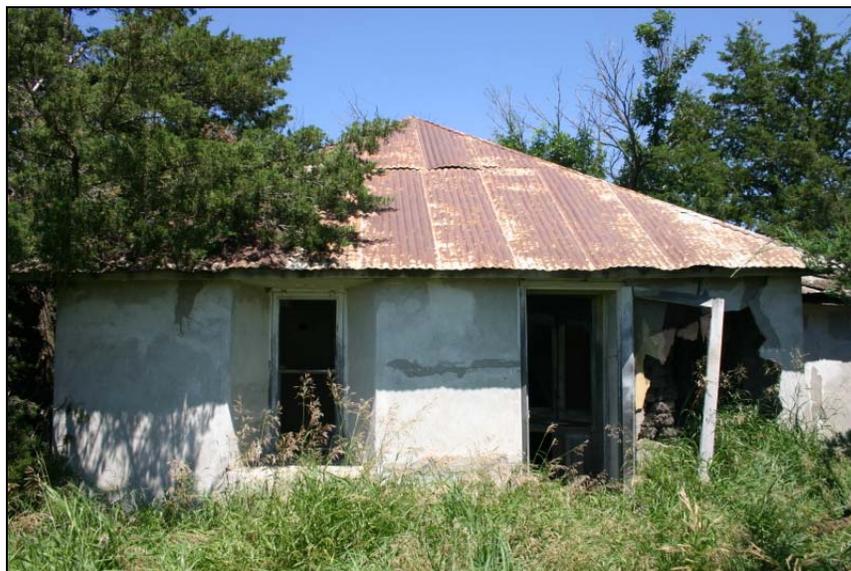
Gabled roof portion, view looking west

Hipped roof portion, view looking north

**Figure 34. Sod – 05: Herman Swanson/Samuel Foster Sod House, ca. 1892/ca. 1902**

The interior of the gabled portion consisted of only one room, while the interior of the hipped roof portion was divided into three rooms (Figures 35 and 36). Sawn lumber partitions separated the three rooms in the hipped portion, and a sod wall separated the hipped portion from the gabled portion. All interior walls were plastered and both floors consisted of 3-1/2" wood tongue-and-groove boards. The house was updated with electricity at one time, but plumbing was never installed.

Herman Swanson filed a Timber Claim on the northwest quarter of Section 24 in 1892. It was at this time that the gabled portion of the house was built. In 1896, he sold the property to W.E. Warren, who sold the property to Samuel Foster in 1902. The claim was finally proved in 1910 and the patent to the land was issued to Herman Swanson, but Foster was the owner at the time. Local residents call this sod house the Foster Residence, and it is speculated that Samuel Foster built the hipped sod addition sometime around 1902 when he acquired the land. Foster remained on the property until 1928, when he sold the land, which had now grown to 240 acres, to Clemmie Foster. She remained on the property until 1964 when it was sold to Mabel Benefiel. Local residents claim the house was inhabited until the 1980s. The Beshaler's bought the abandoned property in 1996.

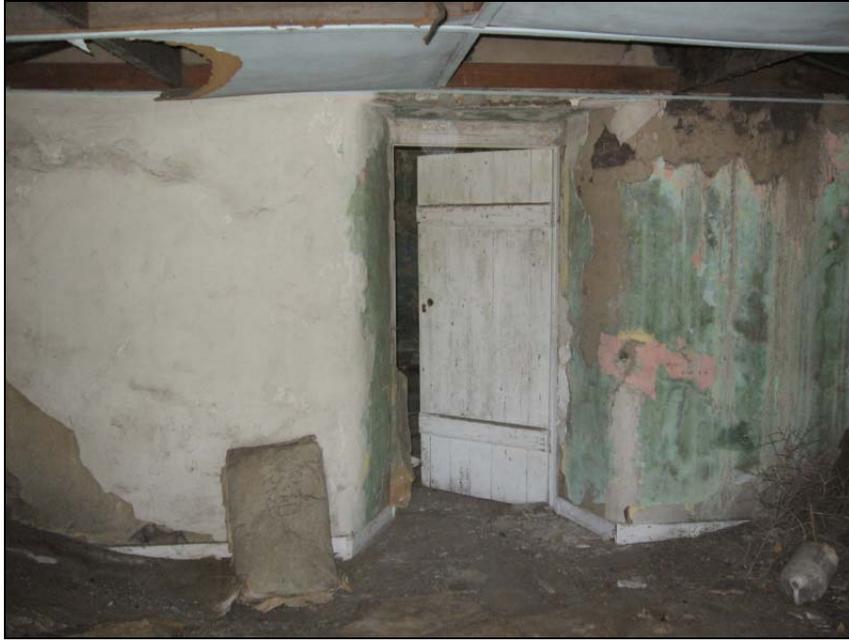
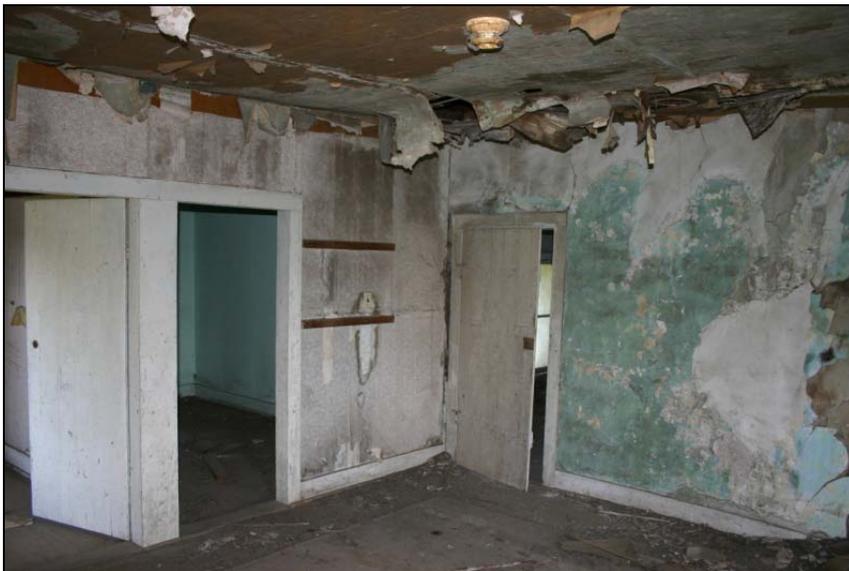
Interior of gable roof portion, view looking west towards hipped portion

Interior of hipped roof portion, view looking northeast

**Figure 35. Sod – 05: Swanson/Foster Sod House interior**
