# THE SOD HOUSES OF CUSTER COUNTY, NEBRASKA

A Thesis Submitted to the Graduate Faculty of The University of Georgia in Partial  
Fulfillment of the Requirements for the Degree

MASTERS OF HISTORIC PRESERVATION

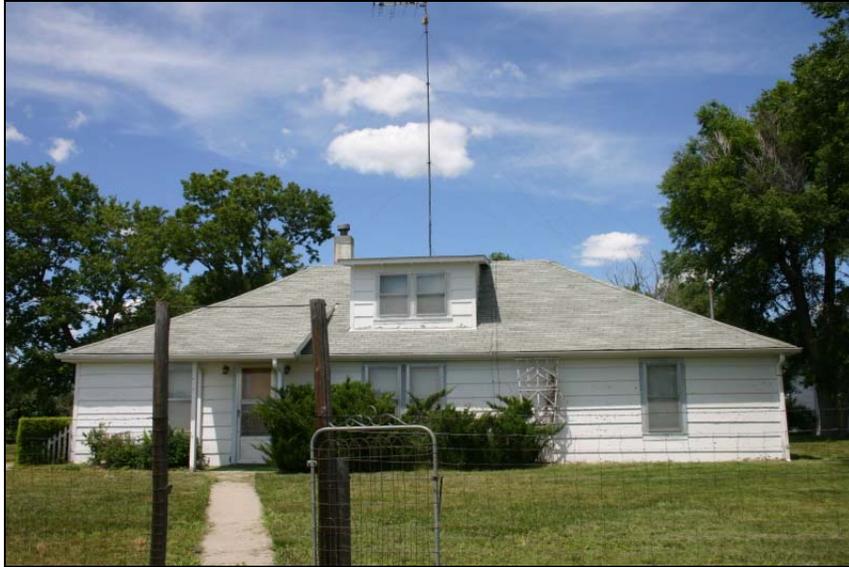
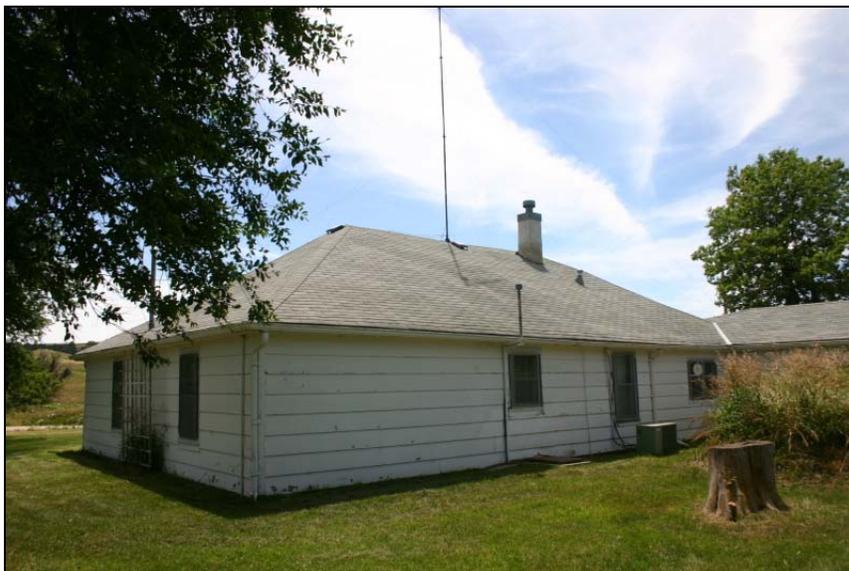
South Elevation, view looking north

Northeast corner, view looking southwest

**Figure 37. Sod – 03: Charles Chesley/Nolan Steele Sod House, 1892**

From the historic photograph, the roof shape appears to be original. The exact construction method of the steeply pitched hip roof is unknown, but local history states that the lumber for the roof came from the Milldale lumber mill. It is currently sheathed with asphalt shingles, but the historic photograph shows it was covered with wood shingles. The side gable frame addition was added to the northwest corner of the house in 1928. Its construction removed a small portion of the sod wall. The interior of the house was inaccessible, but the local newspaper article mentions that the house included four bedrooms and a small upstairs. The house was updated with electricity and plumbing.

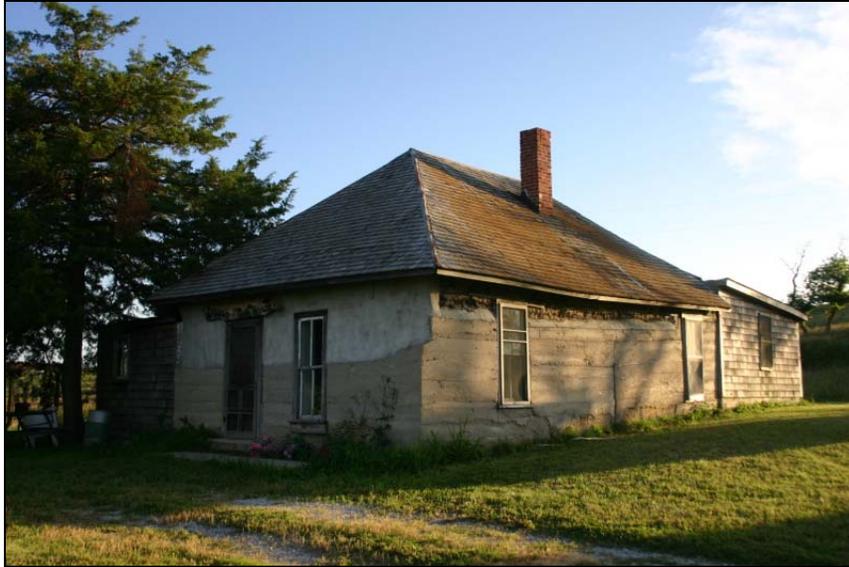
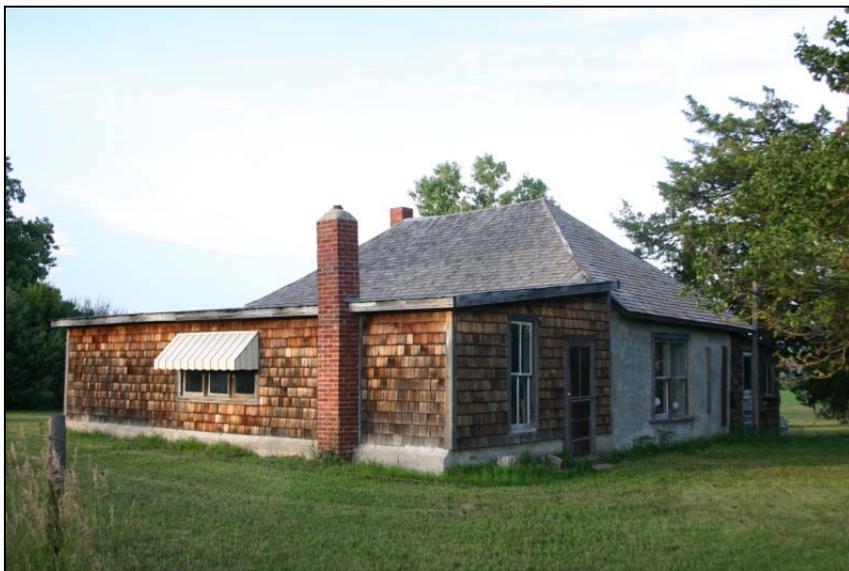
Northeast corner, view looking southwest

Southwest corner, view looking northeast

**Figure 39. Sod – 11: William R. Dowse Sod House, 1900**

The hip roof displays a steep pitch, which allowed space for an unfinished room in the attic. Using sawn lumber, the roof consisted of long rafters that spanned from the ridge beams to the sod walls. The rafters were set directly in the sod and extended roughly one foot beyond the walls. Wood plank spaced lath was laid horizontally across the rafters. The house was initially covered with wood shingles.

Two one-story frame additions were added to the sod house in 1924 to meet the needs of an expanding family. William Dowse removed the western sod wall and added a shed roof addition clad in wood shingles. The southeast corner of the house, which was formerly the void left by the L-plan of the house, was also filled in with frame and clad in wood shingles. The room was left unfinished on the interior and used as a laundry room. The interior of the 1900 sod core consisted of three rooms separated by wood partition walls (Figures 40 and 41). The kitchen was located in the ell projection on the east, the parlor/dining room on the south, and one bedroom in the northwest corner. The window wells were beveled on the interior with a gracefully rounded arch and the interior walls

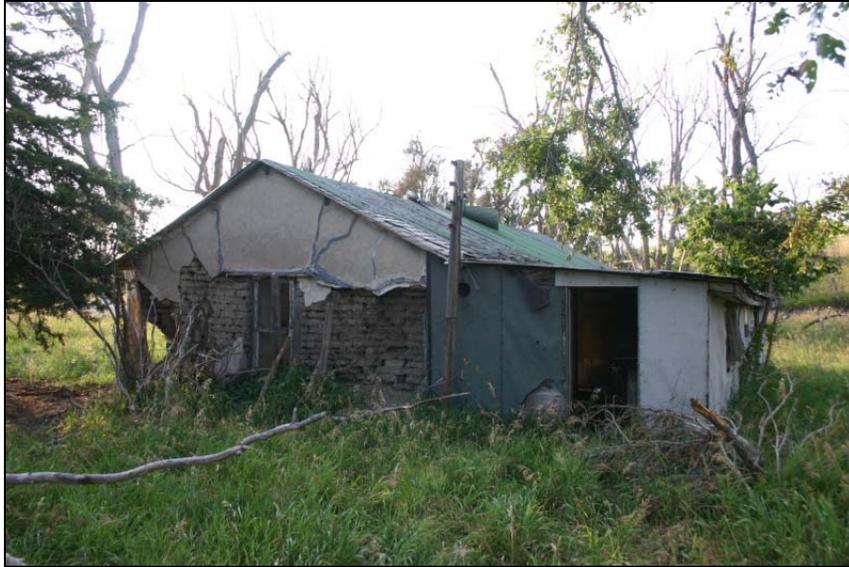
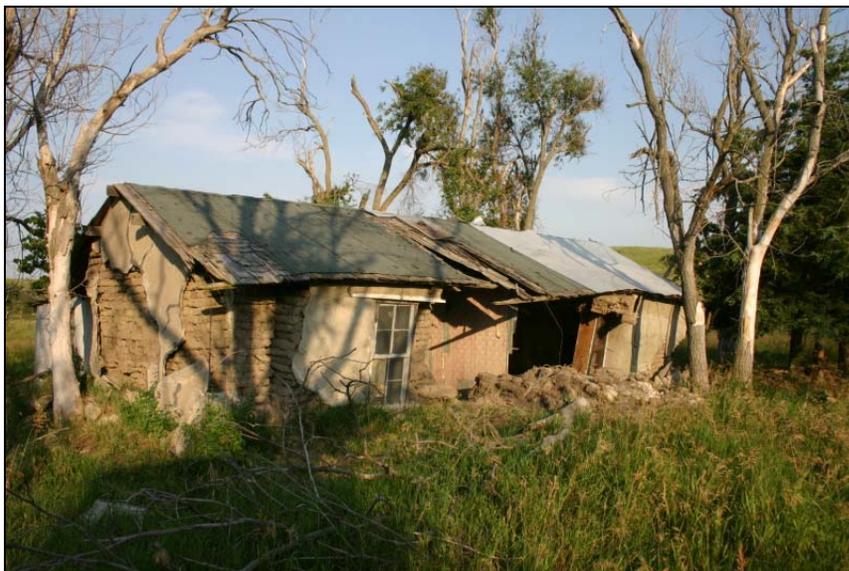
South Elevation, view looking northwest

Northwest corner, view looking southeast

**Figure 42. Sod – 17: Daniel McNulty Sod House, ca. 1907**

northern window is placed flush with the exterior wall and beveled on the interior with rounded corners. The southern window used to be an entrance, since there is a lack of sod beneath the sill. The window is placed midway in the frame and does not feature beveling on the interior or exterior. Two rows of 2"x 10" lintels are placed above the window frames, which are pegged into the walls and topped with three courses of sod. The south elevation features only one centrally placed four-over-four double-hung wood sash window with the same features as the windows on the west elevation (Figure 42).

The McNulty Sod House is in very poor condition. Nearly fifty percent of the west sod wall has collapsed, the southwest corner is heavily eroded, and both the northeast and northwest corners of the house are missing. Most of the stucco on the exterior has vanished and the exposed sod is greatly weathered and eroded. Large holes exist in the roof and the interior ceiling is fully collapsed. The house is severely threatened with a full collapse due to the instability of the missing sod walls.

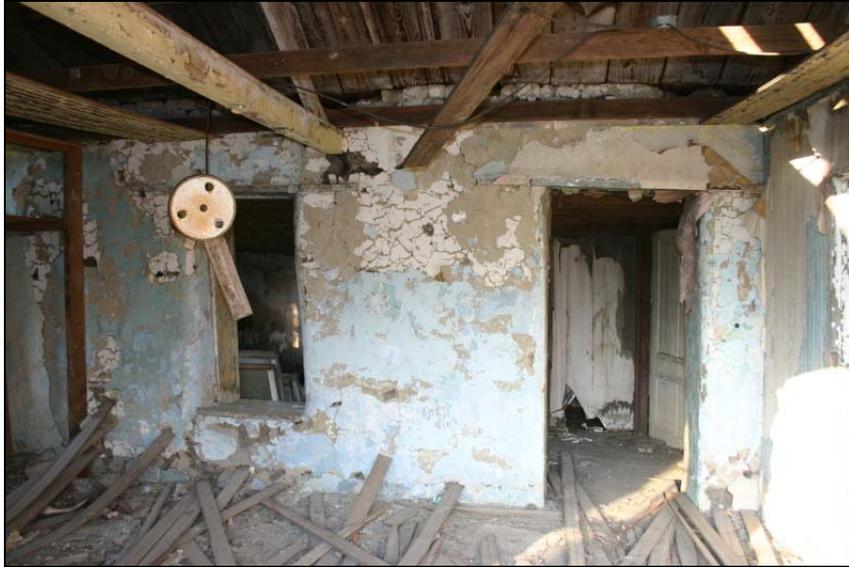
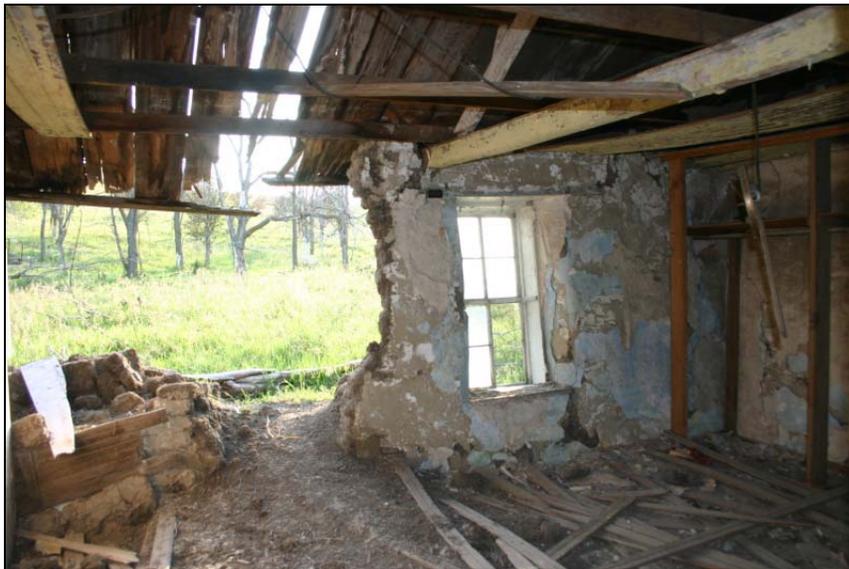
Interior of sod portion, view looking east towards original entrance

Interior of sod portion, view looking west

**Figure 43. Sod – 17: McNulty Sod House interior**

The interior of the sod house consisted of two rooms, each with its own separate entrance on the east elevation (Figure 43 and 44). The walls were fully plastered and the floors were laid with 3-1/4" wood tongue-and-groove. The ceiling consisted of wood bead board, but it has since fully collapsed. Electricity was installed in the house as well as plumbing for the bathroom addition.

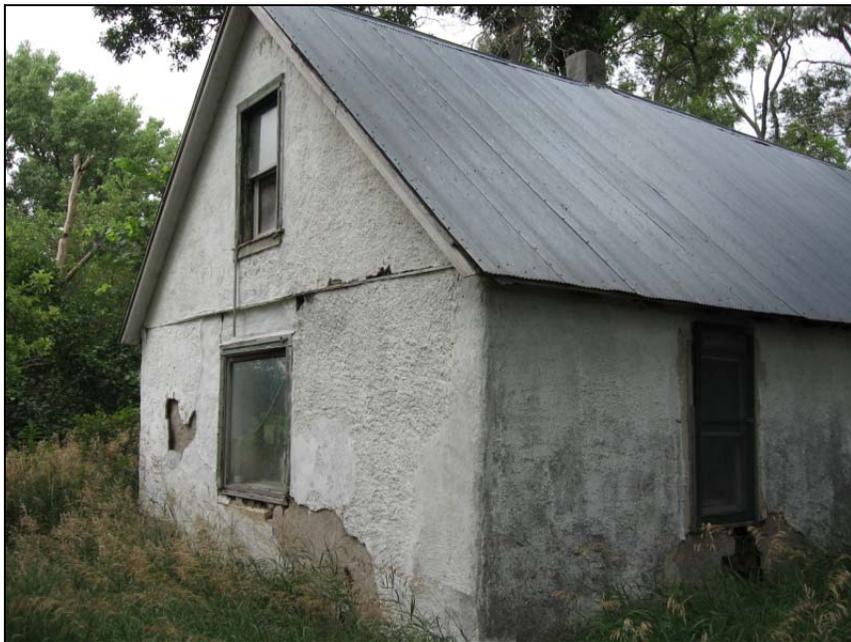
**Figure 45. Sod – 14: Lewis Fischer Sod House, 1934**

Northeast corner, view looking southwest

The Fischer Sod House is completely different from any of the other sod houses found in Custer County. Constructed during the height of the Depression, sod was specifically chosen as a building material even though lumber was readily available and sod was no longer a popular material of choice, even in Custer County. The Fischers used similar techniques on their sod house as those built fifty years prior, such as hauling the sod in a wagon, shaving the walls with a spade, and laying the blocks grass side down, but a few differences separate this sod house from others in the county. It is evident that cutting techniques had been refined since the blocks were thicker, but shorter and more uniform in size. The presence of mortar between the blocks, however, is especially unique. It is rarely mentioned in any literature or study of sod houses that builders used any mortar when constructing their sod walls. No other examples of sod houses in Custer County were found to have used mortar. It is unknown why exactly Lewis Fischer used mortar to build his sod walls, but it can be inferred in the conclusion that combined with the initial stucco coating on the exterior, that the Fischers were concealing the fact that their house was built of sod. It is not assumed that they were ashamed of their dwelling, but that architectural norms had changed by the 1930s, and

even with Custer County's rich legacy of sod, builders wanted a house that resembled others being built at the time. Furthermore, by the 1930s it had been shown that exposed sod walls did not last very long. The Fischer's set out to build a permanent dwelling, and mortared their walls to protect and ensure the durability of their residence. The house is in fair condition today. Several windows are broken and the exterior stucco is beginning to detach, but the house is salvageable to anyone wanting to rehabilitate it.

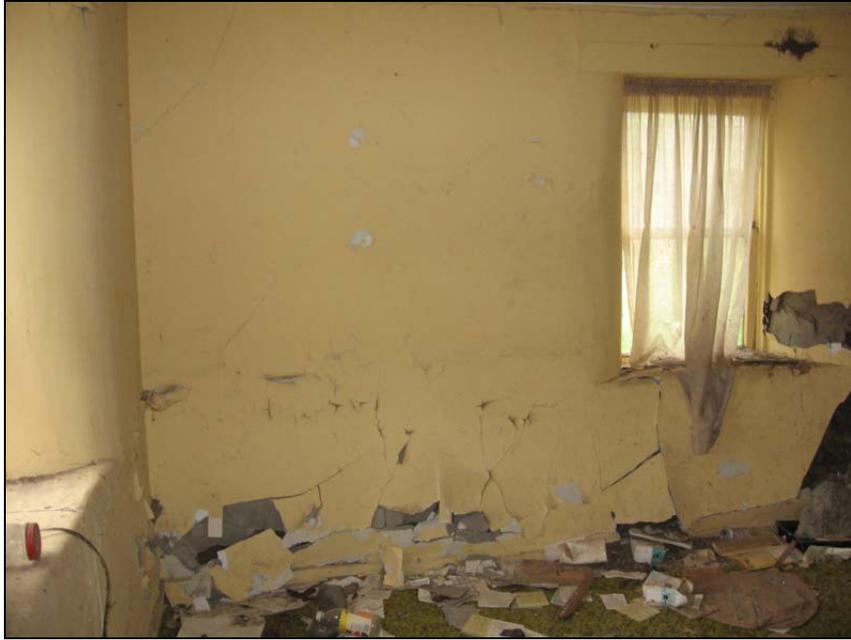
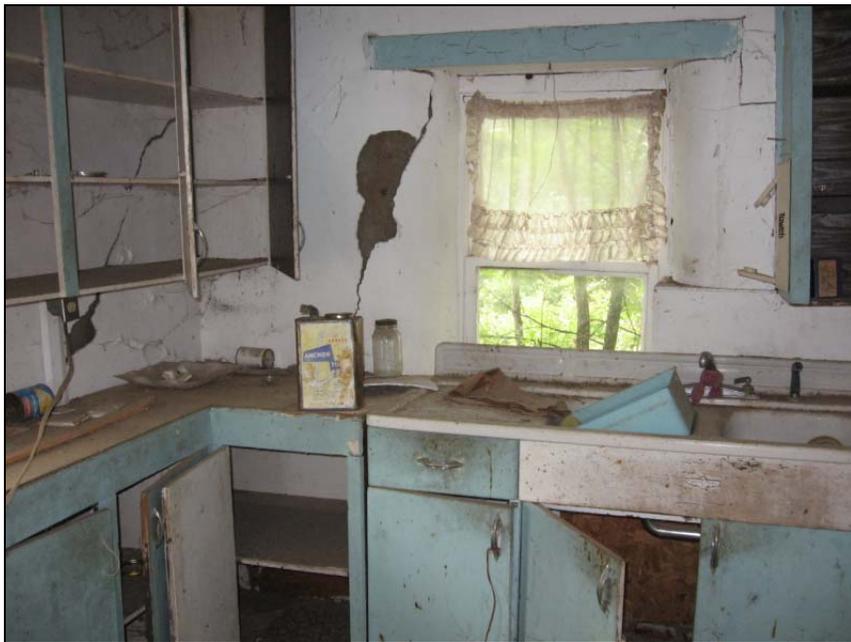
**Figure 46. Fischer Sod House interior**

Interior of living room, view looking northwest

Interior of kitchen, view looking southeast

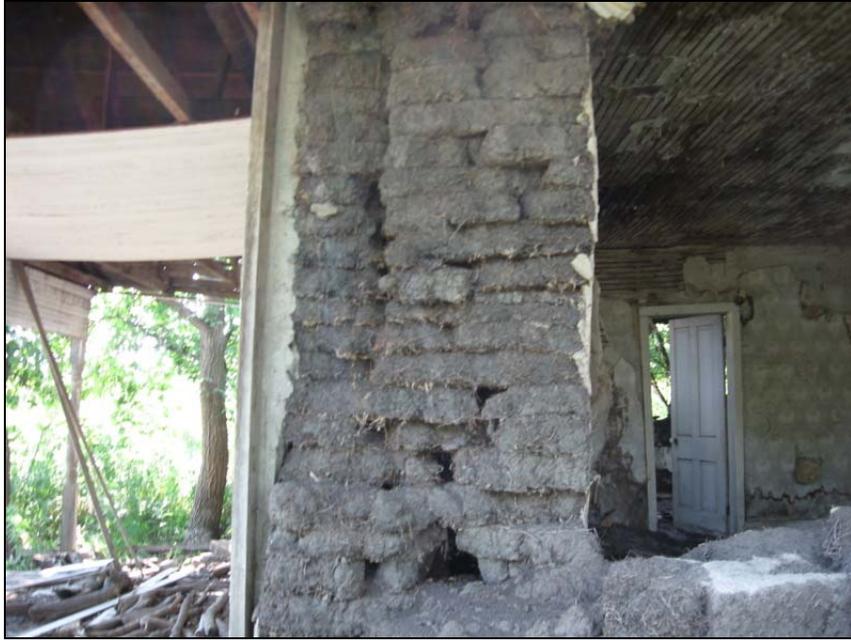
**Figure 48. Sod – 12, Detail of Murray Sod House walls laid three wythes deep**

Nearly all of the walls were laid two wythes deep, except for those of one resource, the Murray Sod House (Sod – 12), which were laid three wythes deep (Figure 48). Blocks were generally laid in one course or two course common bond, just like bricks. A few houses used odd bonding configurations such as a two rows of stretchers and three rows of headers (Sod – 09) or one row of stretchers and two rows of headers (Sod – 17). Wall depth ranged from 20” thick to 38” thick. Most of the walls were between 22” and 27” thick, but over half of them were battered. Three houses used wooden stakes to secure the blocks together. The stakes were generally 16” long and driven between two or three courses of sod. Only one house used mortar between the sod blocks (Figure 49). The Fischer Sod House (Sod – 14) is the latest example surviving in Custer County and among the most unique for its use of a clay/sand/cement mixture of

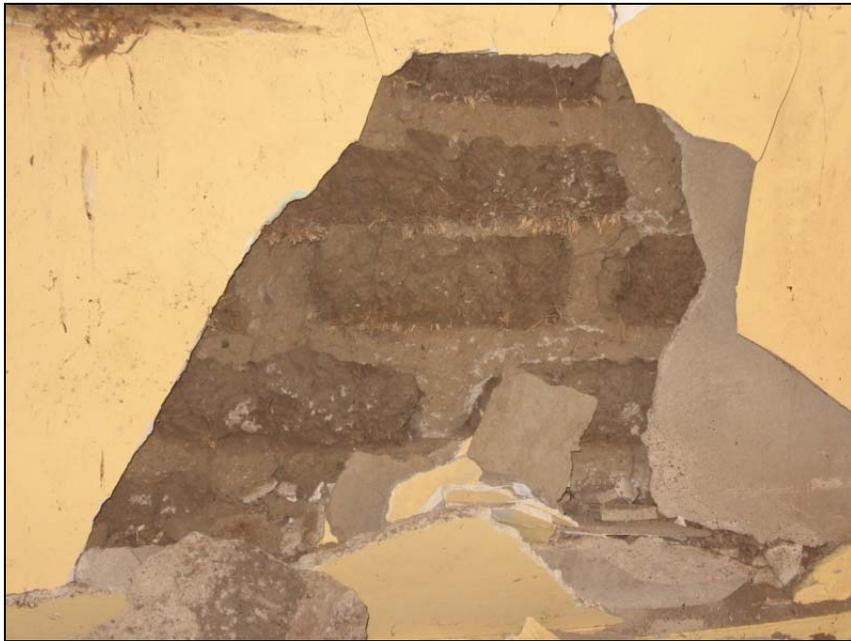
**Figure 49. Sod – 14, Detail of Fischer Sod House walls laid with mortar**

mortar in its walls. This one example proves that sod walls could be laid with mortar, but it was extremely rare.

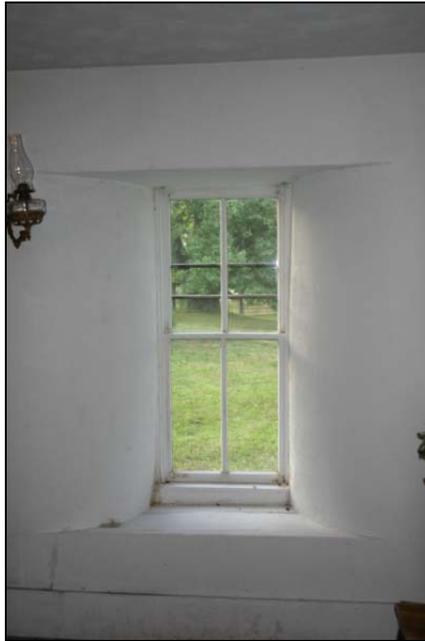
**Figure 50. Sod – 11, Detail of Dowse Sod House arched beveled window wells**

Other window features that are characteristic of sod house construction are the beveling of window wells and methods of weight suppression above the frames. The survey found that most of the windows, if placed flush with the exterior wall, were beveled on the interior with rounded corners. The radius of the arch varied from rather broad, which allowed more light in, to very sharp and angled. Only one house, the Mills Sod House (Sod – 10) did not bevel the interior window wells. This feature seemed to be a construction element where builders could flaunt their skill. The Dowse Sod House (Sod – 11) has gracefully arched window wells, while the window wells on the Melton Sod House (Sod – 01) are irregularly angled (Figure 50). The methods of weight suppression above the window frames was an interesting feature found during the survey. Many of the resources placed two very long lintels, generally measuring 2”x 8”, side by side atop the window frame. Three to four courses of sod were then laid above the lintels. Much of the cloth or paper wadding that Welsch mentions to help suppress the weight of the sod above had deteriorated, but evidence of its existence was still present on some houses. Many of the houses found used this feature above the windows, and the lintel can often be seen on the exterior wall of the house (Figure 51).

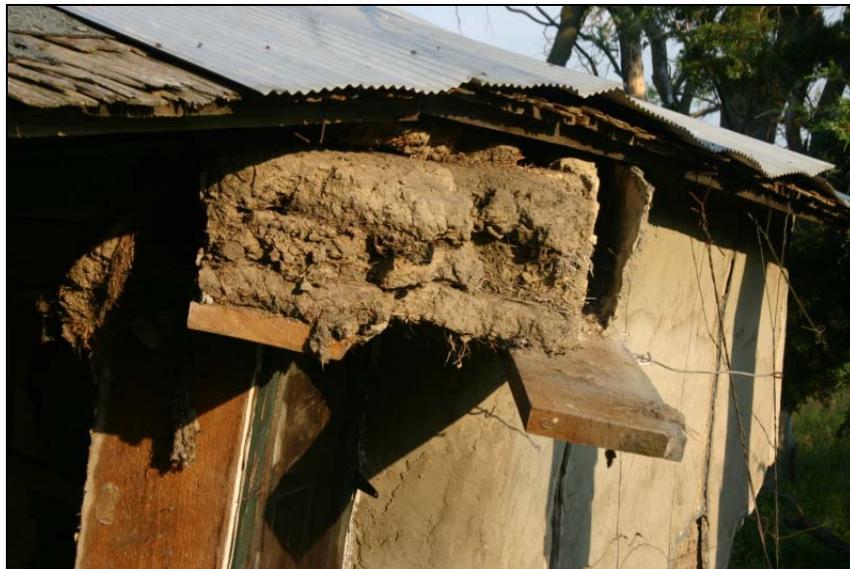
**Figure 51. Sod – 17, Detail of McNulty Sod House window lintels and sod**

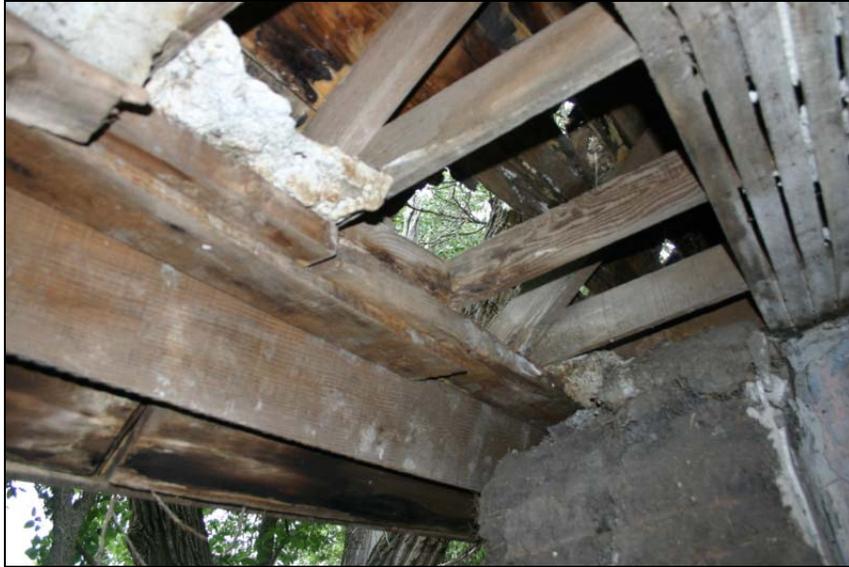
**Figure 52. Sod – 04, Detail of Wonch Sod House built up top plate**

was, however, noted that these types of roofs consisted of rafters which extended from the ridge beams of the hip or pyramid down to the sod walls. Some roofs tied the rafters together near the top of the wall plane with attic joists spanning the width of the house. The joists were then set directly into the sod walls. A few resources contained top plates consisting of layered sawn lumber, which the rafters then rested upon instead of being set into the sod walls. The Wonch Sod House (Sod – 04), the Murray Sod House (Sod –12), and the Smith Sod House (Sod – 19) contained this feature (Figure 52).

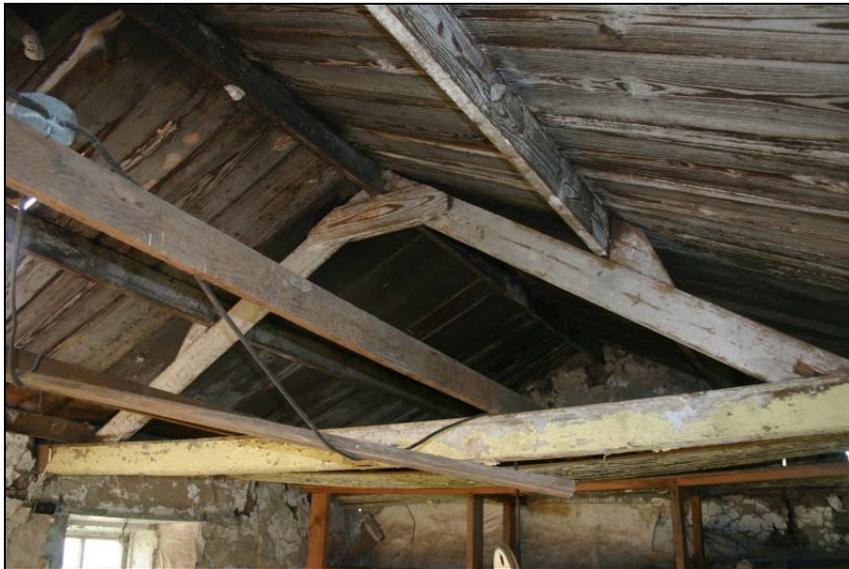
**Figure 53. Sod – 17, Detail of McNulty Sod House roof framing**

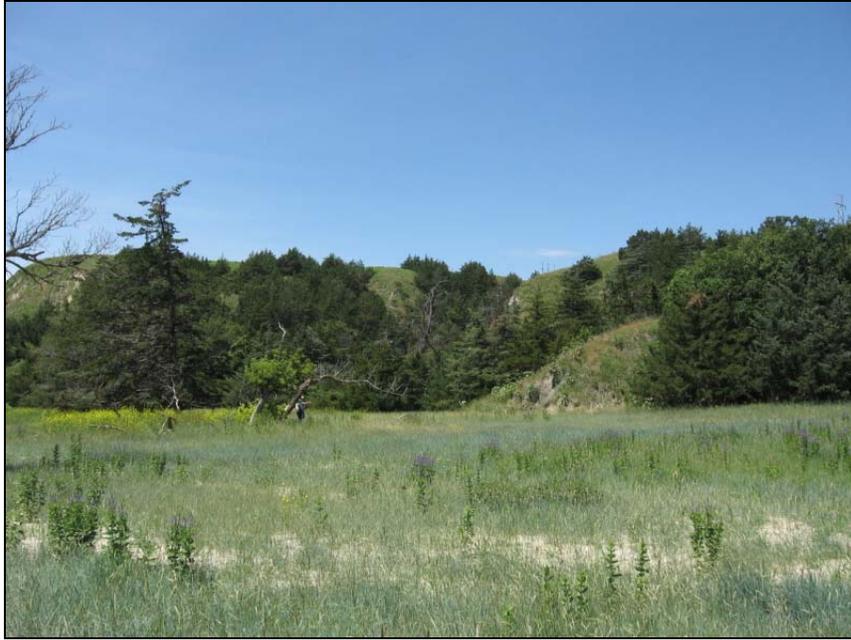
**Figure 54. Surrounding landscape of Sod – 02: Dugout. An ideal building site for a Type I dugout**

An ideal building site would be located in a ravine or next to a hill so the dugout could have a natural roof and a front opening like a cave, but sometimes a land claim did not offer either of these features (Figure 54). In such cases the bank was dug back approximately 12 to 14 feet and the front was built up with sod blocks. An opening for a door was created, which could be framed with lumber, and if space permitted a window was added. Since a dugout was generally a temporary structure, a builder often did not purchase lumber for decking, and a brush and pole roofing method was most often used as described in Chapter 3.<sup>120</sup> The interiors of dugouts could be finished with plaster walls and wood floorboards or left bare. Dugouts blended well with their environment, and sometimes the only sign of habitation was a stovepipe sticking up over the hill or out of the ground. There are many accounts of wagons accidentally running over a dugout, or wandering cattle falling through the roof.

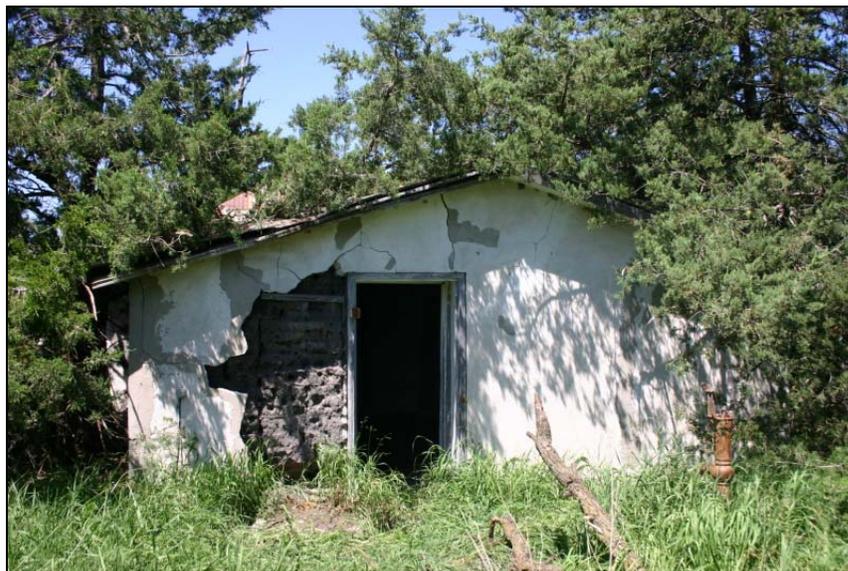
**Figure 57. Type II gable portion of Swanson/Foster Sod House (Sod – 05), circa 1892**

Butcher's photographs showing small sod houses also contain very few windows and doors, and a majority display gable roofs (Figures 56 and 57).

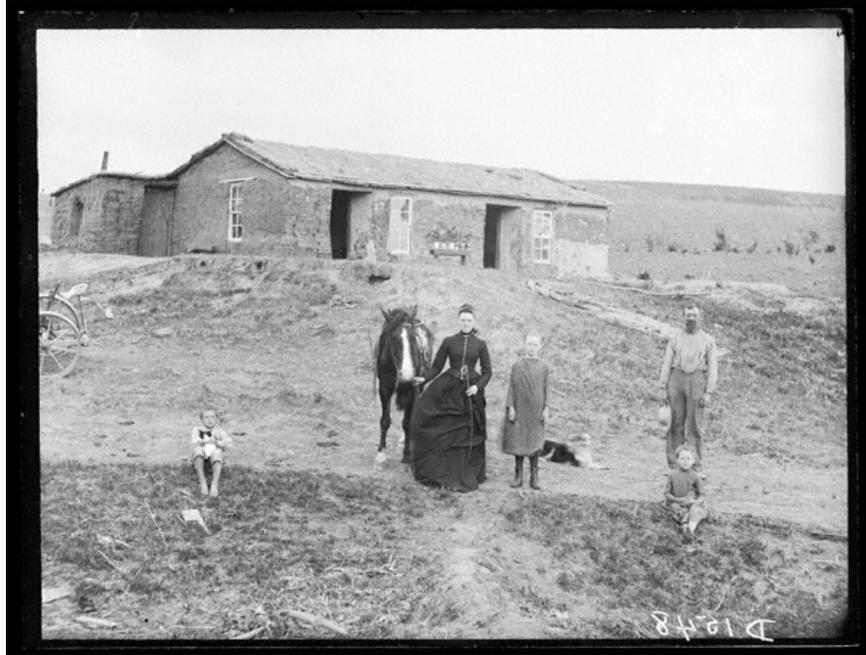
**Figure 58. Unidentified family in front on their Type IIIA sod house, taken 1889. Notice the double entrances, long and narrow plan, and sod addition off the rear**

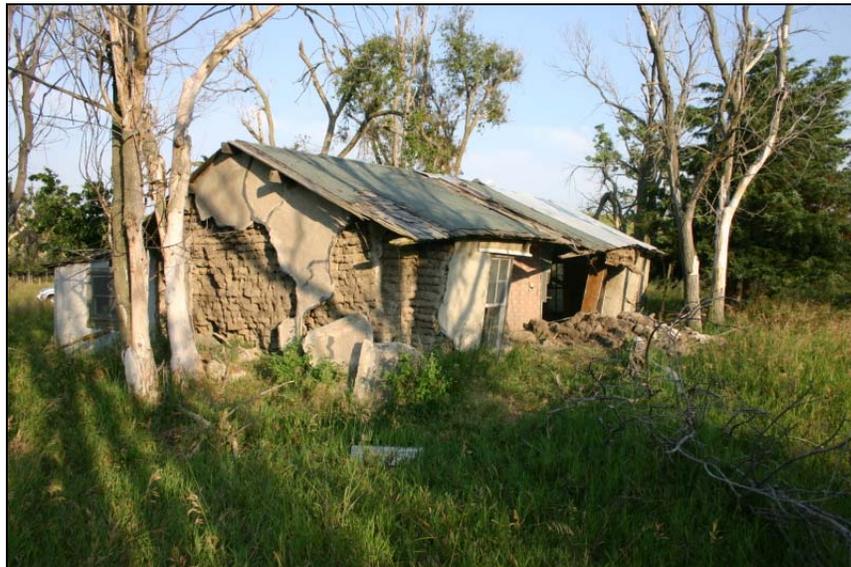
**Figure 59. McNulty Sod House example of Type IIIA sod house**

was divided into two rooms, each with a separate entrance on the east elevation, which was later concealed by a frame addition. The interior partition wall also contained an entrance, but it is unknown whether this was original or added later. It is speculated that the McNulty Sod House could have housed two families (Figure 59). The Milburn Sod House was so deteriorated that it was not possible to determine the number of interior rooms, but judging from the size of the house and its placement of windows and doors, it is speculated that there were at least two. The Kruser Sod House is the most different of the three, because it is not as long as the other two resources. Unfortunately this sod house was nonextant, so interior room configuration could not be confirmed, but a local resident who had visited the house when he was younger mentioned that it had three rooms.

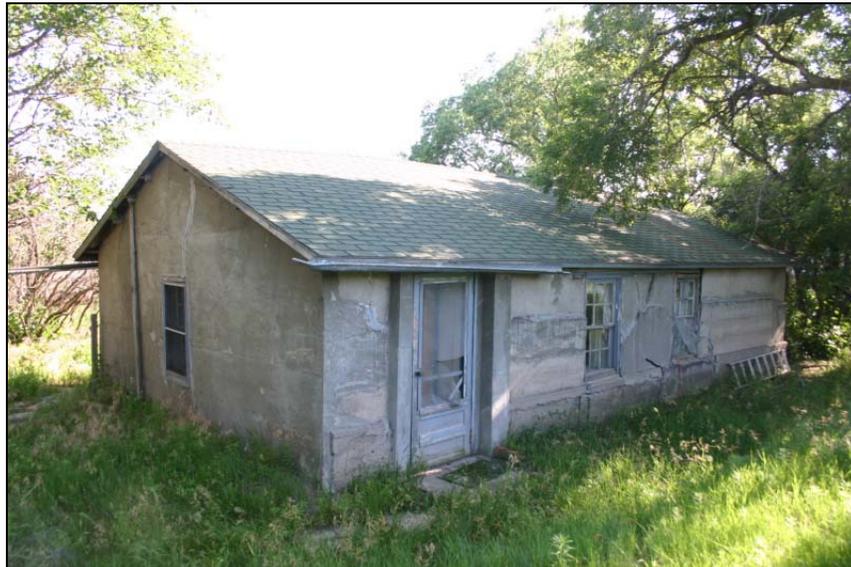
**Figure 61. Example of Type IIIB sod house in Custer County. Geschwind Sod House (Sod - 21), circa 1895**

It is understood that this is not a large difference in width, but when viewed in the field and in Butcher's pictures, the discrepancy is much more noticeable. Just like the Type IIIA sod house, Butcher photographs show a high number of this type featuring windows and doors in similar places, in addition to gable and hip roofs. However, where a Type IIIA sod house may include just one window on the shorter elevations, the Type IIIB sod house may include two or a window and an entrance because there is more wall space. The Custer County survey identified eight sod houses that could be classified as Type IIIB. For example, the Luck Sod House (Sod – 20), built circa 1890, measured 28'1x 20'1 and featured a hip roof. The Geschwind Sod House (Sod – 21) was built in circa 1895 with a gable roof, and measured 32'-9"x 20'-6". The two room Luck Sod House featured windows on each shorter elevation, a window and a door on the longer elevation, but no windows or doors on the other long elevation. The Geschwind Sod House was divided into three rooms, and included one window on each shorter elevation, with two windows and a door on each of the longer elevations (Figures 60 and 61).

Just like the Type IIIA sod house, the Type IIIB sod house was a standard, reliable plan for families who desired a division of space, but wanted even more interior room. Broad and long, the rectangular plan could range generally from about 20' to 25' wide and 28' to 35' feet long or longer. It too was relatively easy to construct and built by families of varying degrees of wealth. The Butcher pictures did not show as many paired entrances on these types of houses as on the Type IIIA house. This type of house could be just as easily modified with additions to accommodate growing families and changing needs, but room division did not seem to exceed two or three rooms. Just like

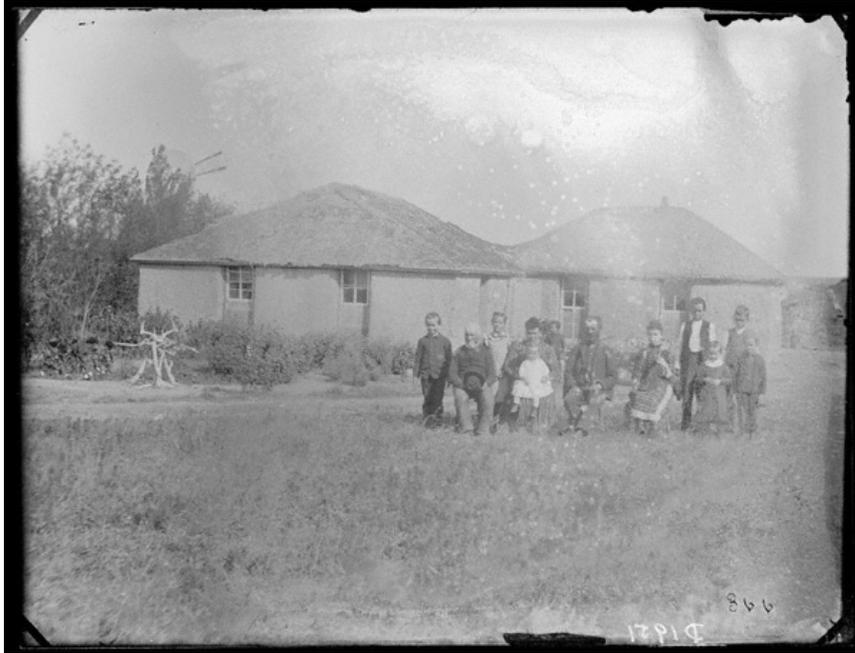
**Figure 62. Twin Type IV sod houses in Custer County, taken 1887**

The Type IV sod house differed from the other types found in Custer County in that it involved more skill to build, in addition to being more expensive. The hipped and pyramidal roofs were difficult to construct and required more lumber, as well as the increased number of windows. The examples of this type found in Custer County possessed a slightly finer degree of craftsmanship than its rectangular counterparts.

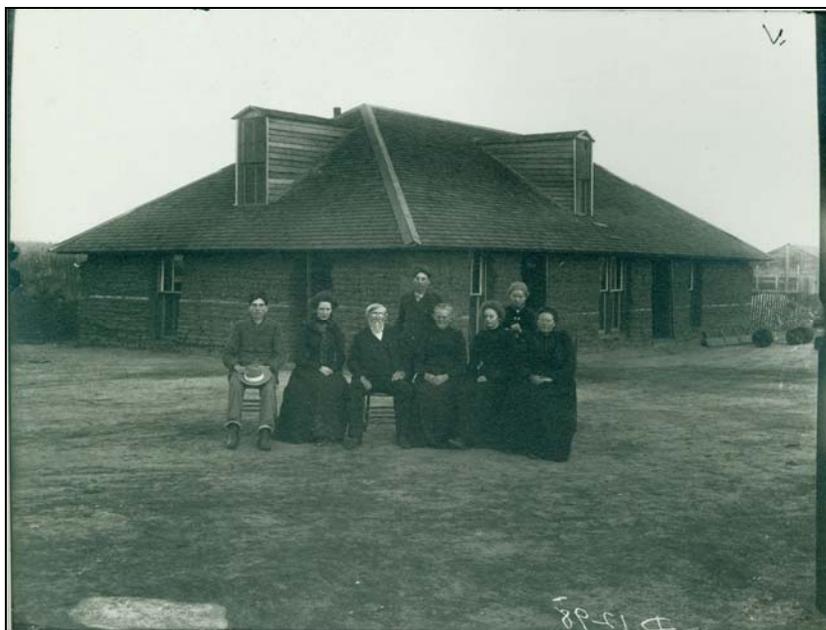
**Figure 65. McCaslin Sod House in Custer County, taken 1887**

In Butcher’s photograph collection, two specific houses in Custer County exemplify this type of sod house. The McCaslin House near Rose Valley in Custer County was built circa 1887. From the picture, one can see the very long walls of sod complete with many windows. It is one story with a frame half story above that contains two large dormers. The sod walls and the frame shingled hipped roof are finely executed with sharp corners and level eaves (Figure 65). The Haumont Sod House really was a

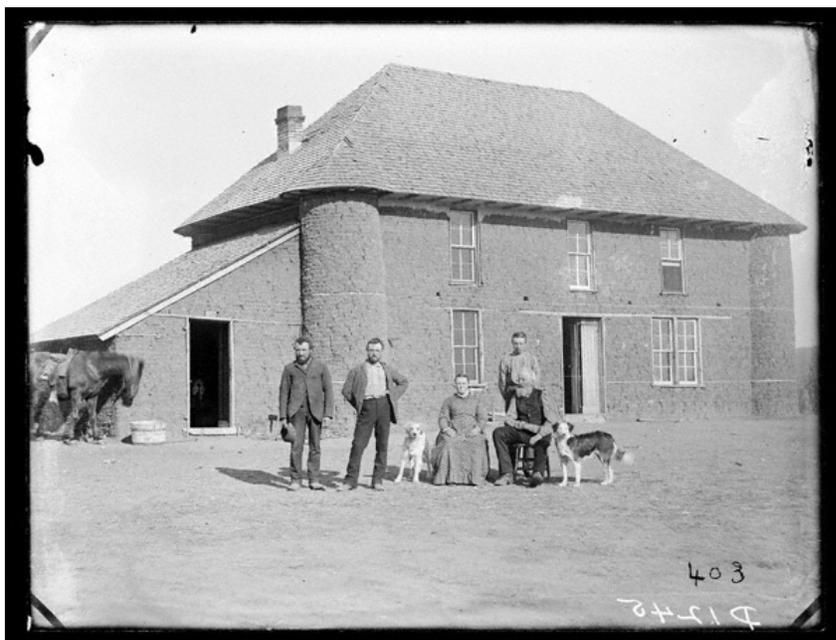
**Figure 66. Haumont Sod House in Custer County, taken 1886**

sod palace. Built in 1884 by Isadore Haumont, the house featured two full stories of evenly laid sod, which stood 19 feet at the eaves. The walls were at least three feet thick and included rounded turrets at the corners that were to resemble a Flemish-style castle. Sheathed in wood shingles, a steeply pitched hip roof covered the dwelling (Figure 66). This extraordinarily rare sod house was listed in the National Register as early as 1969, but was demolished in 1972 under the property owner's wishes.

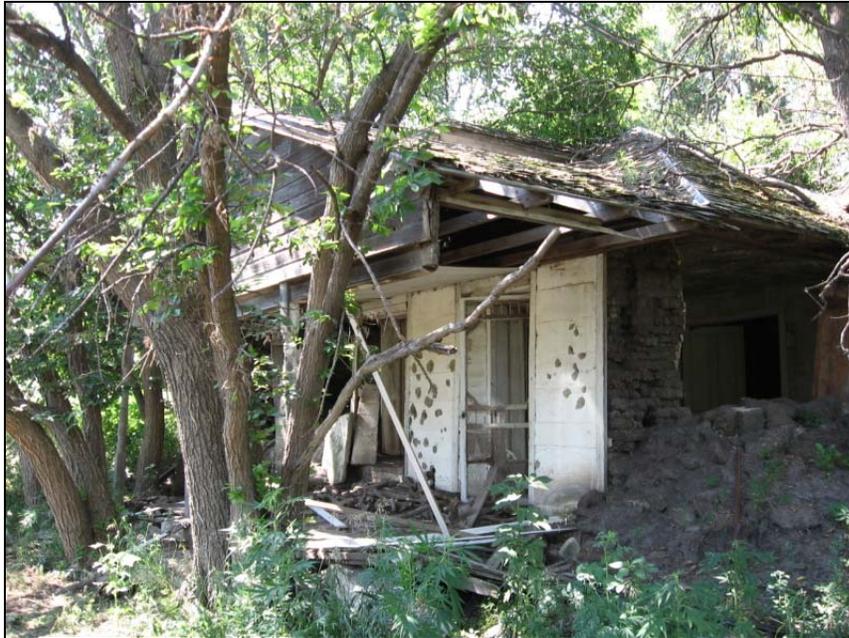
**Figure 67. Example of Type V sod house in Custer County. Murray Sod House (Sod – 12), circa 1883. Due to size of house and dense vegetation, photograph is obscured**

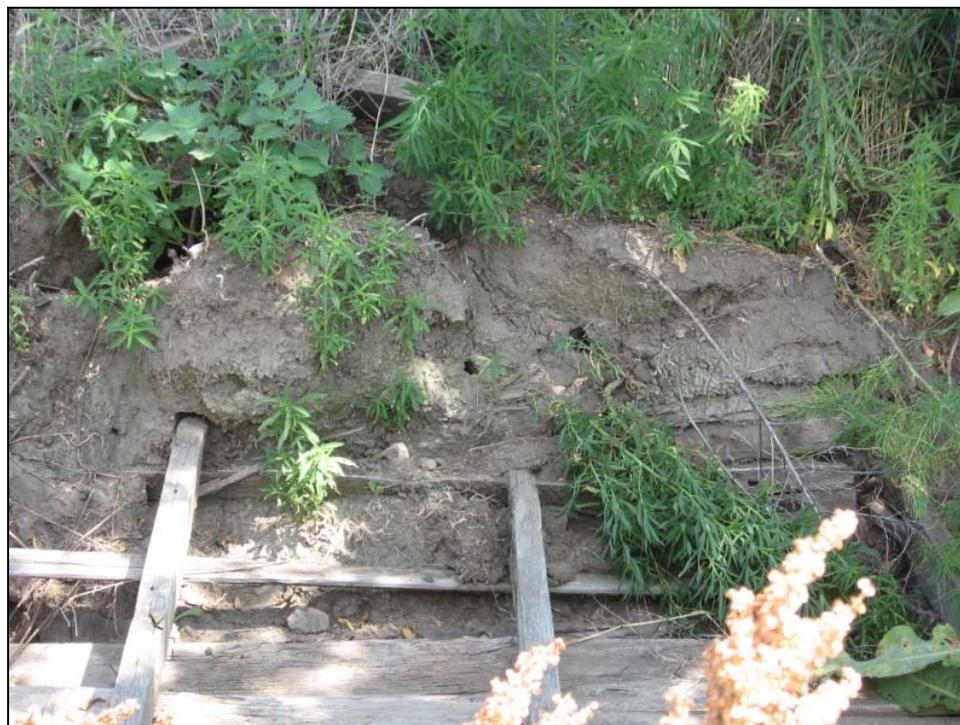
**Photo: 1**

**Condition:** NONEXTANT. House has completely collapsed. A small portion of the melted sod blocks can be seen at grade on the south elevation. Lumber remnants from the addition have fallen atop the mound of dirt.

<b>Photo #</b>	<b>Facing</b>	<b>Date</b>	<b>Description</b>
1	N	7/5/2007	Sod – 06
2	N	7/5/2007	Sod – 06
3	SW	7/5/2007	Sod – 06

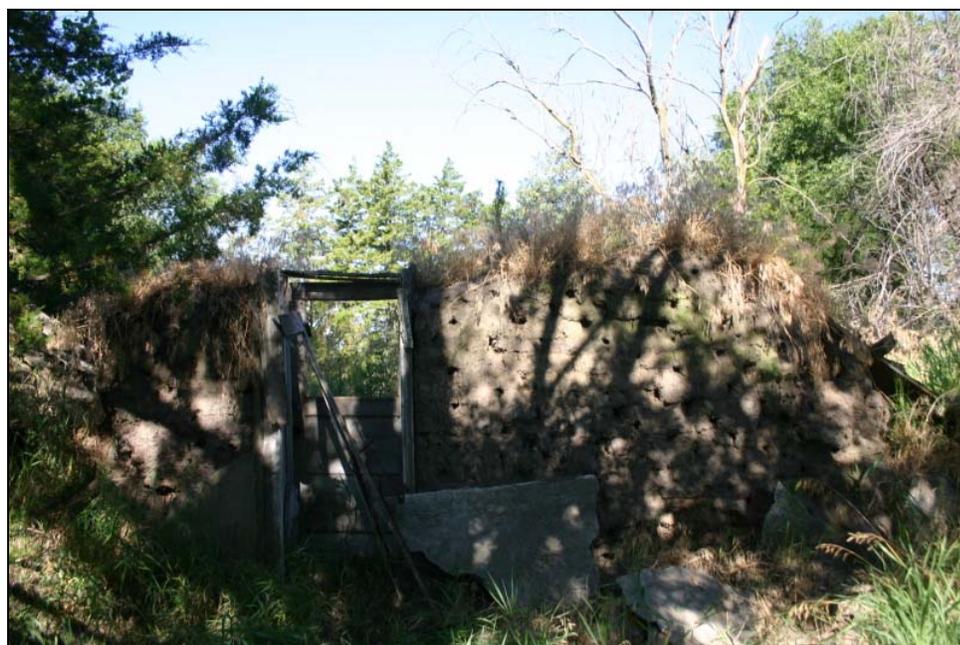
**Photo: 1**

**Condition:** VERY POOR. Roof on house collapsed nearly 20 years ago. Four partial walls remain standing, but the shed roof frame addition to the west is completely gone. Exposed sod walls are heavily weathered and crumbling. One full gabled wall remains on the south elevation, where the center roof beam is still set into the sod at the peak. Remaining roof planks and beams are heavily rotted. House is overgrown with vegetation and very difficult to see from the public right-of-way.

<b>Photo #</b>	<b>Facing</b>	<b>Date</b>	<b>Description</b>
1	W	7/7/2007	Sod – 07, East Elevation
2	NE	7/7/2007	Sod – 07, South Elevation
3	S	7/7/2007	Sod – 07, Interior of north wall
4	NE	7/7/2007	Sod – 07, Interior of east wall
5	S	7/7/2007	Sod – 07, Interior of north wall

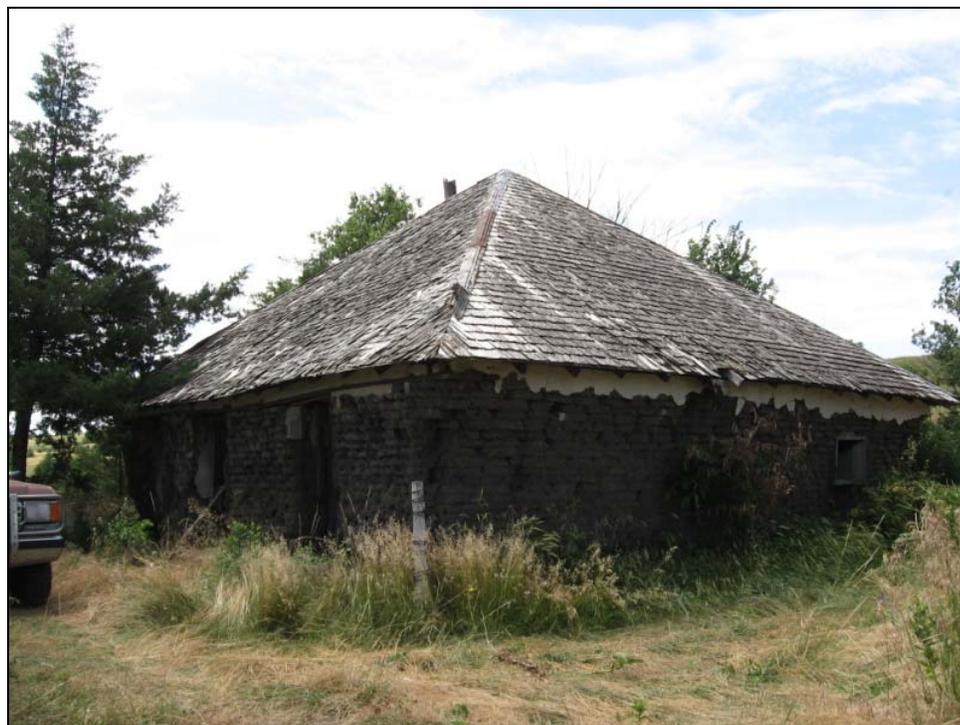
**Photo: 1**

**Condition:** FAIR to POOR. Most of exterior plaster is missing, except towards the eaves. Sod walls are exposed and heavily eroded, especially at the corners. Appears that cattle have been allowed to rub against the sides of the house and enter the house, leaving large piles of dung. Roof contains small holes, but framing appears sound. All glazing

Photo #	Facing	Date	Description
1	SW	7/11/2007	Sod – 09, Northeast corner
2	SE	7/11/2007	Sod – 09, Northwest corner
3	E	7/11/2007	Sod – 09, West Elevation
4	SE	7/11/2007	Sod – 09, Interior
5	SW	7/11/2007	Sod – 09, Interior

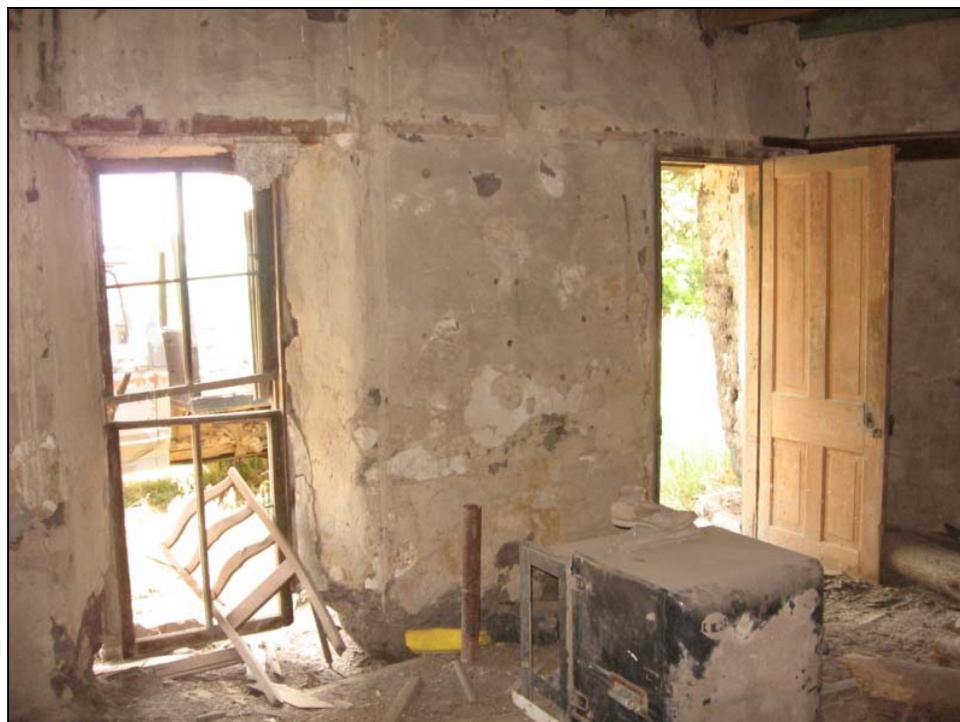
**Photo: 4**

in windows is missing. Lintels and sills display rot, but interior partitions and ceilings appear in fair condition. Water leaks are evident on several interior walls, and the plaster is heavily eroded. House is invested with insects, birds, and vermin.

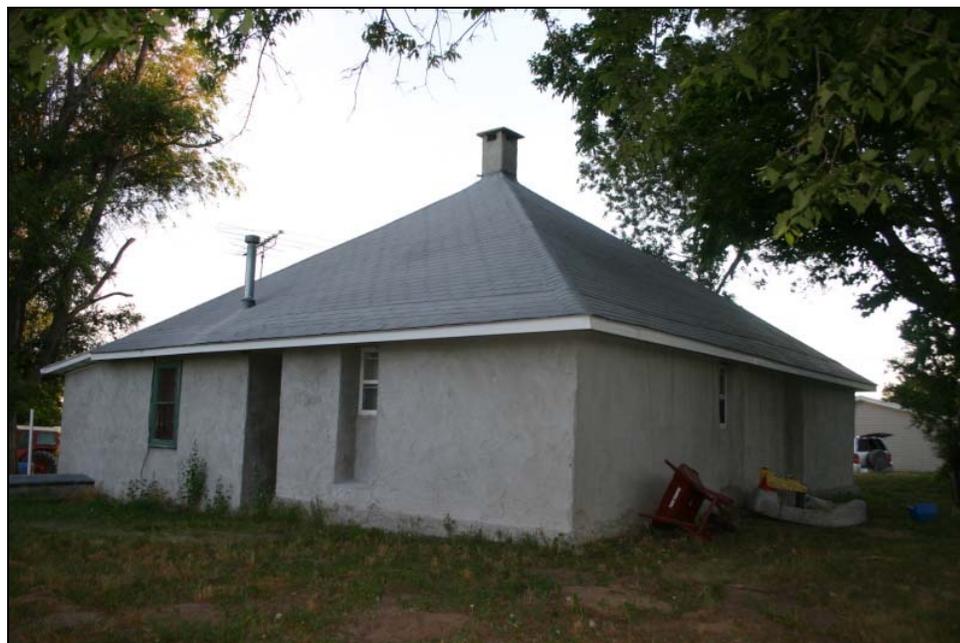
**Photo: 1**

**Condition:** GOOD. Exterior stucco has been maintained and shows no signs of severe cracking that may indicate shifting sod walls in the house. Roof appears sound. Other than a few minor cracks, the interior is in good condition. The walls exhibit a few slight bulges, but the house appears stable. Currently the house is used as a secondary dwelling by the property owner.

<b>Photo #</b>	<b>Facing</b>	<b>Date</b>	<b>Description</b>
1	SW	7/4/2007	Sod – 10, Northeast corner
2	NW	7/4/2007	Sod – 10, East Elevation
3	N	7/4/2007	Sod – 10, South Elevation
4	SE	7/4/2007	Sod – 10, West Elevation
5	NW	7/4/2007	Sod – 10, Interior

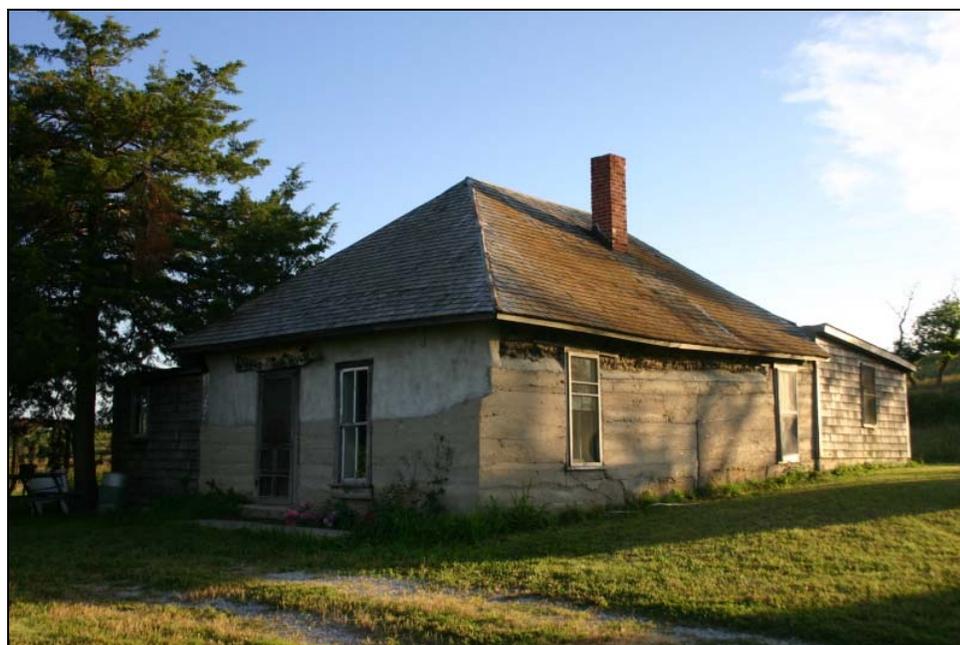
**Photo: 1**

**Condition:** GOOD. Philip and Curtis Dowse heavily restored the house from 1977 to 1982. The exposed sod on the north elevation is crumbling. The attic houses a large number of hornets' nests. There is some cracking above interior door frame, which may or may not signal shifting of the sod walls.

<b>Photo #</b>	<b>Facing</b>	<b>Date</b>	<b>Description</b>
1	SW	7/2/2007	Sod – 11, Northeast corner
2	SE	7/2/2007	Sod – 11, North Elevation
3	NE	7/2/2007	Sod – 11, South Elevation
4	NE	7/2/2007	Sod – 11, Interior parlor
5	NE	7/2/2007	Sod – 11, Interior kitchen
