# THE SOD HOUSES OF CUSTER COUNTY, NEBRASKA

A Thesis Submitted to the Graduate Faculty of The University of Georgia in Partial  
Fulfillment of the Requirements for the Degree

MASTERS OF HISTORIC PRESERVATION

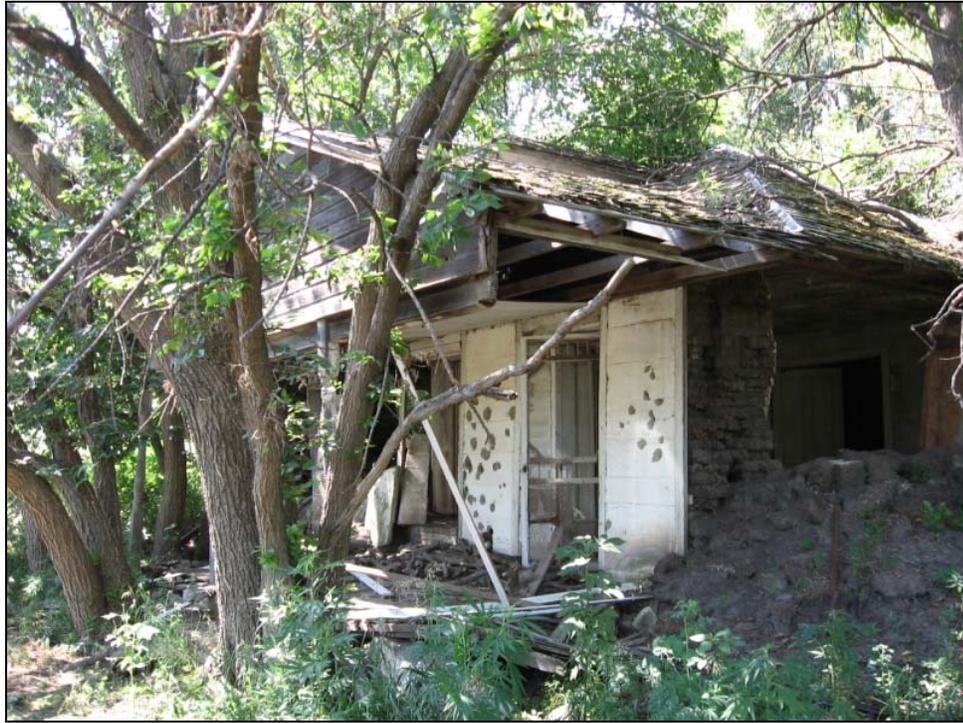
**Photo: 1**

**Condition:** VERY POOR. House has been vacant for nearly fifty years. Large portions of the sod walls are collapsed on every elevation. Several window frames have fallen out of place and large holes exist in the roof. Concrete and plaster is severely cracked and falling apart. Interior wall joints are separating, especially at the corners. Vegetation is growing into the walls. Interior wood contains significant amounts of rot. Ceiling of rectangular wing has completely collapsed, preventing entry into that portion of the house. Frame shed addition has also completely collapsed. House is dangerous to enter since the wood floor is so badly rotted, it can barely handle anything more than 100 pounds.

<b>Photo #</b>	<b>Facing</b>	<b>Date</b>	<b>Description</b>
1	NW	7/8/2007	Sod – 12, South Elevation
2	NW	7/8/2007	Sod – 12, East Elevation
3	SW	7/8/2007	Sod – 12, North Elevation
4	N	7/8/2007	Sod – 12, West Elevation
5	S	7/8/2007	Sod - 12, Interior

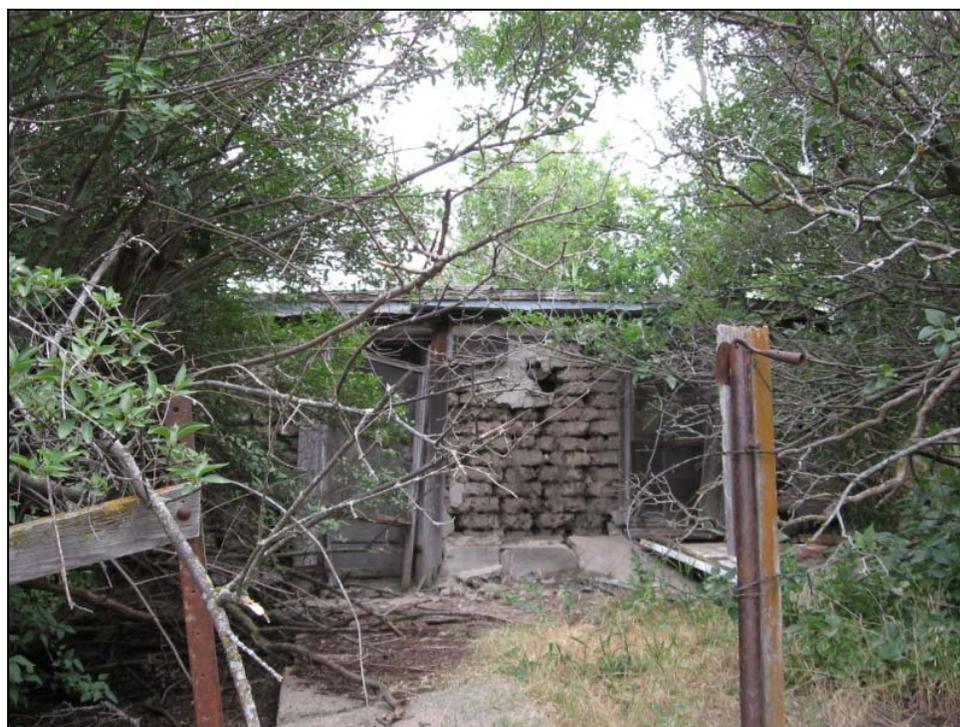
**Photo: 1**

Photo #	Facing	Date	Description
1	N	7/10/2007	Sod – 13, South Elevation
2	SW	7/10/2007	Sod – 13, East Elevation
3	NE	7/10/2007	Sod – 13, West Elevation
4	SE	7/10/2007	Sod – 13, Interior
5	NW	7/10/2007	Sod – 13, Interior

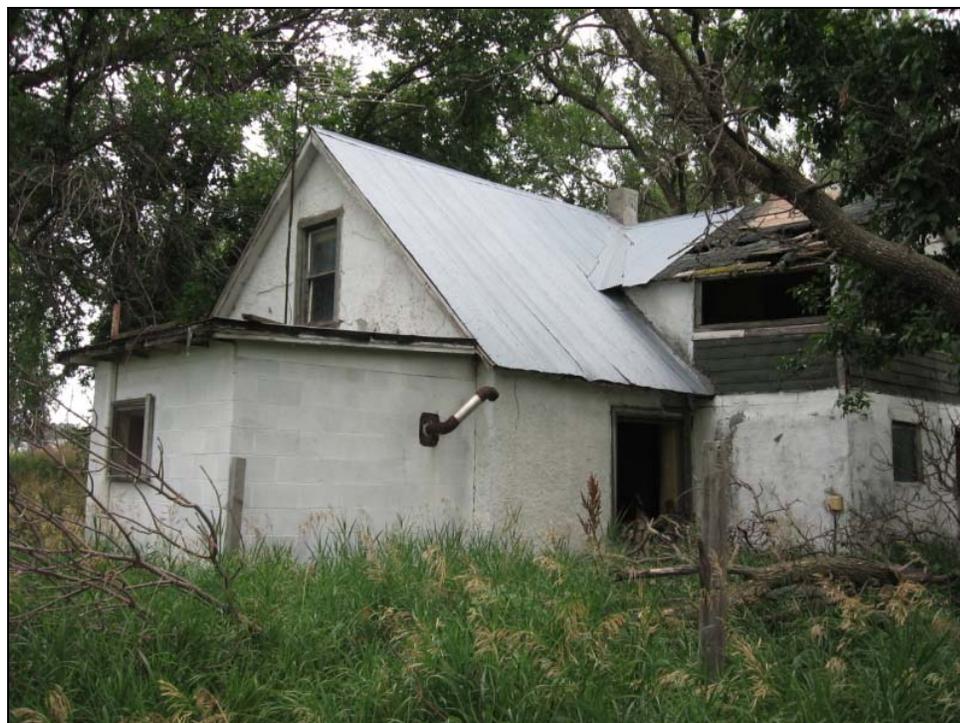
**Photo: 1**

Photo #	Facing	Date	Description
1	NE	7/9/2007	Sod – 14, Southwest corner
2	SE	7/9/2007	Sod – 14, Northwest corner
3	W	7/9/2007	Sod – 14, East Elevation
4	S	7/9/2007	Sod – 14, Exposed sod blocks
5	NW	7/9/2007	Sod - 14, Interior

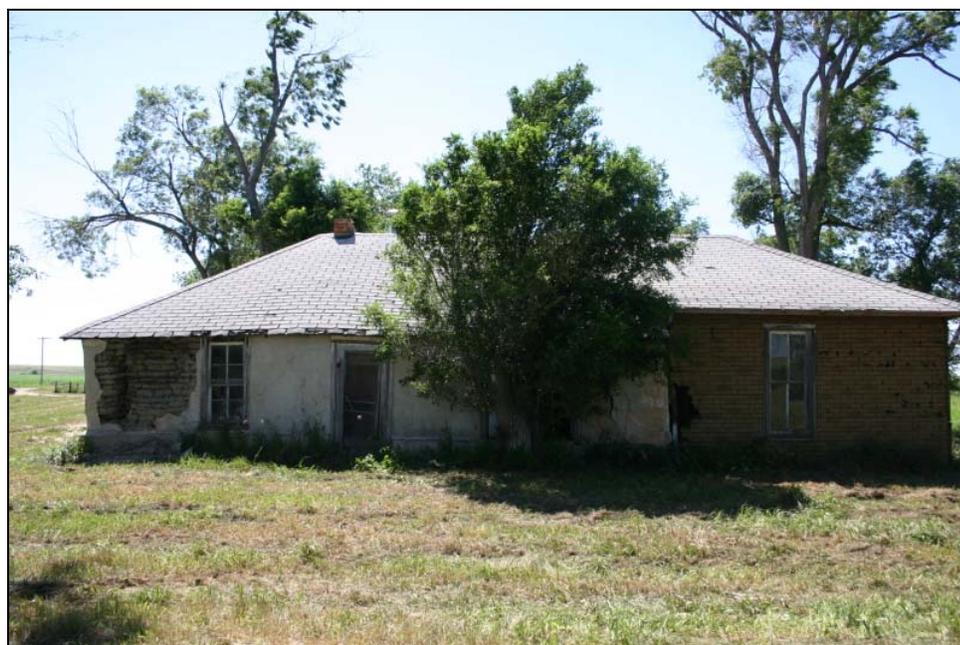
**Photo: 1**

Photo #	Facing	Date	Description
1	W	7/7/2007	Sod – 15, East Elevation
2	N	7/7/2007	Sod – 15, South Elevation
3	SE	7/7/2007	Sod – 15, West Elevation
4	NE	7/7/2007	Sod – 15, West Elevation
5	SE	7/7/2007	Sod – 15, Interior

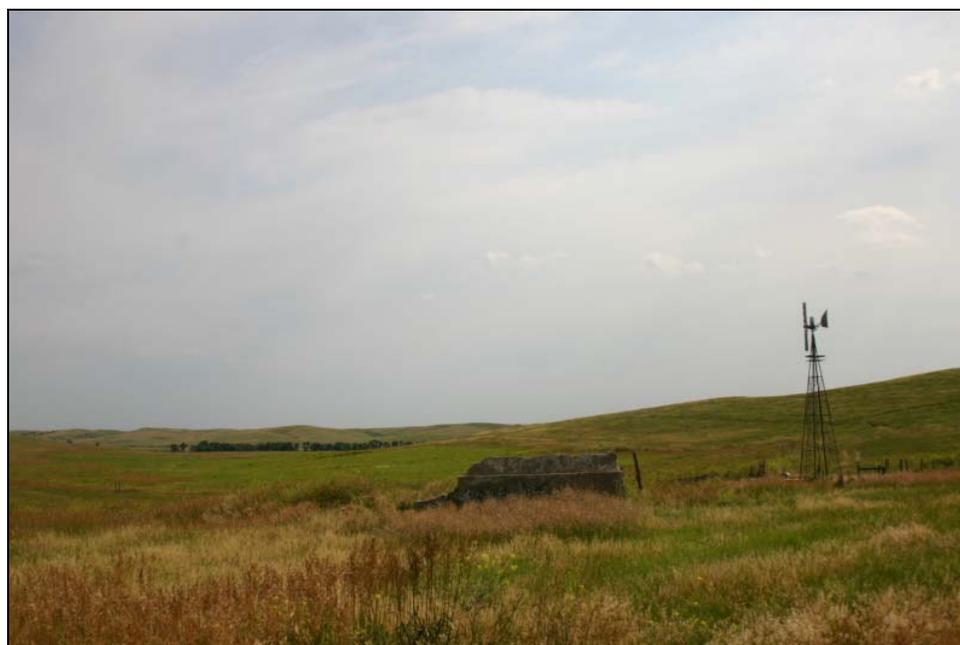
**Photo: 1**

**Condition:** NONEXTANT. The sod walls are no longer standing. Only a partial wall of concrete with the imprints of sod blocks remains.

<b>Photo #</b>	<b>Facing</b>	<b>Date</b>	<b>Description</b>
1	SW	7/2/2007	Sod – 16, North Elevation
2	NE	7/2/2007	Sod – 16, Rear of north wall
3	N	7/2/2007	Sod – 16, Rear of north wall
4	S	7/2/2007	Sod – 16, Detail of north wall exterior
5	N	7/2/2007	Sod – 16, Detail of sod imprints

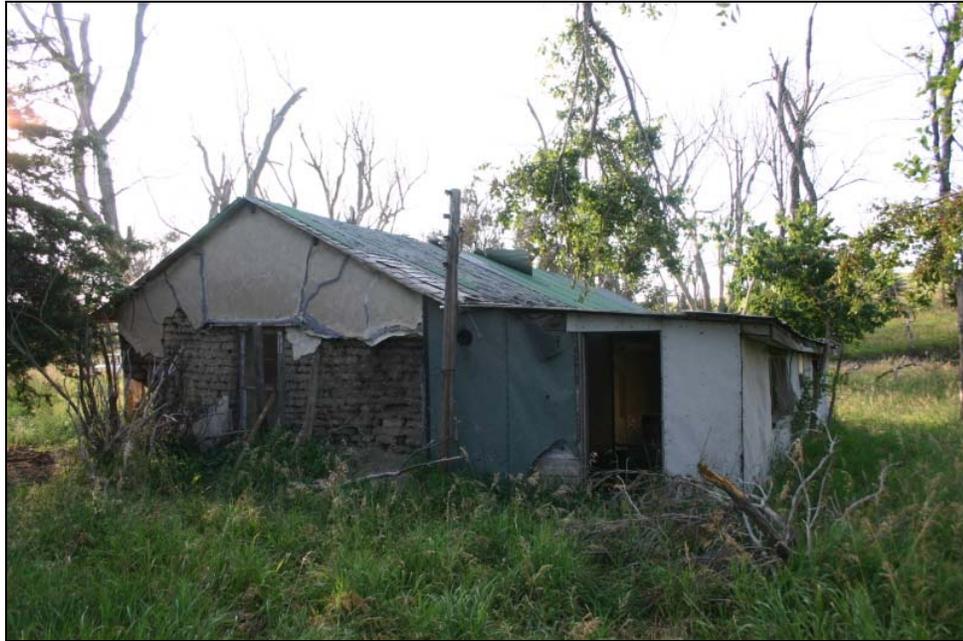
**Photo: 1**

Photo #	Facing	Date	Description
1	NW	7/3/2007	Sod – 17, South Elevation
2	SE	7/3/2007	Sod – 17, West Elevation
3	S	7/3/2007	Sod – 17, North Elevation
4	SW	7/3/2007	Sod – 17, Northeast corner
5	E	7/3/2007	Sod – 17, Interior

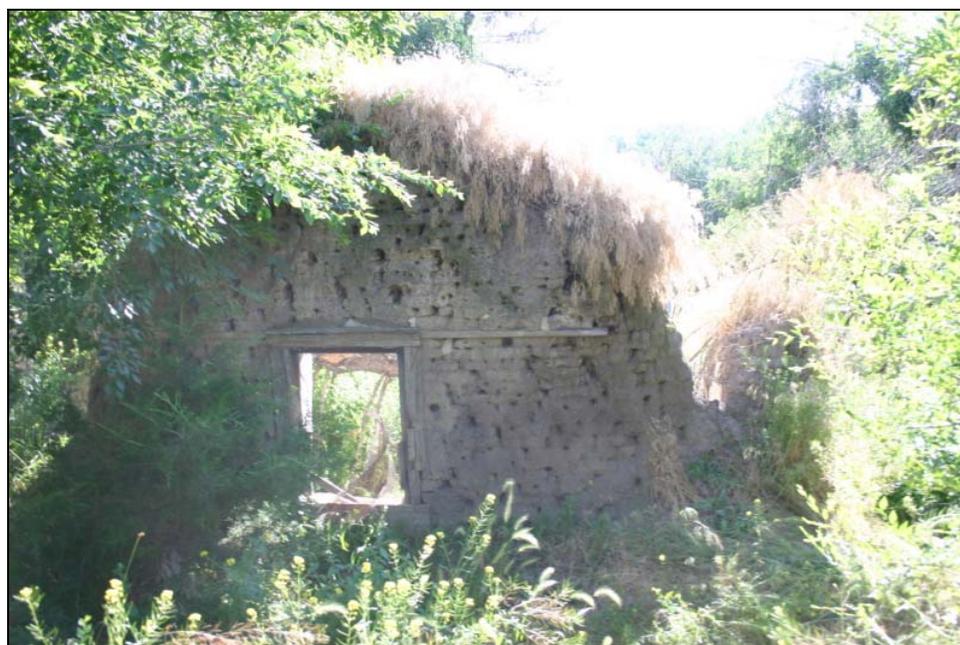
**Photo: 1**

**Condition:** VERY POOR. House has completely collapsed and only three partial sod walls remain. Footprint of house is difficult to determine because house is heavily overgrown with trees and brush. Remaining sod walls are massive and thick, but heavily eroded. Only one window frame remains, but the glazing is broken. Portions of the brick

<b>Photo #</b>	<b>Facing</b>	<b>Date</b>	<b>Description</b>
1	SW	7/4/2007	Sod – 18, East Elevation
2	SE	7/4/2007	Sod – 18, Interior of east wall
3	N	7/4/2007	Sod – 18, Interior of inner sod wall
4	S	7/4/2007	Sod – 18, North Elevation
5	SW	7/4/2007	Sod – 18, Detail of east wall

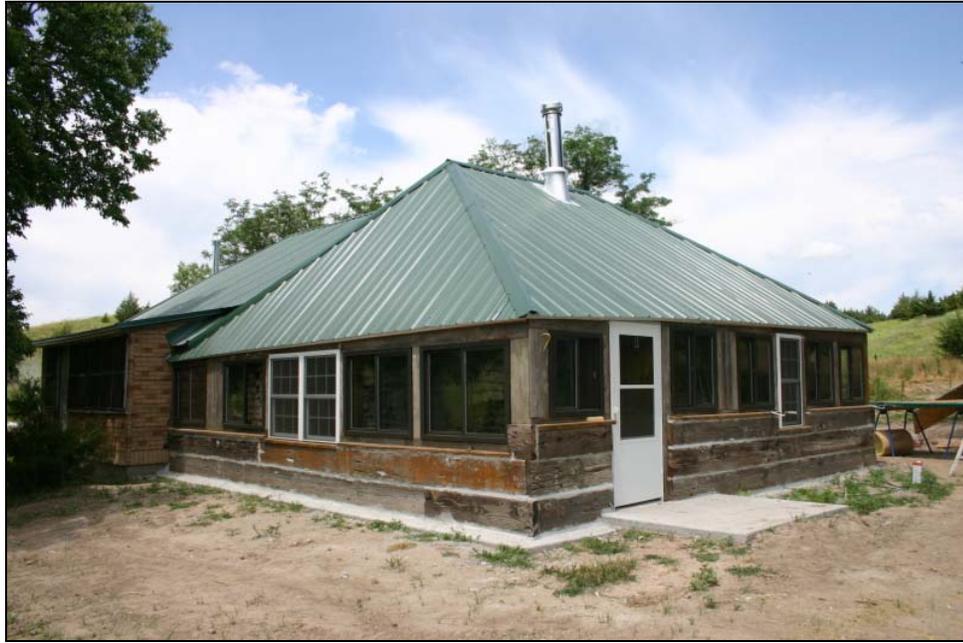
**Photo: 1**

**Condition:** GOOD. Since 2003, the house has been rehabilitated into a summer cottage and therefore many of the problems have been remedied. The original wood frame wall partitions in the sod core were rotted and removed. The windows were replaced and boxed in and the ceiling was raised. Parts of the roof system were replaced with modern lumber due to rot. The wood floors were removed and replaced with a concrete floor.

<b>Photo #</b>	<b>Facing</b>	<b>Date</b>	<b>Description</b>
1	NW	7/2/2007	Sod – 19, Southeast corner
2	SW	7/2/2007	Sod – 19, Northeast corner
3	SE	7/2/2007	Sod – 19, Northwest corner
4	NE	7/2/2007	Sod – 19, Southwest corner
5	SE	7/2/2007	Sod – 19, Interior of sod core

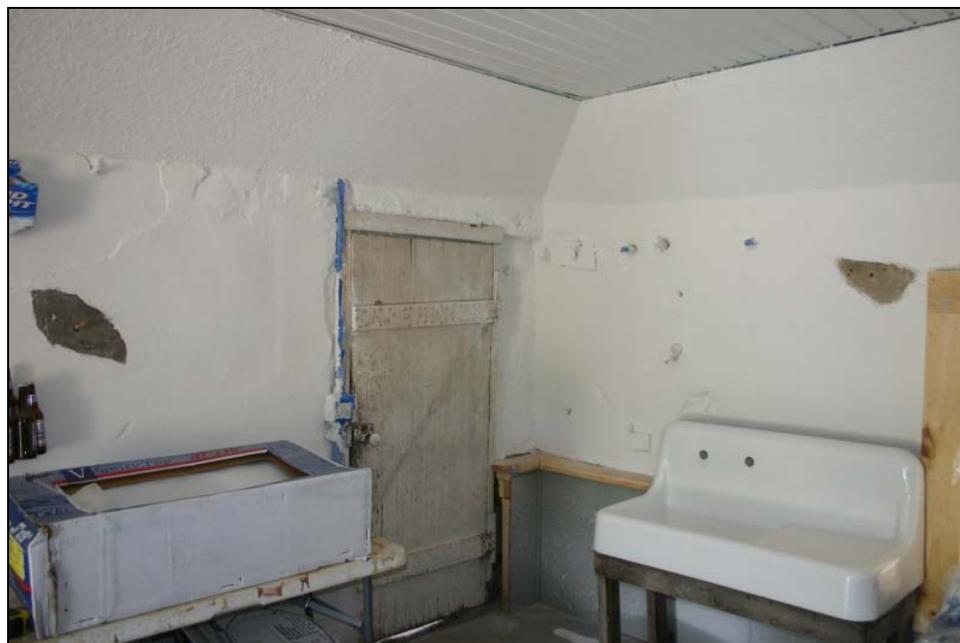
Photo: 5

The sod walls were heavily damaged from water and had begun to collapse, but the current stabilized them with wood logs.

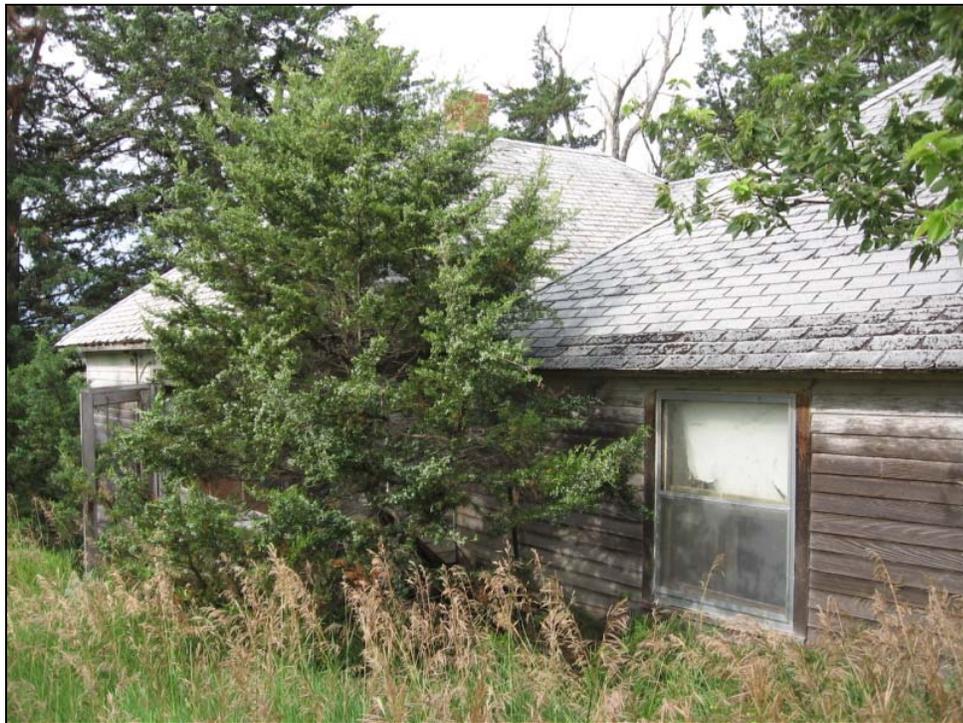
**Photo: 2**

<b>Photo #</b>	<b>Facing</b>	<b>Date</b>	<b>Description</b>
1	NE	7/10/2007	Sod – 20
2	SW	7/10/2007	Sod – 20, East Elevation
3	SE	7/10/2007	Sod – 20, North Elevation
4	SE	7/10/2007	Sod – 20, West Elevation
5	SE	7/10/2007	Sod – 20, Interior

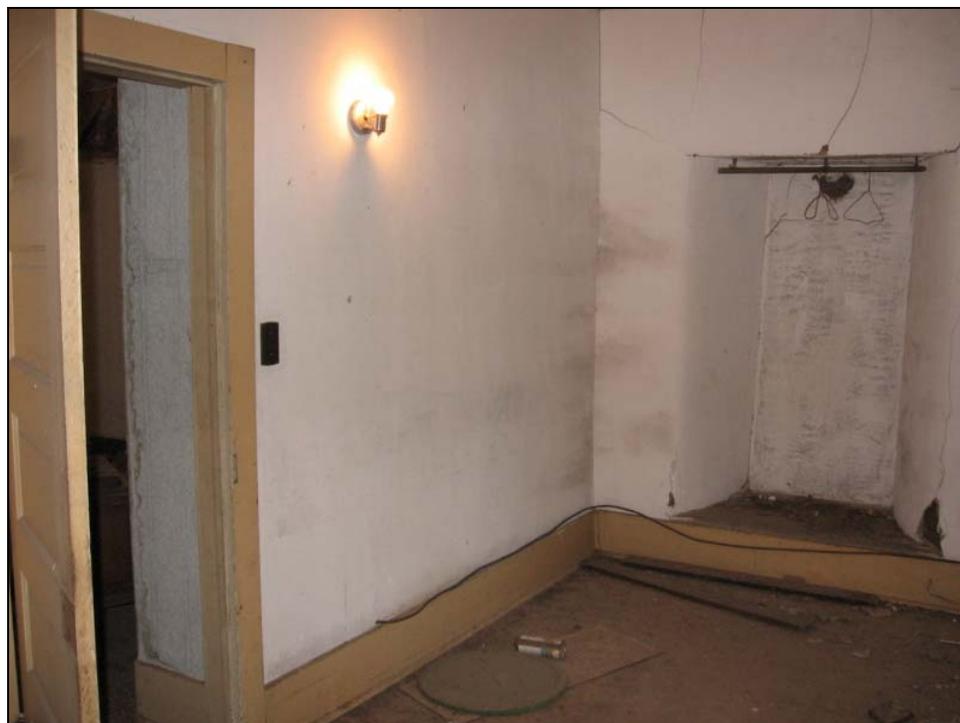
Photo: 5

**Condition:** GOOD. House appears structurally sound with no evidence of significant settling, shifting, or warping. The paint has worn off the exterior clapboard and there are signs of mildew near the base of the house. The interior of the house shows signs of water damage in both the sod core and the addition. Interior walls reveal exposed sod where the plaster has worn off. Where bead board has covered the sod, the wood is rotted and heavily deteriorated.

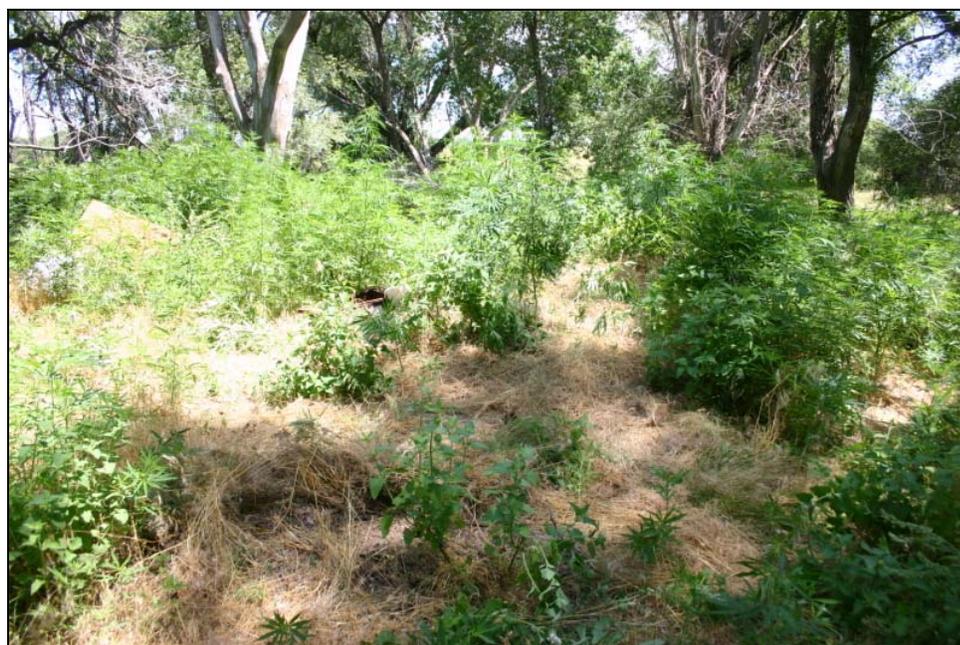
**Photo: 1**

**Condition:** NONEXTANT. House has completely collapsed and melted into the earth. Only a mound of dirt and remnants of sawn lumber remain. Footprint of house was determined by former concrete sill that surrounded the perimeter of the house.

Photo #	Facing	Date	Description
1	NW	7/4/2007	Sod – 22, Mound of remaining sod house
