PRESERVING AMERICA'S LATE TWENTIETH CENTURY DOMESTIC
ARCHITECTURE: A STUDY OF THREE NEIGHBORHOODS IN ALLEGHANY COUNTY,
VIRGINIA

A Thesis Submitted to the Graduate Faculty of The University of Georgia in Partial Fulfillment
of the Requirements for the Degree

MASTER OF HISTORIC PRESERVATION

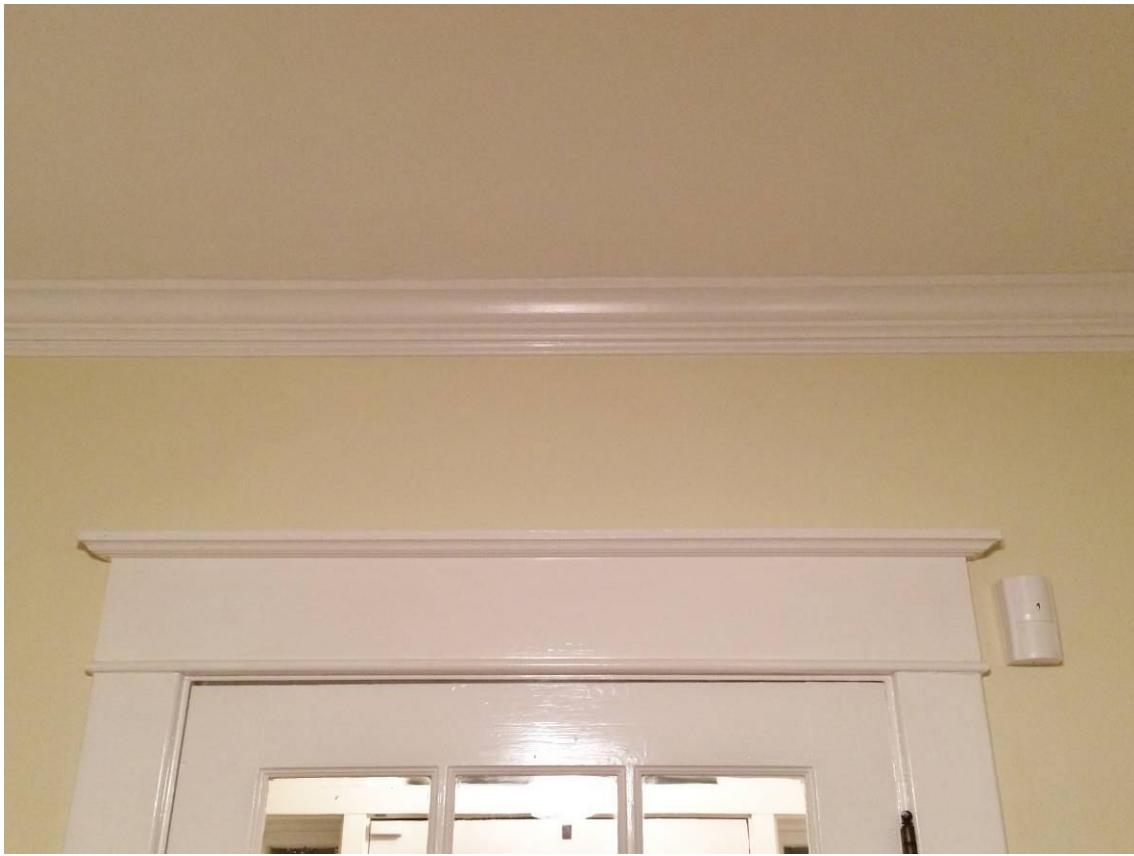
Figure 68: 612 Addams St., Decorative Details – Solid wood trim/crown molding and decorative wooden door surround, Rosedale, Alleghany County, VA (Leonard, 2014)

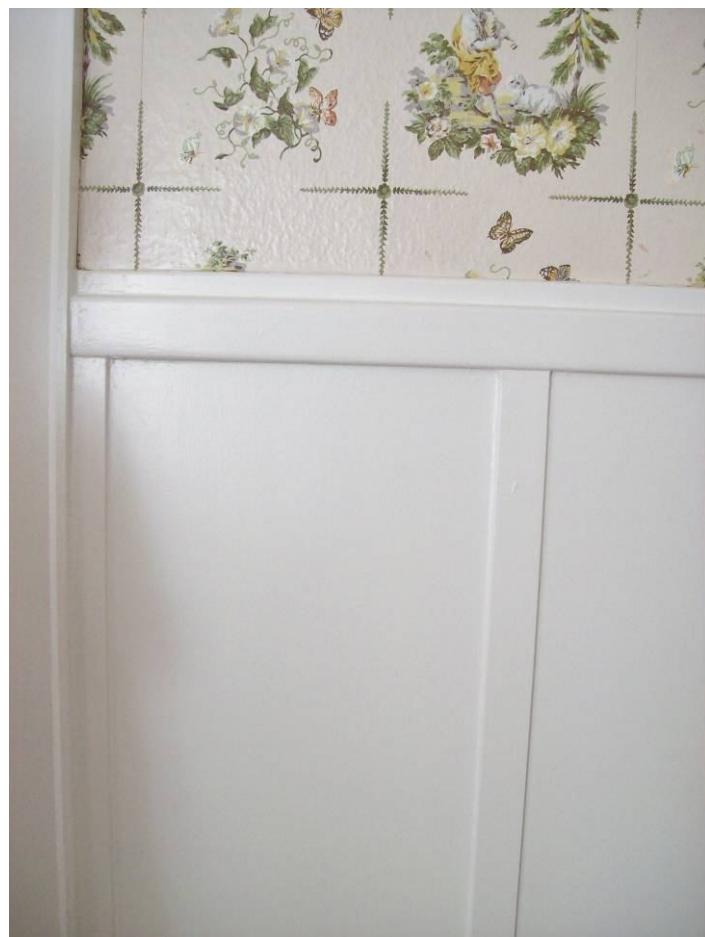
Figure 70: Red Gum Wainscoting, 101 Parkview Avenue, Clearwater, Alleghany County, VA
(Leonard, 2014)

Although less elaborate than Rosedale, Clearwater also features decorative details. Baseboards and crown moldings were present, but are generally simpler than those in Rosedale. These too are made from solid wood, and likewise, most doors are solid wood rather than hollow. Other unique features found in Clearwater were red gum wainscoting, interior archways, built-in wooden wardrobes, and exposed, decorative wooden beams.

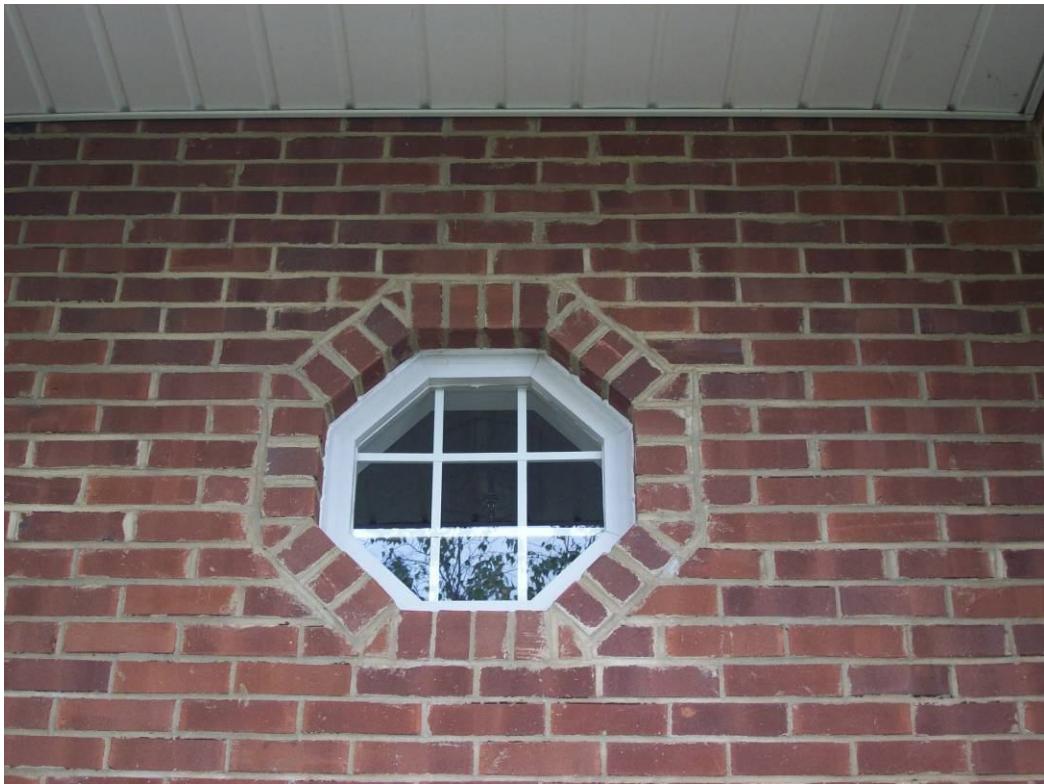
Figure 72: 202 Sherry May Street, Plastic Window & Muntins, Poor Re-pointing Job, Clearview, Alleghany County, VA (Leonard, 2014)

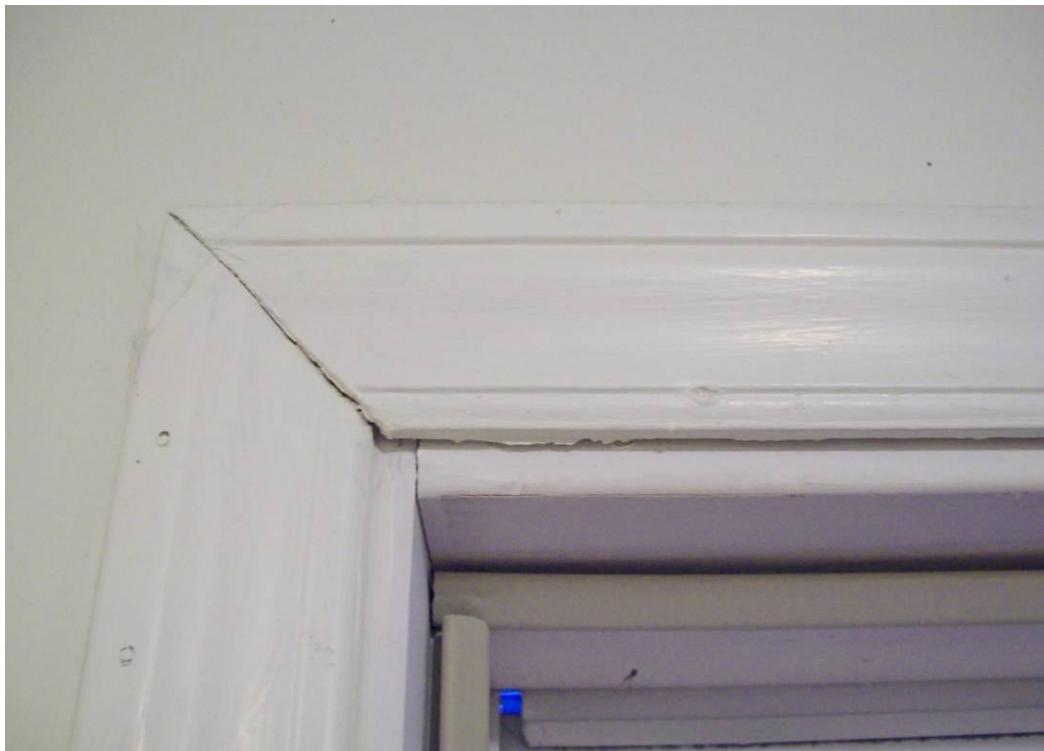
Figure 73: 105 Sammy's Road, Deteriorating Door Frame & Broken Seal, Clearview, Alleghany County, VA (Leonard, 2014)
