USING GREEN INFRASTRUCTURE TO SUPPORT WATER-BASED  
RECREATION IN LAKE HERRICK

A Thesis Submitted to the Graduate Faculty of The University of Georgia in Partial Fulfillment of the  
Requirements for the Degree

MASTER OF LANDSCAPE ARCHITECTURE

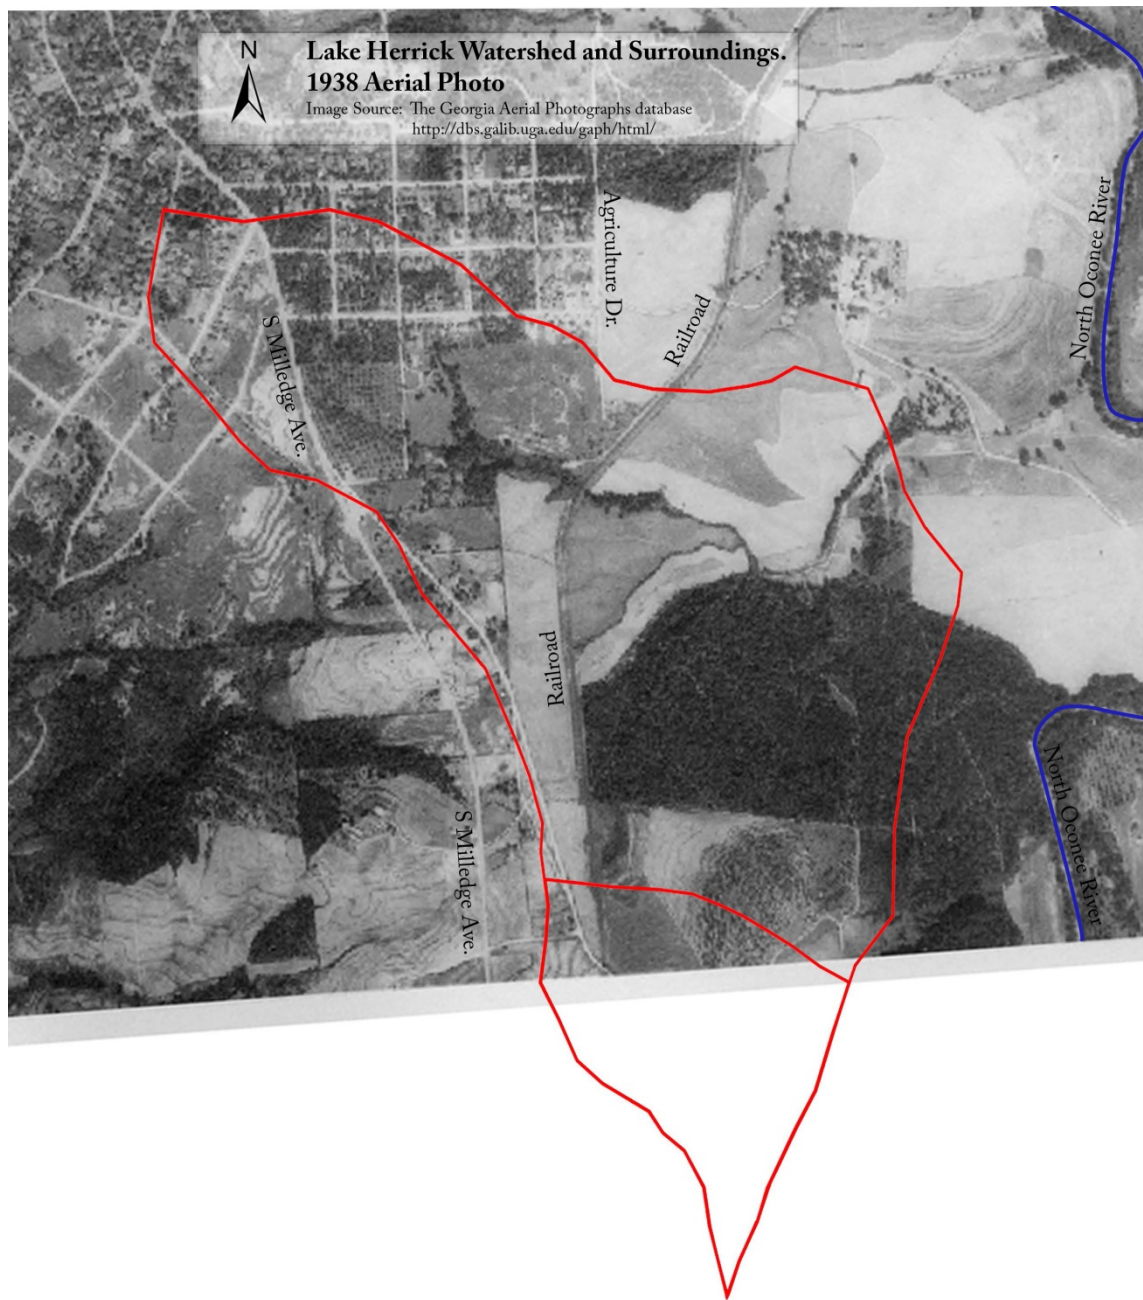
*Figure 1: 1938 aerial photo of the Lake Herrick watershed. The watershed and most of the surrounding landscape is used for agriculture, with the exception of Oconee-Denmark forest.*

The following series of aerial photos shows the changing landscape of the Lake Herrick watershed over the course of 75 years from 1938 to 2013. A red line demarcating the watershed boundary has been superimposed over each photo, including a boundary line that delineates the Parvo Pond subcatchment (the smaller, southern-most portion of the watershed).

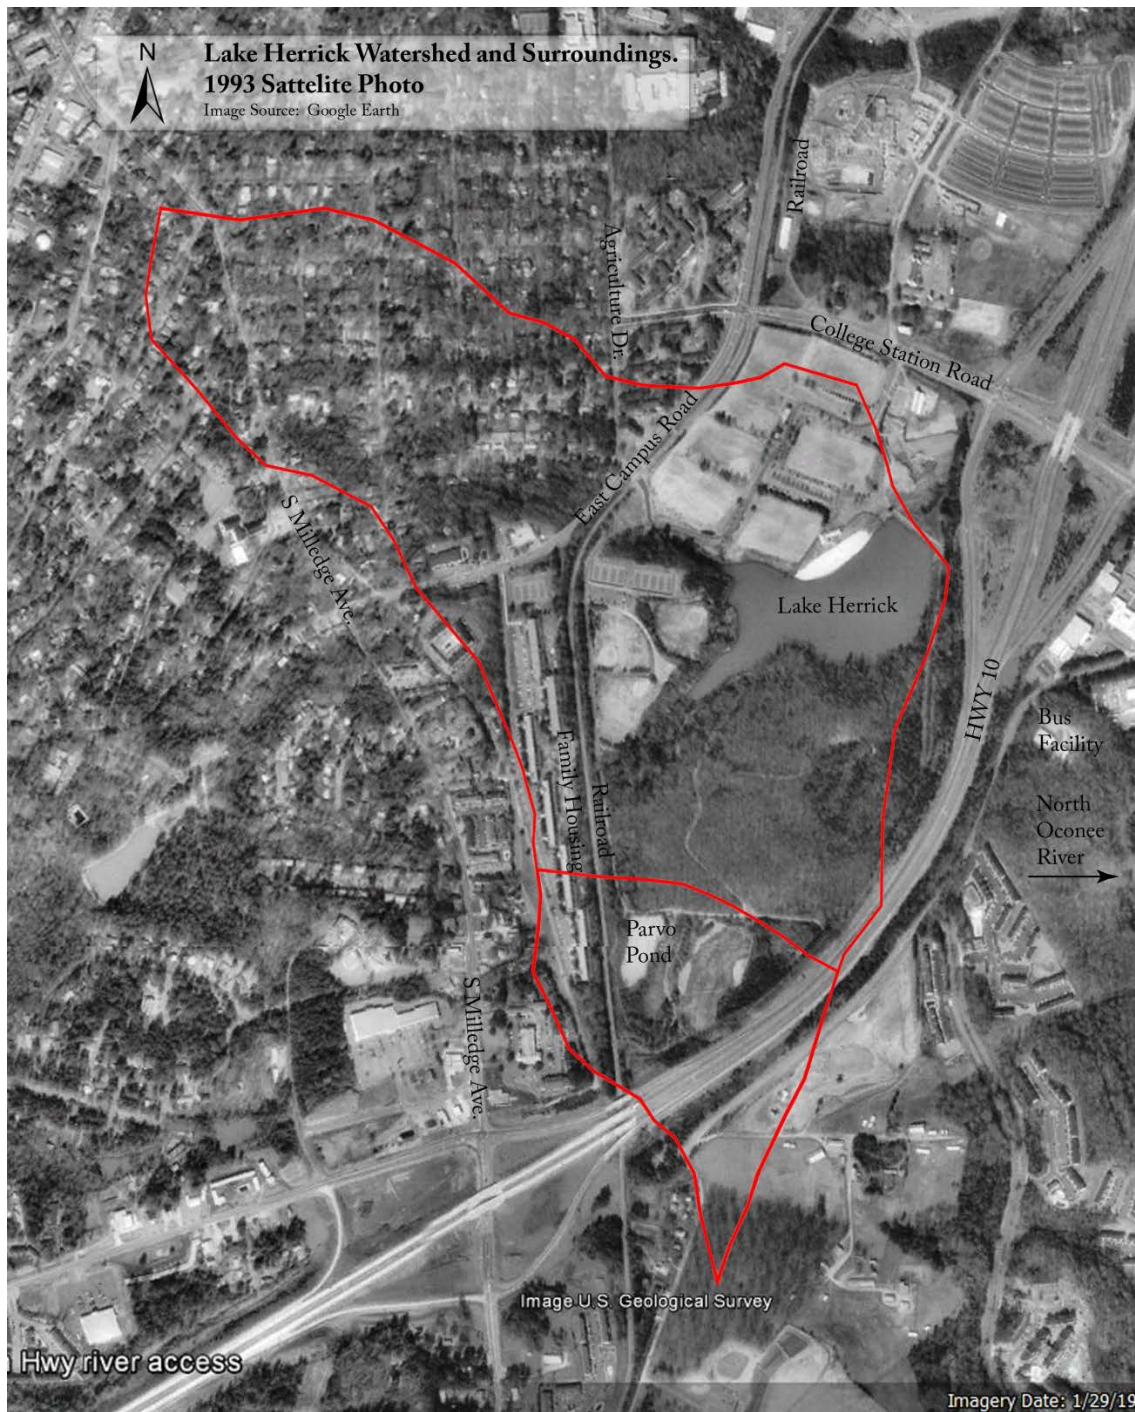
Figure 5: 1993 satellite photo of the Lake Herrick watershed. Lake Herrick, the intramural fields, baseball fields, tennis courts, Oconee Forest Park, and Hwy 10 are all established. The UGA Campus Transit facility is under construction. Parvo Pond is a different color than Lake Herrick; heightened sediment inputs from the construction may have contributed to this, but the pond is also perpetually turbid due to input from a natural spring.

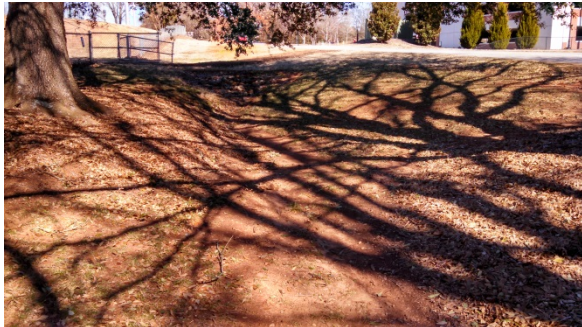
*Figure 9: Photo of the upper portion of the intramural fields swale. The swale is shaded and grass coverage is sparse.*

Three of the four intramural fields along East Campus road fall within Lake Herrick's watershed. Along with some road surface adjacent to the parking deck, they are drained by a culvert pipe that discharges into a swale that runs along the east side of the southern-most field. This swale terminates in a drain that conveys runoff under Lake Herrick Drive and discharges near the shoreline where the western tributary stream flows into the lake. Much of the surface of the swale is bare soil. This is possibly because there are a number of large trees that provide shade and prevent the growth of grass. There is denser grass coverage towards the bottom of the swale near the drain. Here, the grass is noticeably

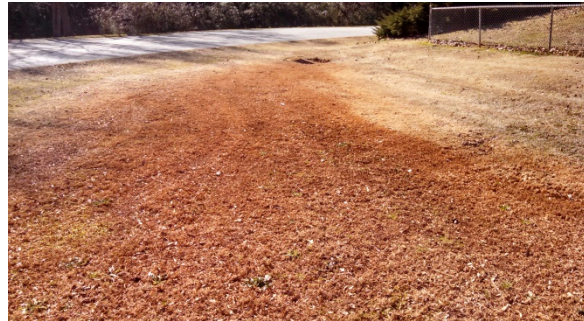
*Figure 10: Photo of the lower portion of the intramural fields swale. Sediment is visibly streaked across the grass.*

stained with sediment from the upper reaches of the swale. This conveyance feature is a clear contributor of sediment to Lake Herrick. Piles of accumulated sediment are visible near the discharge point, along the streambed where the tributary stream flows into Lake Herrick.

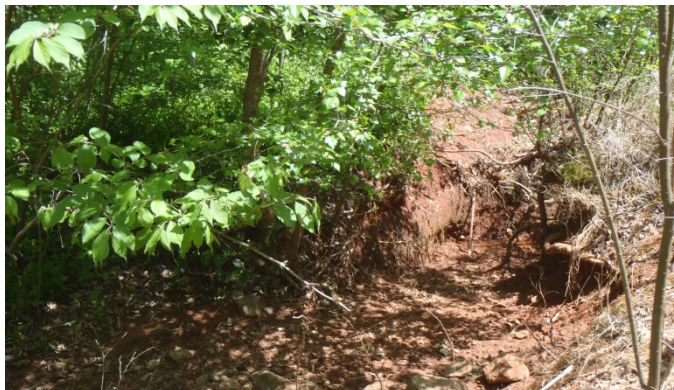
*Figure 11: Photo of a ditch that conveys runoff from the bus facility to Parvo Pond.*

Lake Herrick and Parvo Pond were subject to heavy sediment loads generated by the construction of the University's Bus Facility on Riverbend Road during the mid-1990's. It is likely that sediment loads from that site have subsided, as construction was completed around 20 years ago and the ground is

now fully covered in vegetation and impervious surface. However, runoff from the facility still flows into Parvo Pond, following an overland path that includes some ditches that appear to have been carved out by erosion. Runoff from large storm events likely does still convey sediment into Parvo Pond,

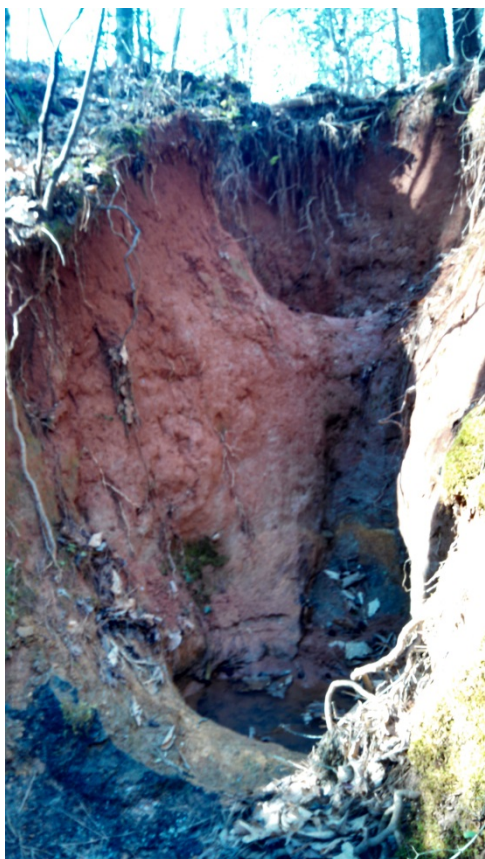
*Figure 12: Photo of the eroded gully where runoff from Family Housing discharges.*

There are two additional drainage ditches in the watershed that are deeply incised and likely contributing large amounts of sediment to the lake: one is at the outlet of an exceptionally long culvert

pipe that drains the family housing parking lot. This discharges in the forest near the tennis courts, in close proximity to the wetland area. Here, the drainage ditch has become a deep gully, eroding to depths of over five feet. This process has undoubtedly contributed substantial sediment to Lake Herrick's inlet cove. Because the flow-path by which runoff is conveyed to this point is very long, there are opportunities for siting design interventions to mitigate the impact of erosive discharge.

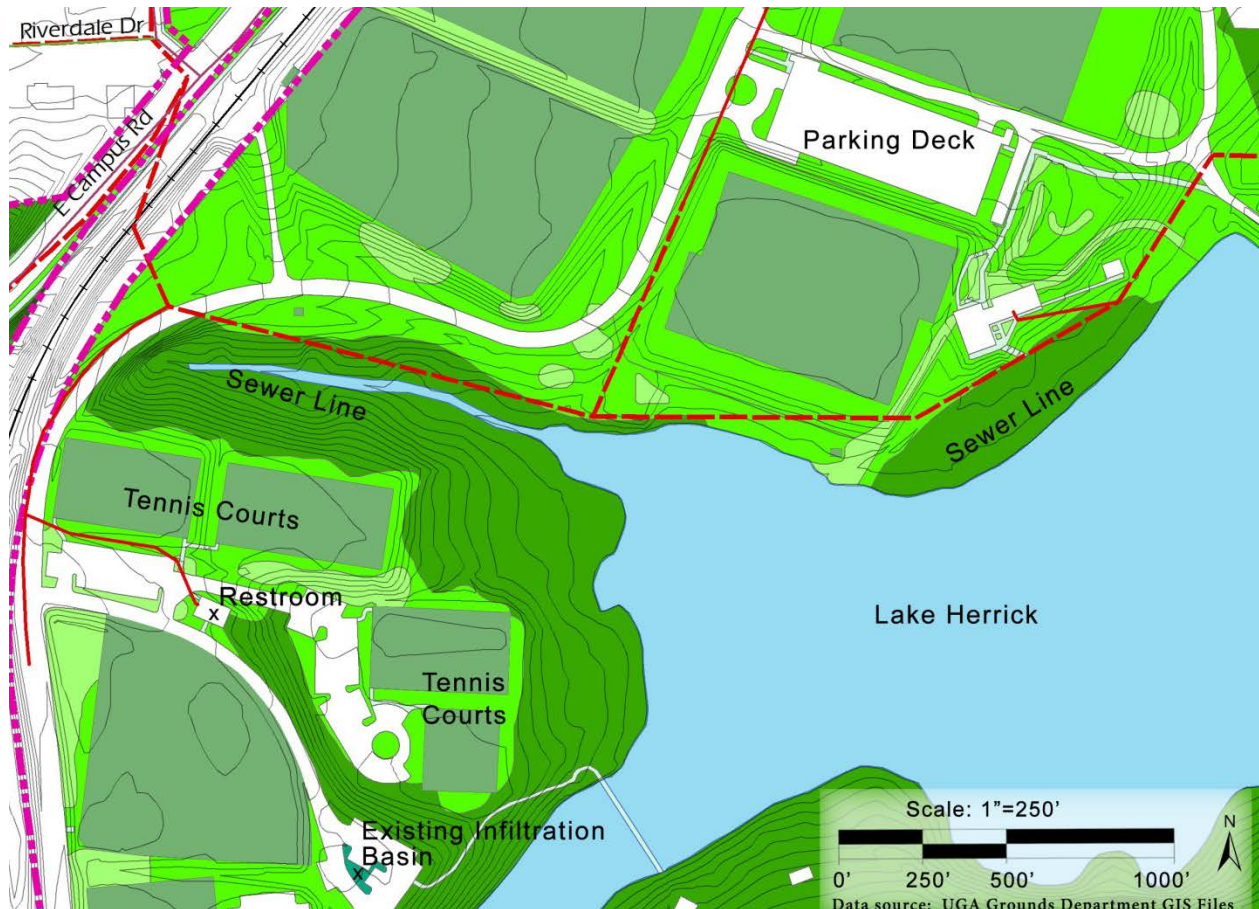
*Figure 13: Map of the sewer line that runs close to the lakeshore.*

terminates at the restroom building near the tennis courts. It is possible that leaks in this sewer line could leach bacterial contaminants into Lake Herrick. However, there is no indication that this is currently an issue.

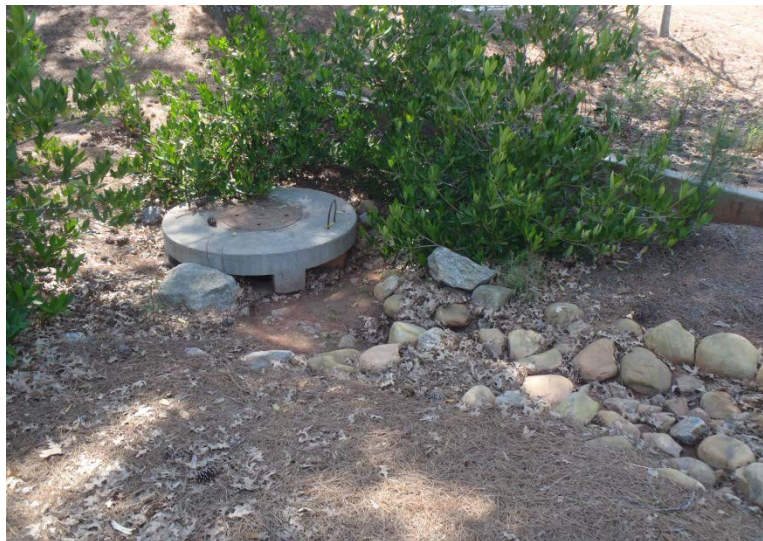
*Figure 14: Photo of a storm inlet near the tennis courts. This outlet structure in one of the existing rain gardens is not elevated, and thus allows for no ponding before the SCM overflows. Better function could be achieved if the structure's inlet elevation were raised.*

with permeable pavement. That lot drains to a roughly 1,500 square-foot rain garden with an elevated outlet that facilitates some ponding and infiltration. Its exact dimensions are not clear because it is not recorded in the Grounds Department's GIS files. This area overflows through two culvert pipes to a second 1,438-square foot depressed island in the center of the lot closest to the tennis courts (see Figure 13). This island was designed as an infiltration basin by Beall Gonnissen & Company with input from University Architects and the Grounds Department. It was the first infiltration-based stormwater control measure on campus, constructed circa 2000 and renovated circa 2008. (Vick 2015) Currently, its inlet and outlet structures are oriented in a way that provides for little storage, and no infiltration. It apparently provides little stormwater management function beyond simple conveyance, limited uptake by plants, and a slightly extended time of concentration. The structure should be monitored to ensure that it is functioning properly. It could potentially be retrofitted for enhanced filtration and infiltration. (UGA Grounds Department GIS data)

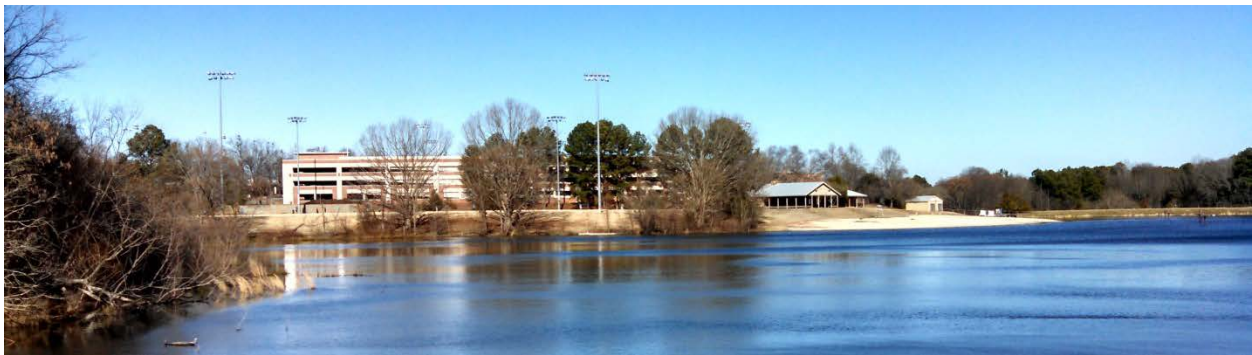
*Figure 16: Photo of the view across Lake Herrick from the wooden bridge. Planting evergreen trees and other vegetation towards the left side of the new intramural fields parking deck would improve the view and make the structure less of a visually overwhelming element in the landscape.*

Views across Lake Herrick toward Oconee Forest Park provide a pleasant natural scene in the midst of a heavily developed area. Views in the opposite direction, from Oconee Forest Park towards the intramural fields, have recently been impacted by the construction of a four-story parking deck located just behind the beach.

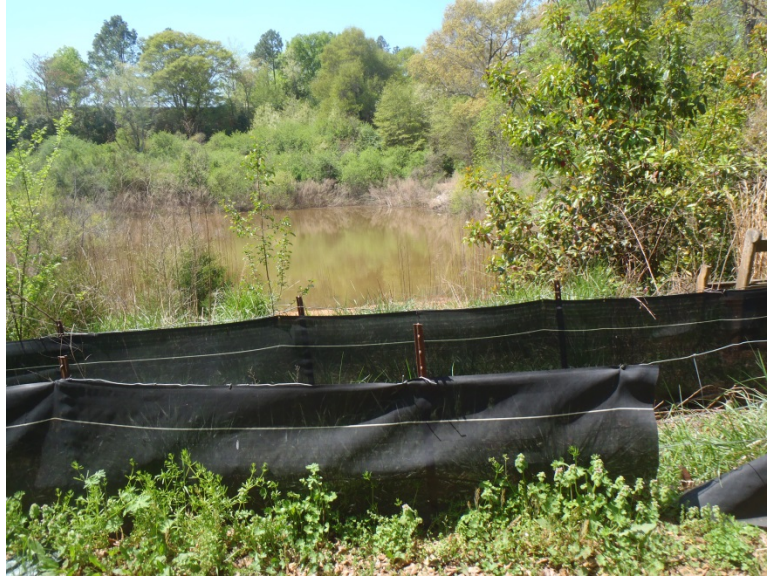
*Figure 17: Photo of silt fencing around Parvo Pond.*

Silt fencing extends all the way around Parvo Pond, and is an unsightly feature. Although it probably was never intended as a long-term strategy for mitigating sediment inputs to the water body, it has remained in place for many years. Alternative sediment control strategies should be implemented, as this structure detracts from the aesthetic quality of the landscape.

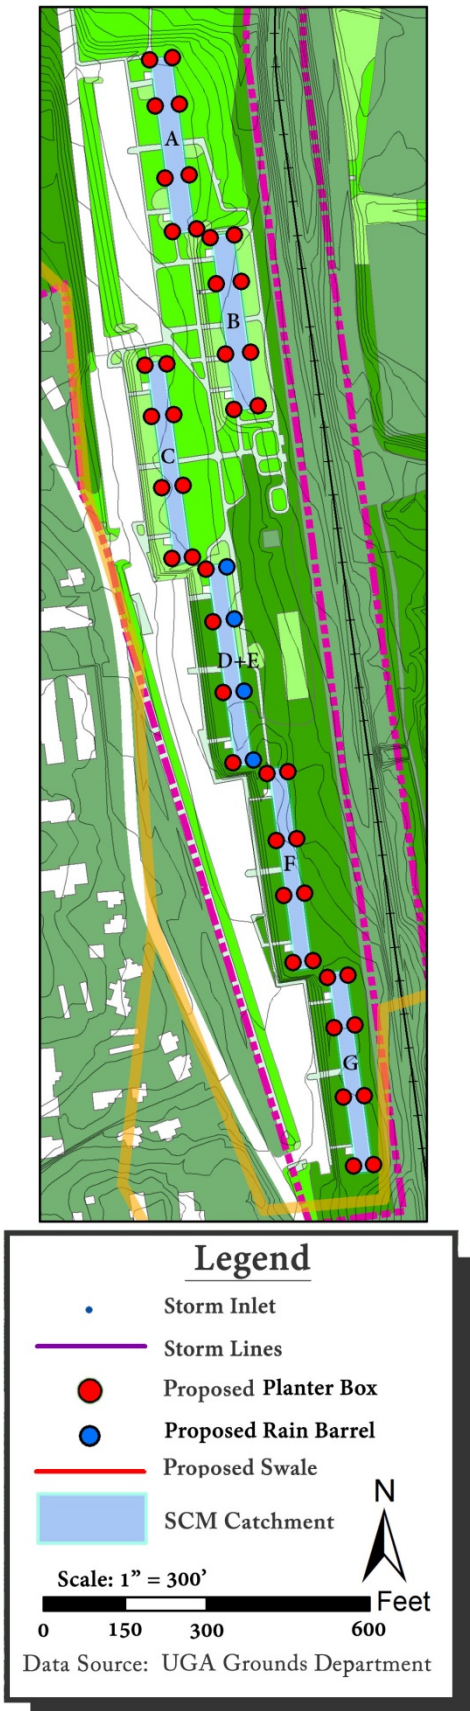
*Figure 20 (left): Map of proposed Family Housing planter box and rain barrel locations.*

Dispersing flows from the family housing rooftop downspouts would check the low-level erosive transport. Additionally, water from the rooftop can potentially be reused for both functional and aesthetic benefits. A cistern or several rain barrels should be installed to capture water near the garden area (behind Building Q) and provide irrigation at the Family Housing

community garden. At each downspout that is not being utilized for rainwater harvesting, planter boxes would serve to detain the remainder of the runoff and filter any contaminants that might flow off the roof. The planter boxes should be planted with attractive, low maintenance, native vegetation to uptake rainwater and contribute to a pleasant environment. Planter boxes could potentially even serve as additional space to grow edible plants.

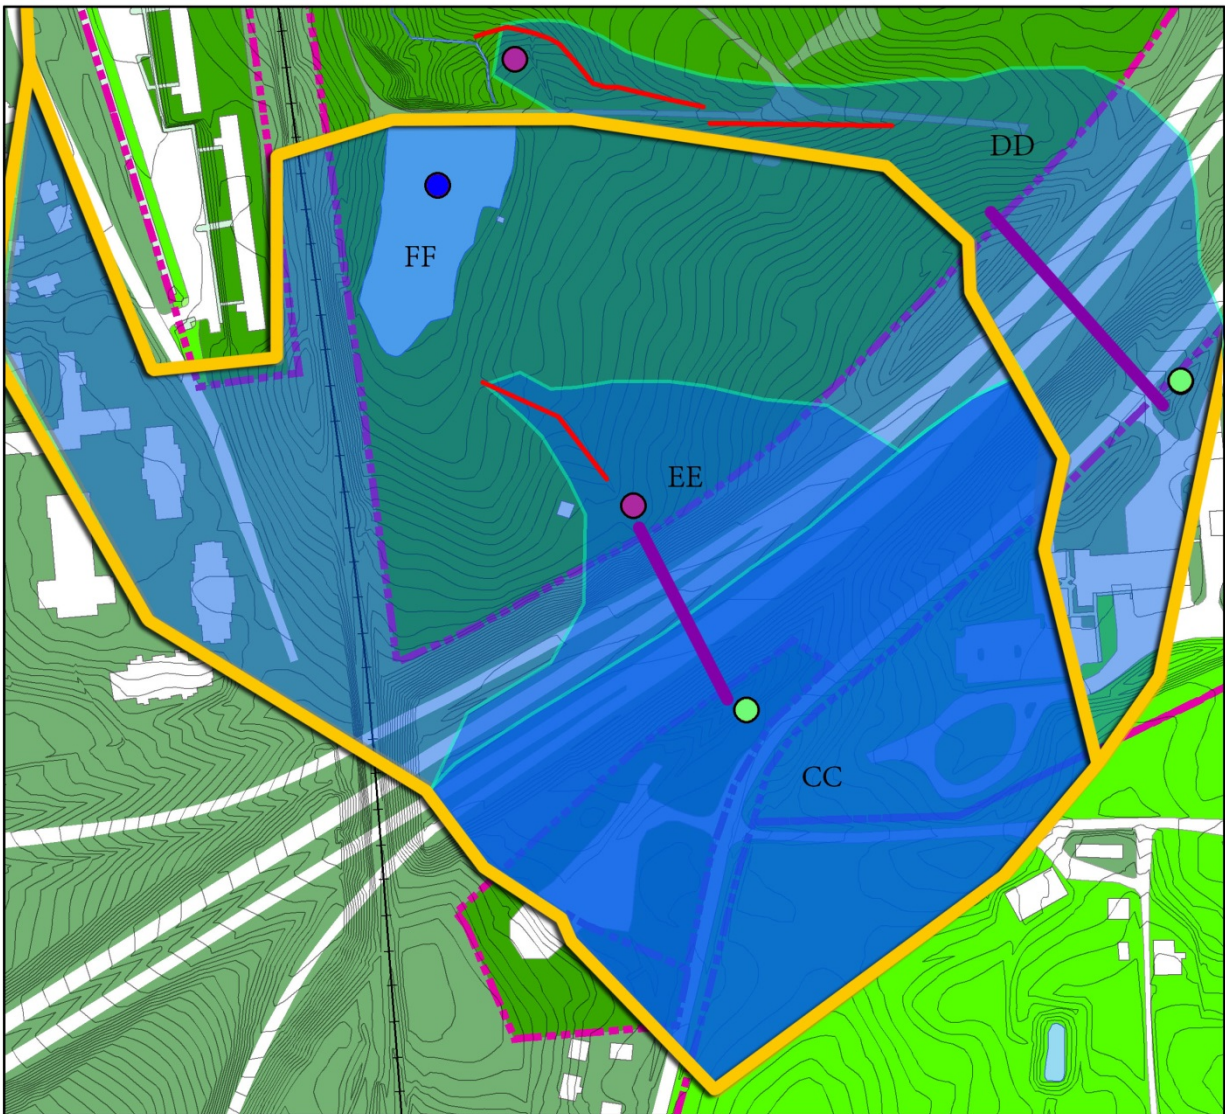
Figure 26: Map of proposed Parvo Pond, Oconee Forest Park, and bus facility SCM locations.

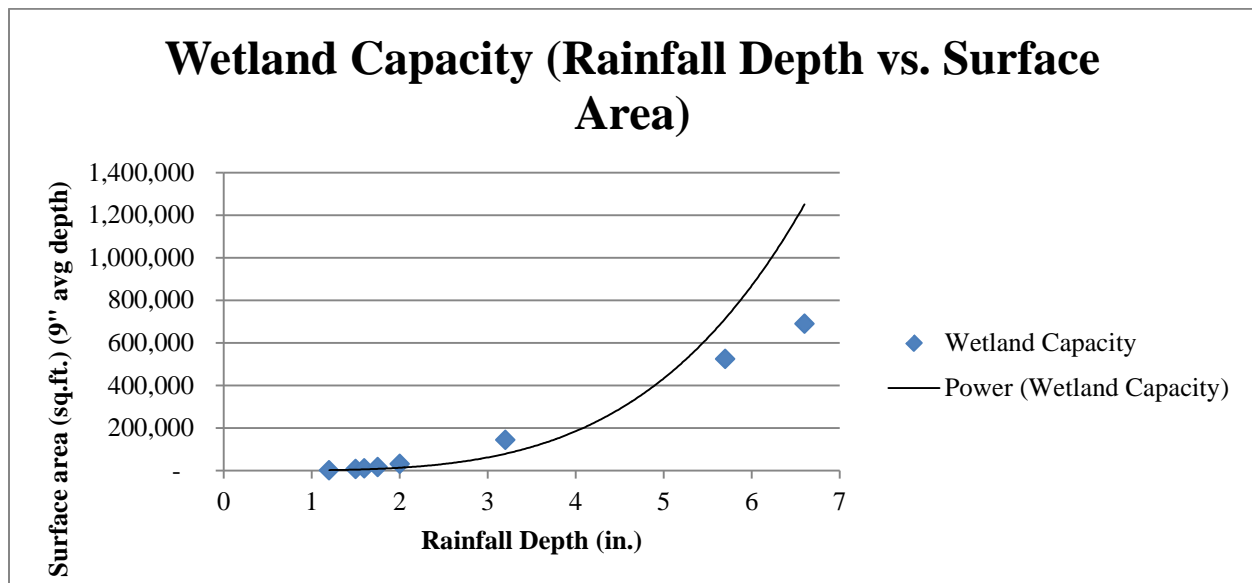
Figure 27: Wetland Capacity Optimization Chart estimates wetland capacity by plotting rainfall depth against surface area. The SCM size is optimized at the point of inflection on the power curve, which is where the curve begins to increase on the Y axis at a greater rate than the X axis.

Table 14 displays calculations regarding the required dimensions for a stormwater wetland to treat various design volumes.

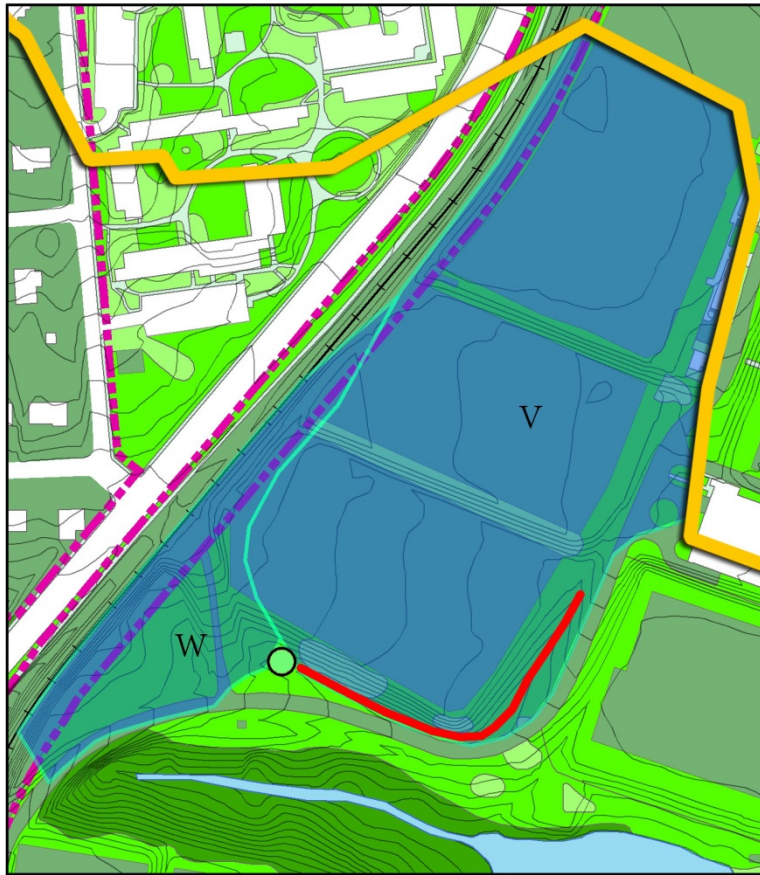
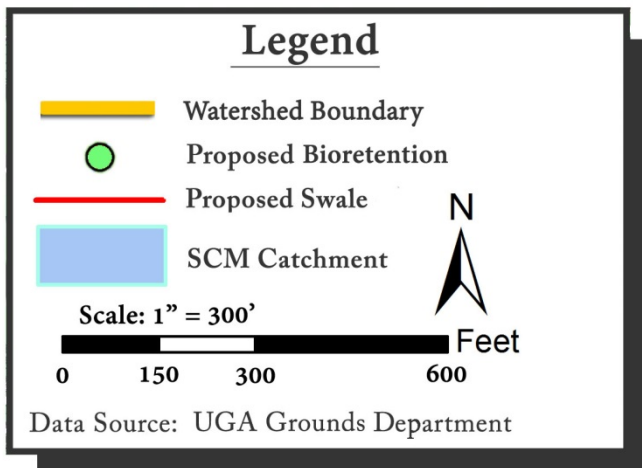
Figure 29: Map of proposed Intramural Field SCM locations.

The 11.69-acre Catchment V, which drains three of the intramural fields, is 35 percent impervious. Its permeable areas have well-drained CYb2, CYc2 (Both Hydrologic group A) and Cba
