SHUTTER TO THINK: ISSUES IN THE TREATMENT OF HISTORIC WINDOW  
SHUTTERS

A Thesis Submitted to the Graduate Faculty of The University of Georgia in Partial Fulfillment  
of the Requirements for the Degree

MASTER OF HISTORIC PRESERVATION

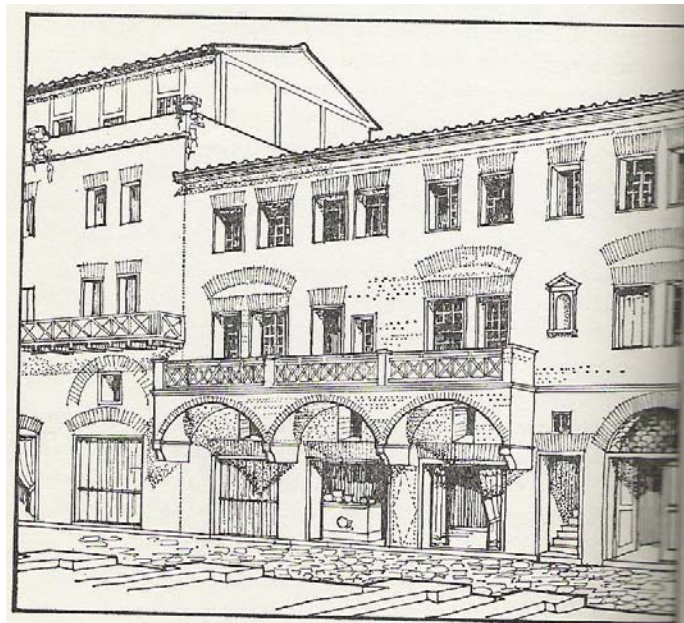
Figure 2.1 Ostia Insula Façade showing wooden vertical shutters on ground level.  
(Source: McKay, 90)

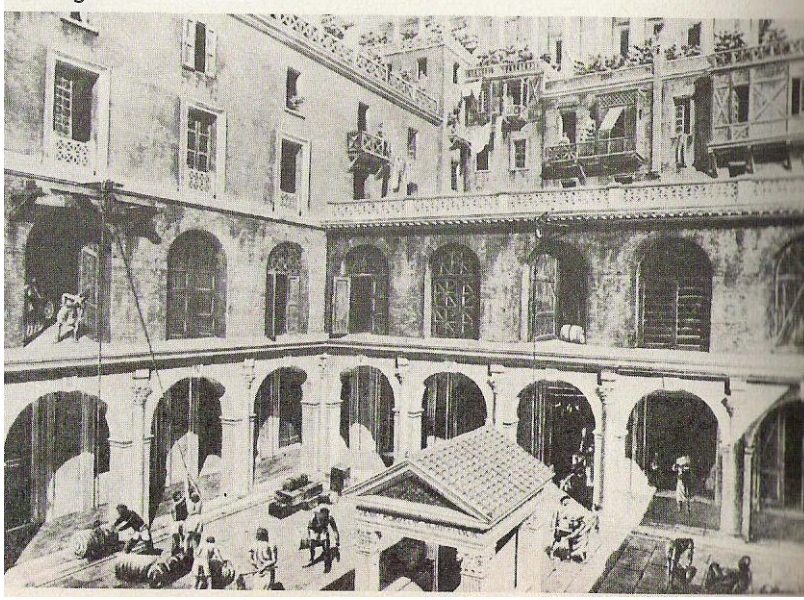
Figure 2.2 Building Insulae in Rome. Wooden shutters are depicted in the upper levels. (Source: McKay, 95)

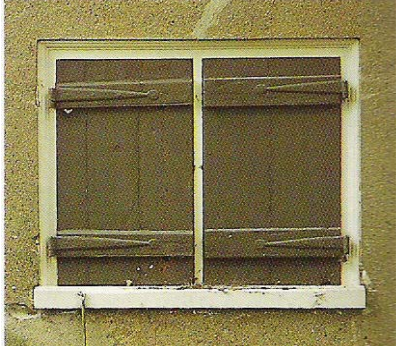
Figure 2.3 Board and batten shutters hung on iron strap hinges.(Source: Calloway, 114)

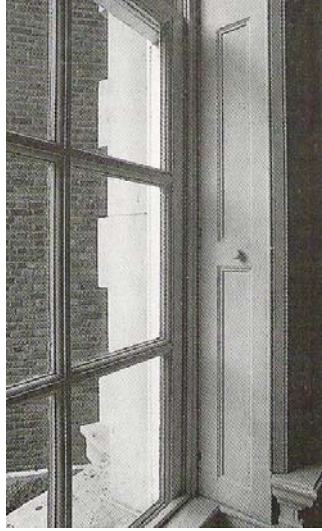
Figure 2.5 An interior shutter is recessed in a window splay. (Source: Fiske, 27.)

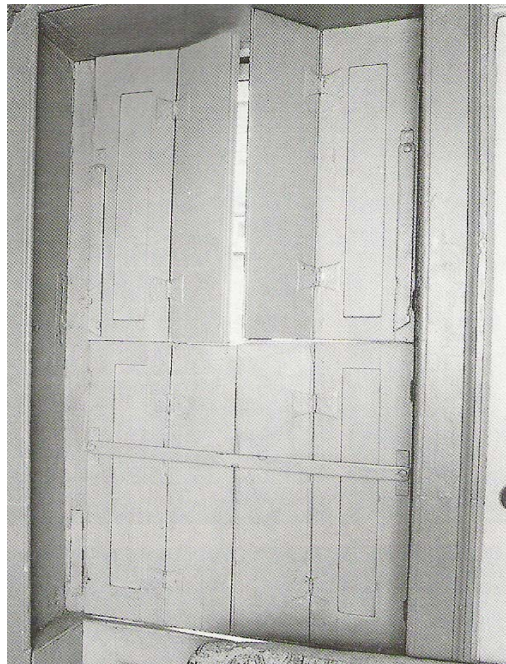
Figure 2.6 Butterfly hinges on interior shutters from the Georgian period. (Source: Calloway, 84.)

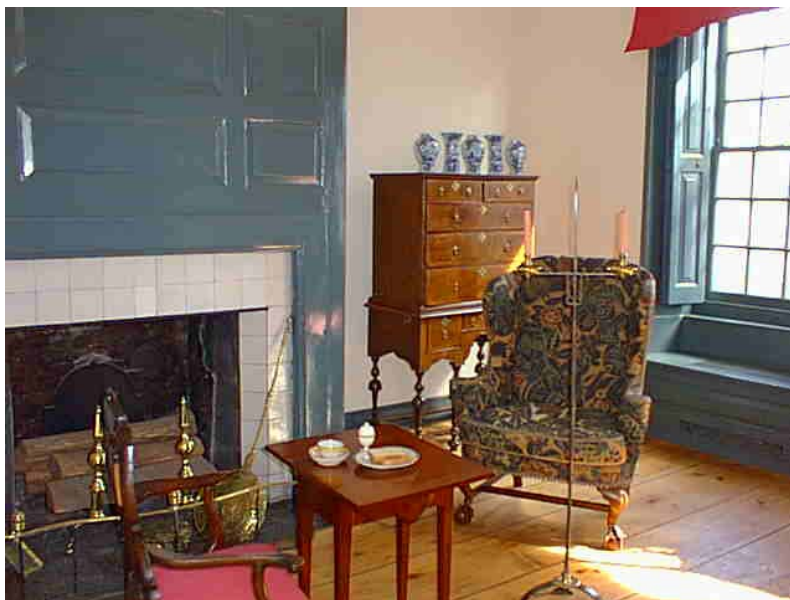
Figure 2.7 Interior shutters in the east bed chamber of the Van Cortlandt House. (Source: <http://www.vancortlandthouse.org/>.)

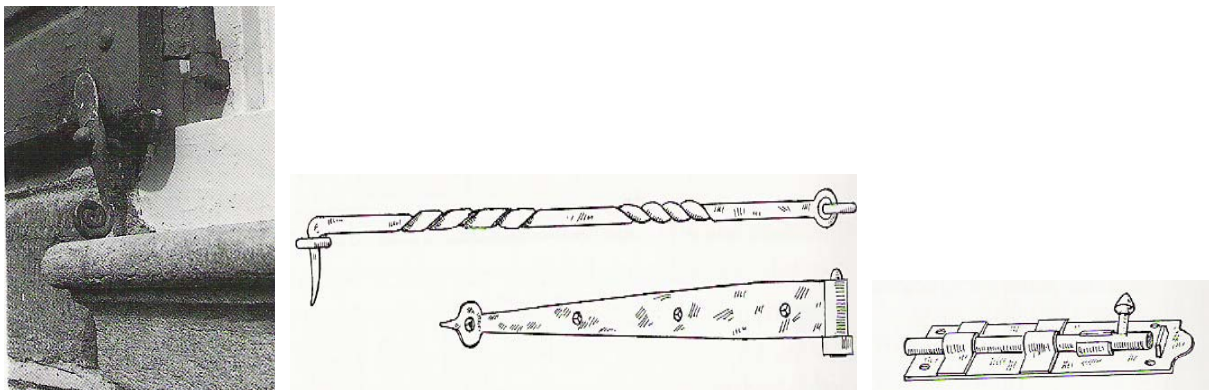
Figure 2.8 (Left to right) A shutter dog from Massachusetts circa 1800, shutter hardware: a shutter hook, and hinge, typical bolt. (Source: Calloway, 514)

Written records from Williamsburg indicate that H, rising joint HL, cross garnets, side, strap, and dovetail (the butterfly form was also referred to as the dovetail) hinges were all used during the eighteenth century. The shapes of these hinges are self-evident from their respective names. It is known that rising joint hinges were sometimes used during this period. These hinges are those in which the bearing surfaces of the knuckles are finished diagonally so that the door or shutter is lifted when it is opened. George Wythe placed an order for “48 pr. HL rising joint for

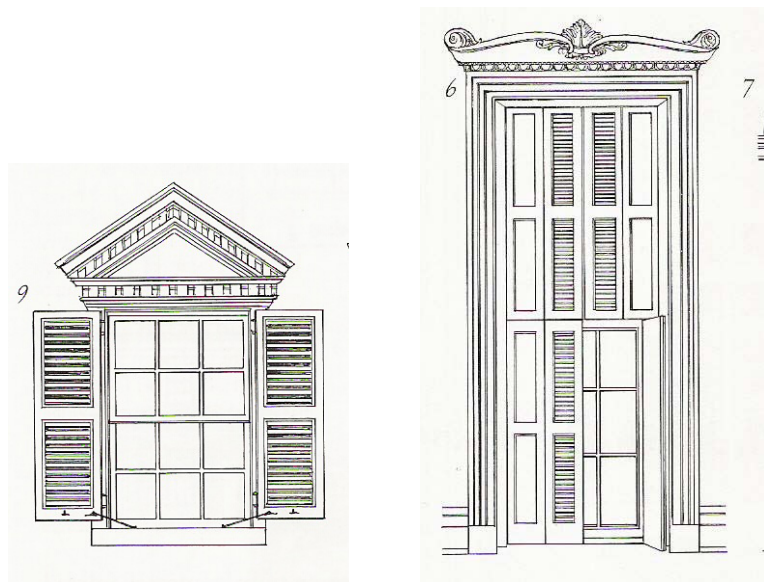
Figure 2.9 (From left to right) A late eighteenth century pedimented dormer window with louvered shutters, interior shutters on a Greek Revival style window, circa 1830. (Source: Calloway, 212).

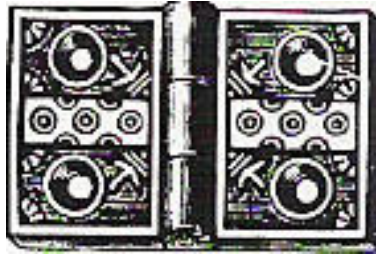
Figure 2.10 Eastlake shutter hinge. (Source: Calloway, 282)

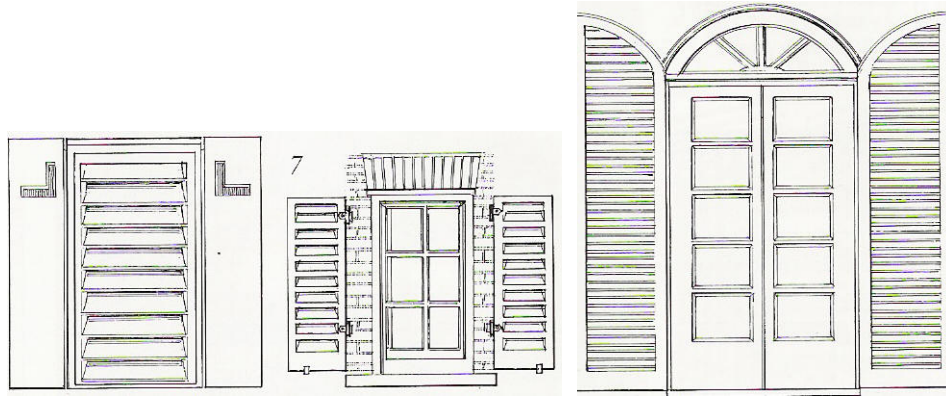
Figure 2.11 Examples of shutters from the 1930's. Calloway suggests that shutters such as these "... give scope to Modernist decorative detailing or are slatted to create bands of shade." (Source: Calloway, 425.)

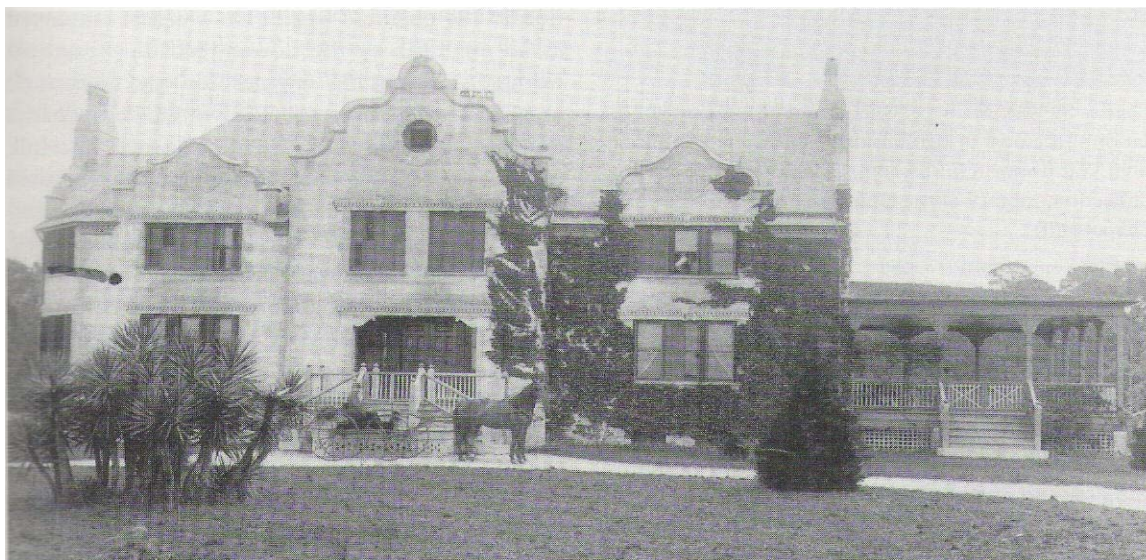
Figure 3.2 An early photograph of Hollybourne Cottage depicting open and closed shutters. (Source: McCash, 89.)

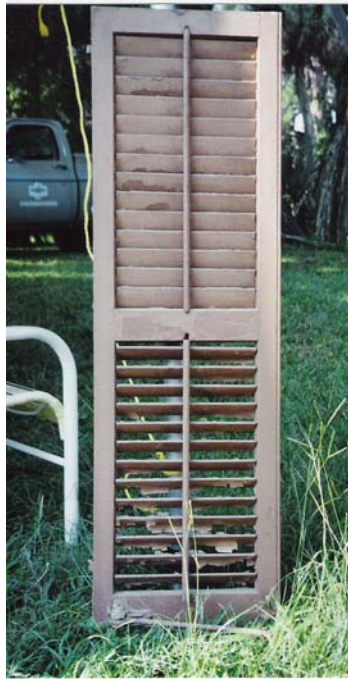
Figure 3.3 A sample shutter taken from the facade of Hollybourne Cottage. (Source: Author.)

There are fifty-seven pairs of window shutters found on the first and second stories of Hollybourne Cottage; twenty-three on the first story and thirty-four on the second story. The shutters are functional, louvered, and are painted brown. The attic and basement windows do not utilize any shutters. The shutters are not standardized in terms of size and appear to be more a function of the size of the relative window opening than of their own aesthetics. In general, the shutters appear to fall into one of four size categories: 15" x 66 5/8", 15 5/8" x 53 5/8", 15 1/2" x 49 3/4" or 12 1/8" x 66 5/8". Shutters were constructed using mortise and tenon joints and metal pins.

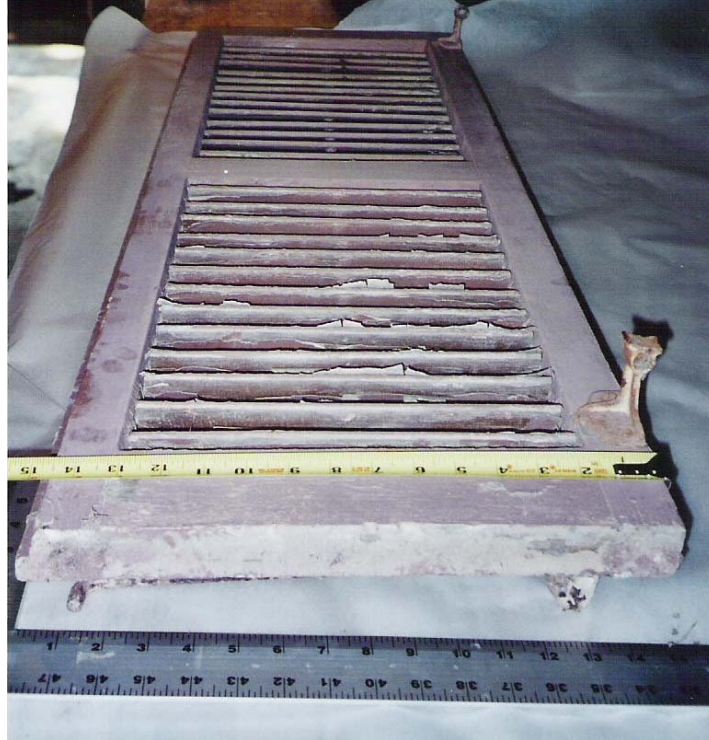
Figure 3.4 This shutter taken from Hollybourne Cottage still has its original hardware. (Source: Author.)

The hardware found on the shutters is largely extant and believed to be original. It consists of metal pintel hinges and metal shutter or blind holdbacks. The design of the pintel hinge varies with its position on the shutter that is the top and bottom pintels are different as are the left and right pintels. Furthermore, hardware found on the first story shutters is different from the hardware found on the second story shutters.

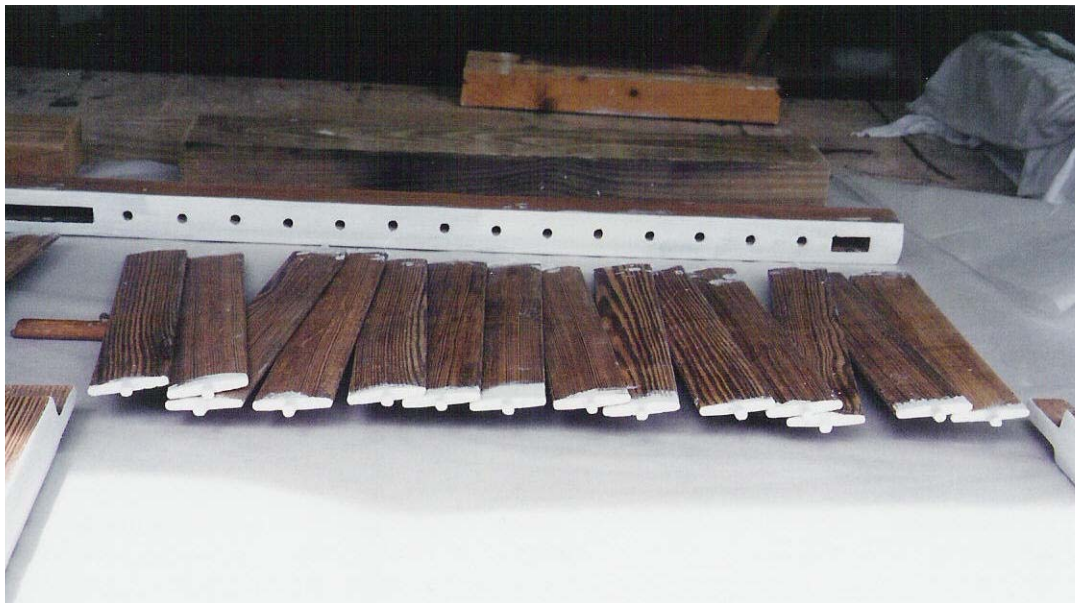
Figure 3.5 A dismantled shutter is ready to be reassembled. The frame employs a mortise and tenon joint while the louvers fit into holes drilled into the frame. (Source: Author.)

All the shutters that were inspected were constructed using mortise and tenon joints which indicates that the shutters are probably pre-twentieth century. There was some physical evidence that indicated the replacement of louvers. Of the extant louvers, two general shapes were found (see figure 3.4). The shape most often found consisted of a flat back side and a concave curve on the outside. Due to the craftsmanship involved in creating this shape as well as the frequency with which it was found, these louvers are believed to be the original. The second

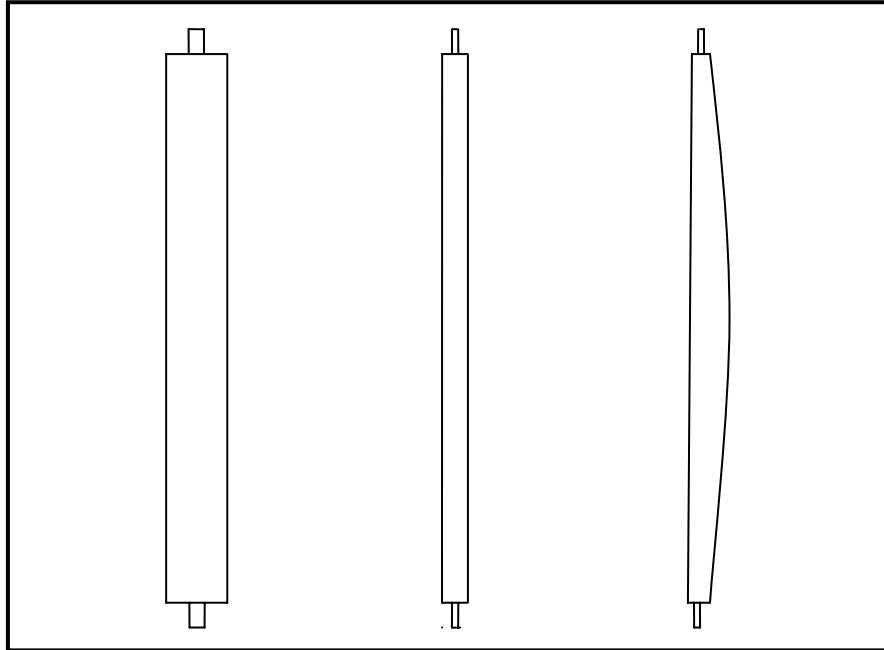
Figure 3.6 From left to right: Plan view of a louver, cross-section of a replacement louver, cross-section of an original louver. Drawings are not to scale. (Source: Author.)

shape encountered on the shutters was very similar except it was flat on all sides. These louvers are believed to be replacements as they are less frequently found and their shape is simpler and therefore easier to reproduce quickly when needed for a replacement. In some cases, the wood also appeared to be different on these louvers, however, there was no analysis conducted on the replacement louvers to verify this.

is a small piece of wood that sticks out roughly ¼". This protuberance fits into a hole in the frame and serves to connect the louver as well as to let it turn. Frequently, this piece of wood gets sheared off rendering the louver useless. Some of the louvers examined showed signs of this breakage and were repaired using a piece of metal shaped to protrude like the wood and attached to the end.

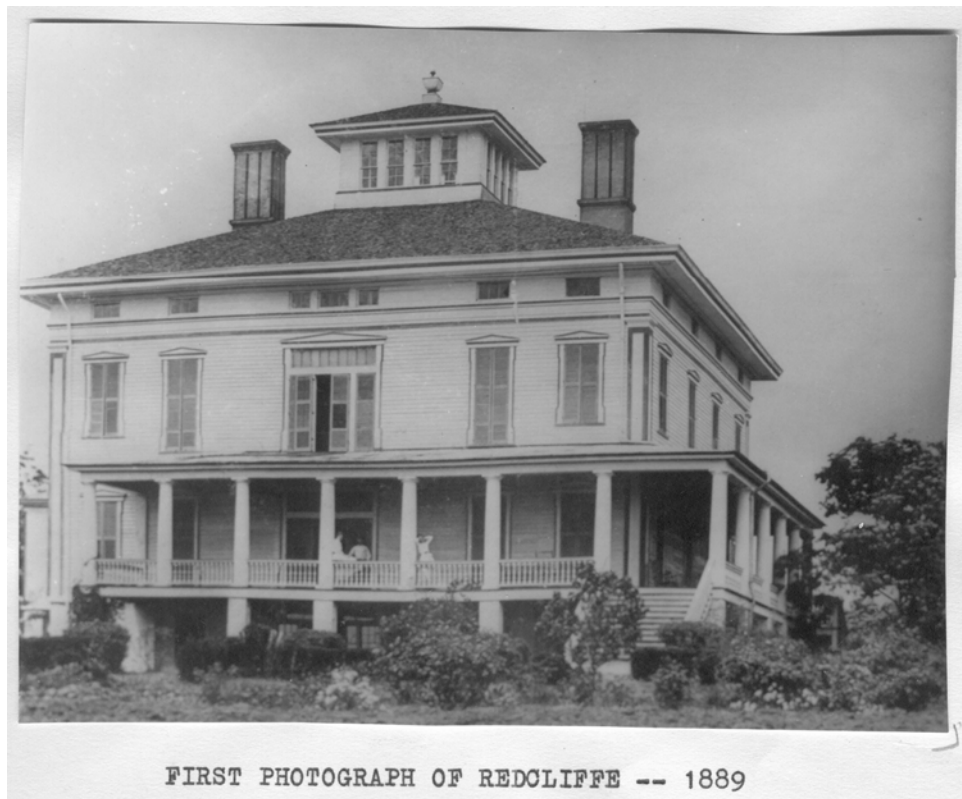
Figure 4.2 The earliest known photograph of Redcliffe Plantation, 1889. (Source: Redcliffe plantation Archives.)

size.<sup>38</sup> Although there were no records found indicating the inclusion of shutters on the front and rear doors at the time of construction, there is photographic evidence that indicates they were in place as early as 1889. (See Figure 4.2)

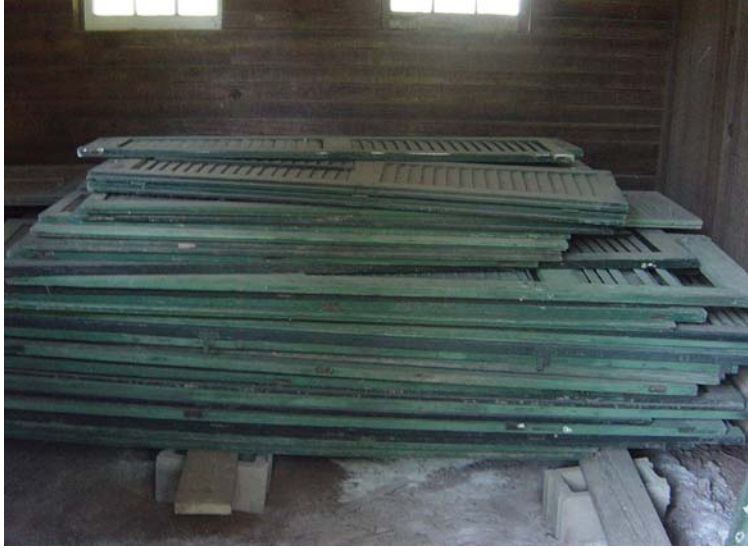
Figure 4.4 These shutters, believed to be the originals, are being stored in the stable. (Source: Author.)

What are believed to be Redcliffe's original shutters are extant and are being stored in an outbuilding, formally the stable, on the property. The shutters have been stacked upon each other and rest rather precariously on concrete blocks traversed with a piece of wood. Loose louvers from the shutters have been collected in metal trash cans set next to the stacks. There does not appear to be any given set of criteria by which the shutters are organized. The current method of storage is not conducive to preserving the remaining shutters.

The shutters found in the stable are of wood construction. A sample taken from one of these shutters was determined by Professor L.R. Schimleck at the Warnell School of Forest Resources at the University of Georgia to be constructed of Bald Cypress (*Taxodium distichum*).<sup>44</sup> The natural growth range of bald cypress extends from Delaware to Florida and west to Texas. The trees typically inhabit the rich soils found in the deepest areas of swamps and along water bodies and in flood plain forests.<sup>45</sup> This type of wood is generally sought after for its decay resistant properties.

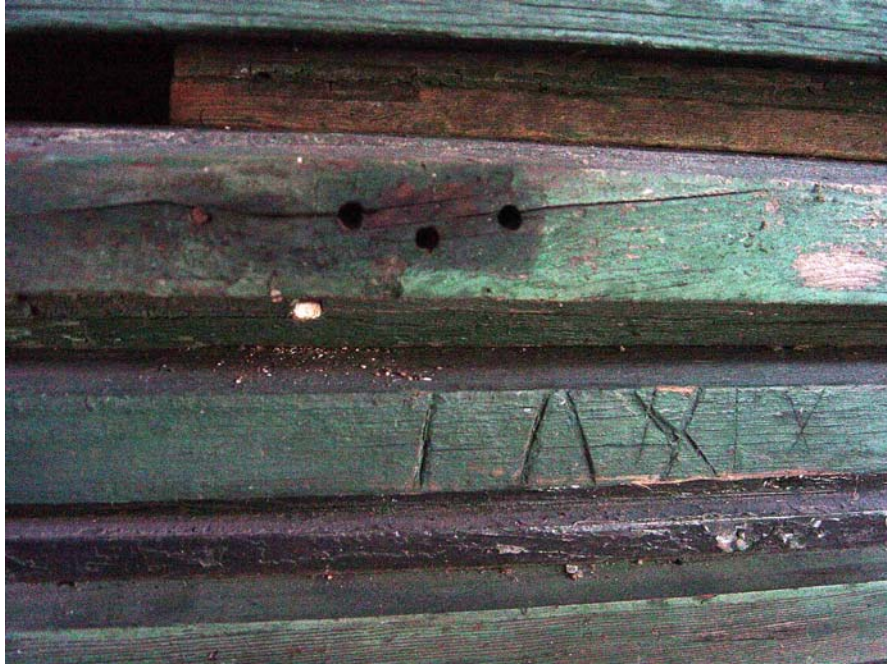
Figure 4.5 Roman numerals etched into the sides of the shutters are indicative of a numbering system. (Source: Author.)

Mortise and tenon joints along with pins were used for the construction of the shutters. Some of the shutters have Roman numerals chiseled into the side presumably to correspond with a particular window. Some of the metal pins are also numbered. This may also be indicative of a numbering system. The shutters appear in various conditions. Many have lost numerous louvers and have broken tenons. Others have actually been cut or broken in half. In some cases where the tenons are extant, they have begun to split. Many of the shutters show signs of previous repair with an unidentified white epoxy-like substance. (See Figure 4.6) The wood, in general, shows signs of rot and ultra-violet light damage.

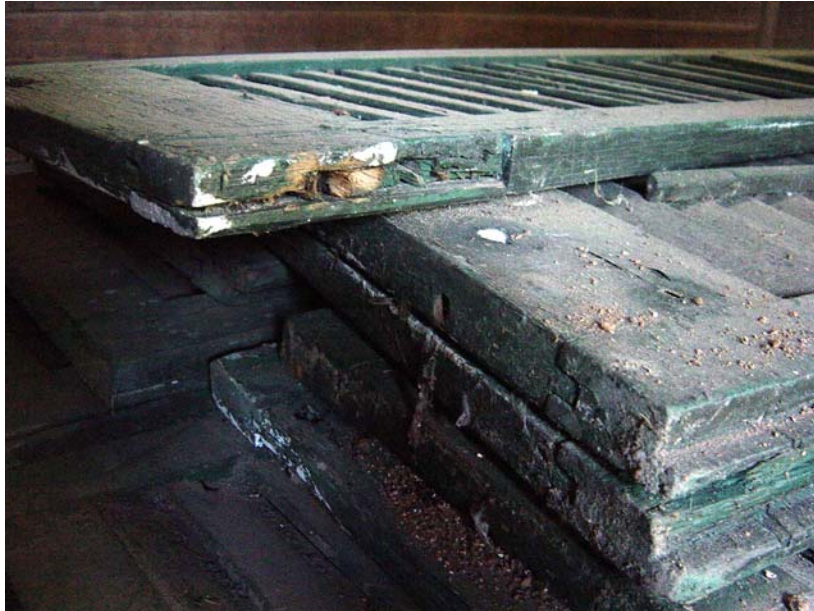
Figure 4.6 Shutters depicting mortise and tenon joints and previous repairs. (Source: Author.)

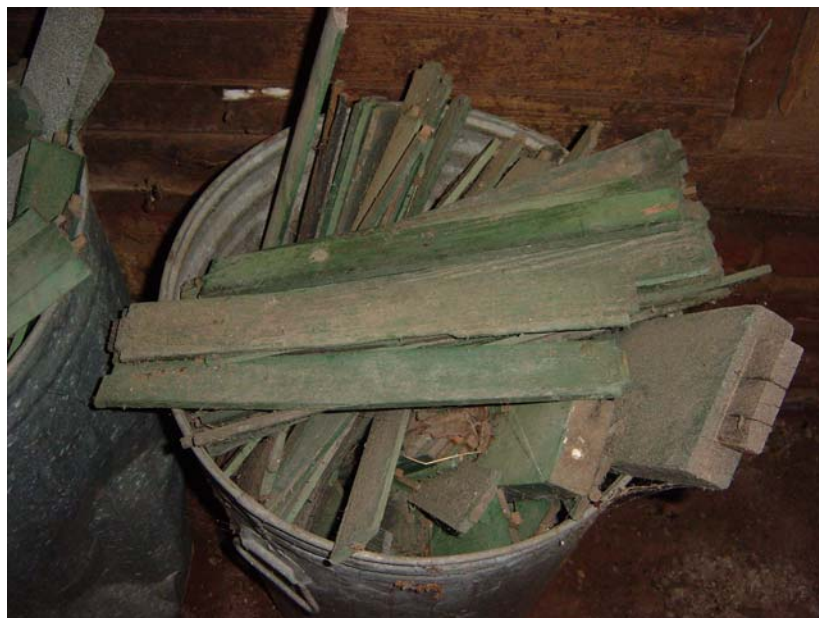
Figure 4.7 Broken and unattached louvers from Redcliffe Plantation. (Source: Author.)

Many of the unattached louvers being stored in the trash cans are in good condition. The louvers were cut from a single piece of wood with a piece protruding from each end, similar to those found on Hollybourne Cottage. This protuberance fits into a hole in the frame and serves to

connect the louver as well as to allow it to rotate. Many of the loose louvers, however, are missing this connective piece.

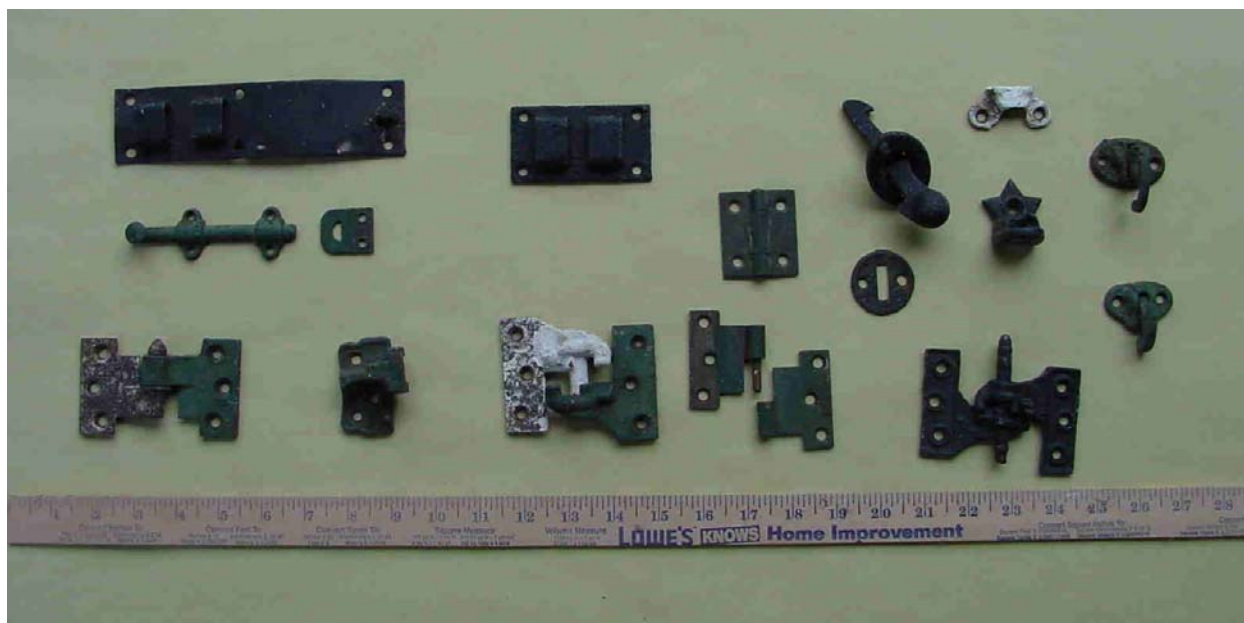
Figure 4.8 Redcliffe Plantation exterior shutter hardware. (Photo: Fielding Freed, Redcliffe State Park Manager.)

believes that most of the hardware had been taken off the pre-Park Service shutters with the intent of being refinished although that project never came to fruition. Mr. Freed also stated that he believed the pair of small, stamped metal hinges located in the center of Figure 4.1 dates from the early to mid-twentieth century.<sup>46</sup> Beyond the knowledge of what has been bought since the state's stewardship, there is no extant documentation regarding previous hardware.

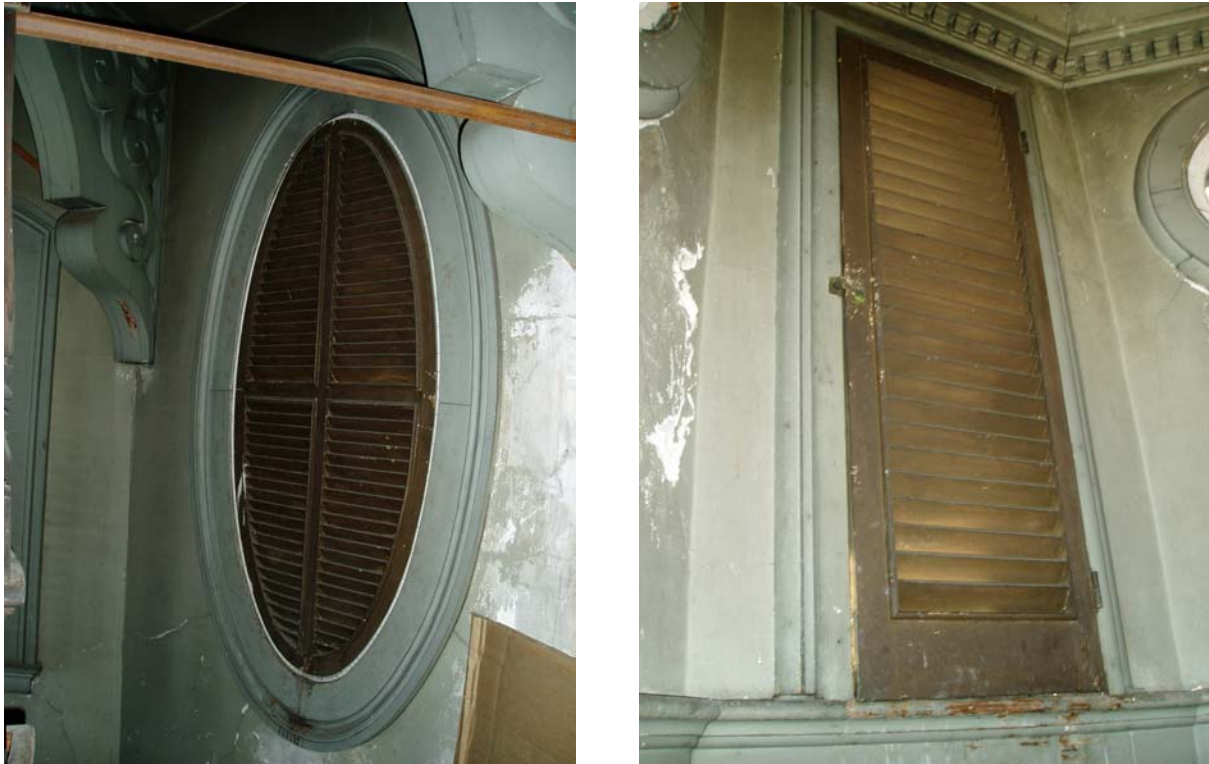
Figure 5.2 The Hay House employs two different shutter shapes in the cupola. (Source: Allison Moon.)

the shutters are hinged to the window sash and open inward. There was no evidence of paint found on these shutters.

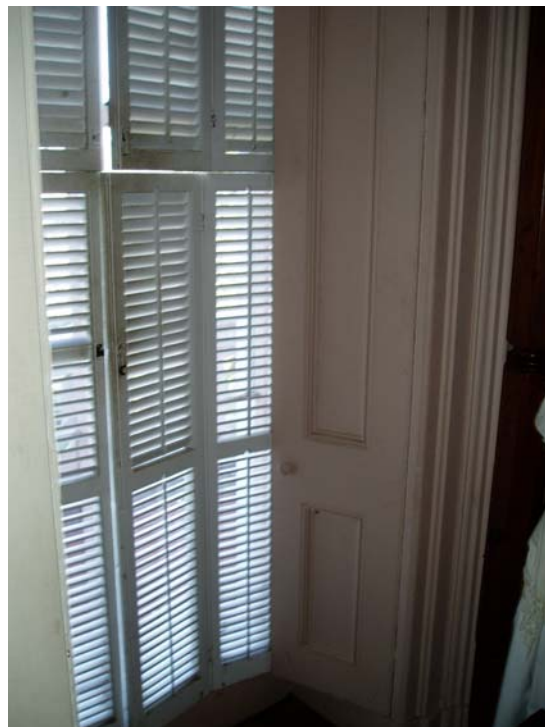
Figure 5.3 Interior folding shutters located on the second story. (Source: Allison Moon.)

The first and second story shutters are folding shutters which are interior shutters that have a second leaf. When these shutters are open they block the entire width of the window sash; when closed, they fold neatly into a shutter box located in the window reveal. This type of shutter was typical of the mid-nineteenth century. These shutters are also constructed with wood using mortise and tenon joints although metal pins are used as opposed to the wood pegs found on the cupola shutters. The shutter hardware found on the primary levels of the house includes metal butt hinges, butterfly hinges, and shutter bars with hooks.

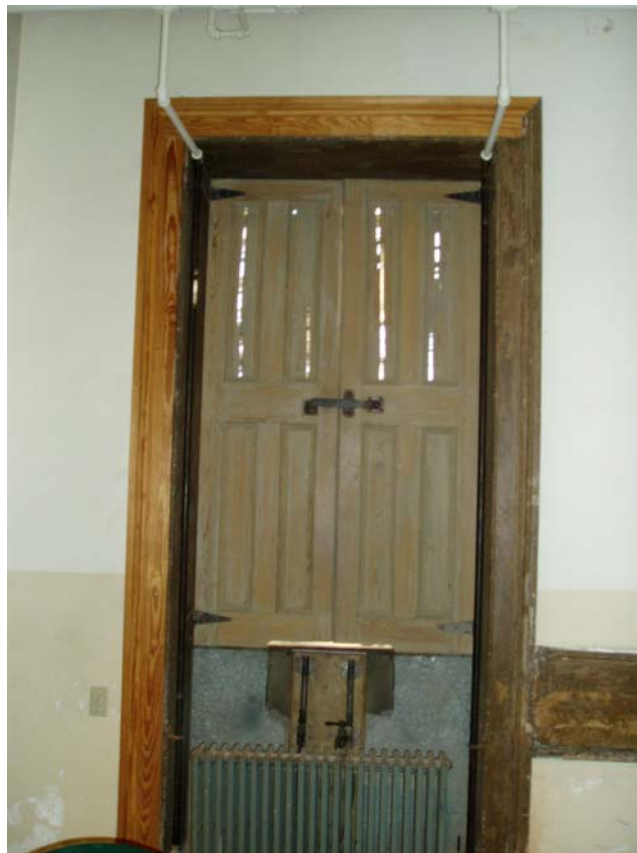
Figure 5.4 Paneled shutters located in the basement kitchen. (Source: Allison Moon.)

The basement story of the Hay House also employs window shutters. Shutters found on this level are paneled shutters with large strap hinges. According to the *Johnston-Felton-Hay House Historic Structure Report and Master Plan: Part Two: Master Plan*, the shutters are constructed of mahogany and some were identified as in need of repair. Although, the shutters on this level appear to be in good condition, there was no evidence found to confirm that repairs occurred. In general, shutters fell into three size categories: 87 ½” x 21 ½”, 119” x 22 ½”, and 81” x 24”. Measurements were taken from shutters in the restored kitchen and represent one panel of a two panel shutter.

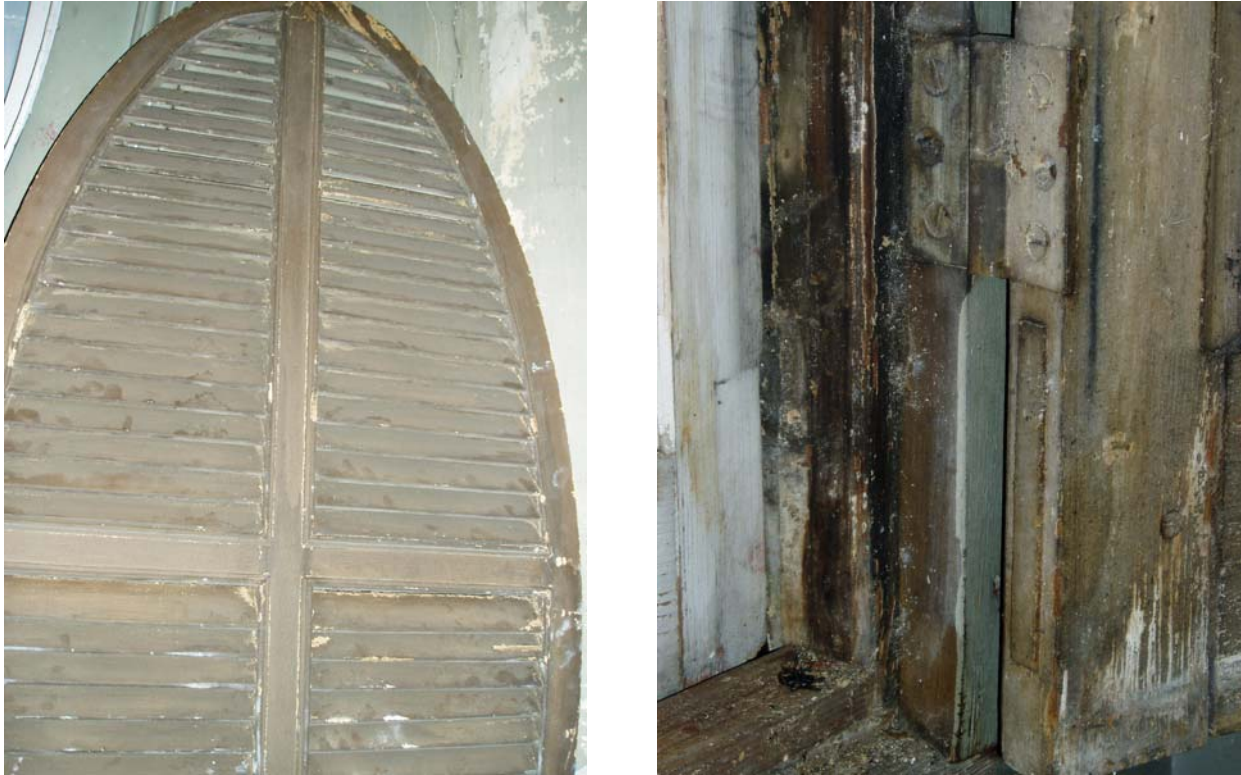
Figure 5.5 Water damage, rot, and paint failure are the most dominant conservation issues found on the cupola shutters. (Source: Allison Moon.)

The primary levels of the house are those that were used most often by the families that resided there. The shutters located on these levels reflect this usage. While there appears to be little water and ultra-violet damage, many of the louvers are broken or missing. Paint failure is also a problem on some shutters.

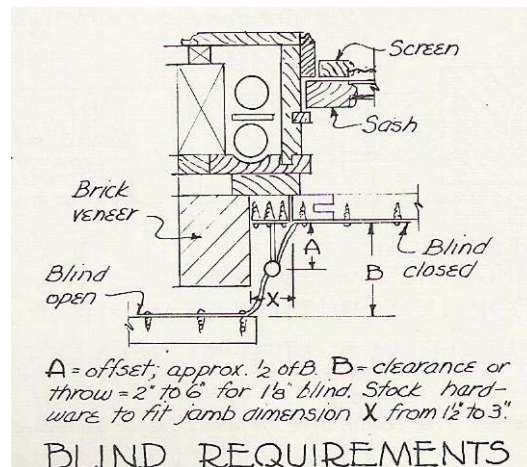
Figure 7.1 Window shutter installation requirements. (Source: Architectural Graphic Standards.)

Finally, after window shutters have undergone preservation treatment, they face a final challenge. Window shutters need to be installed correctly in order to function properly. Figure 7.1 illustrates the proper installation of shutters:

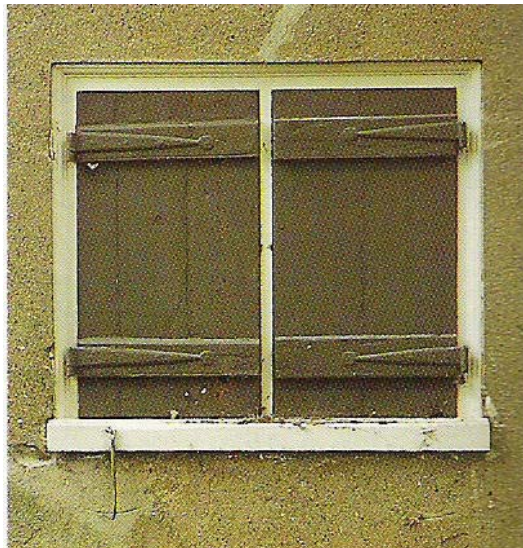
(Source: Habel, 48)

**Board and Batten Shutter:** A shutter made from vertical boards joined together with two or more horizontal boards nailed on to the back side.

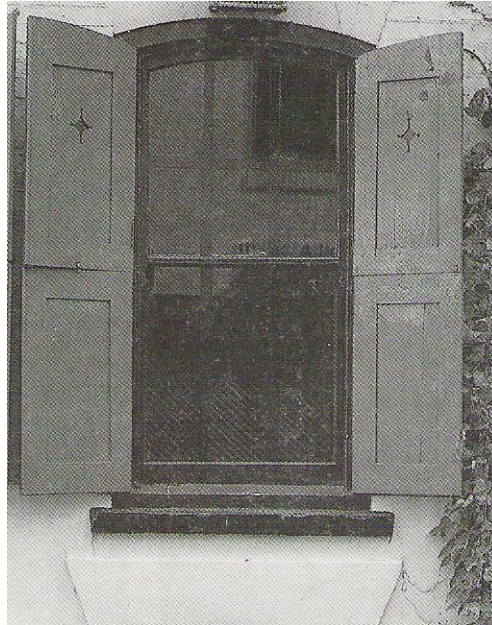
(Source: Calloway, p.84.)

**Dutch Shutter:** Shutters built in two sections (top and bottom) which operate independently.

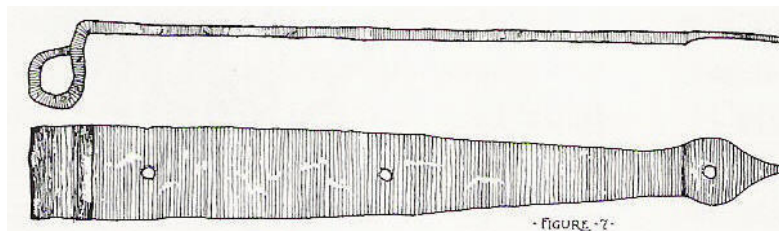
**Hinge:** Attaches shutter to structure, or pairs of shutters to each other. Tremendous variety of styles and designs allow the shutter to pivot fully out of the window opening and lay flat against the wall. And also facilitate removal. Styles range from narrow shutter butts, to wider swinging H hinges. Advanced shutter hinge designs include self-locking and gravity-locking features to hold the shutter in position.

Top to bottom: Hook Lock and Strap Hinge (Source: Linley, 13)

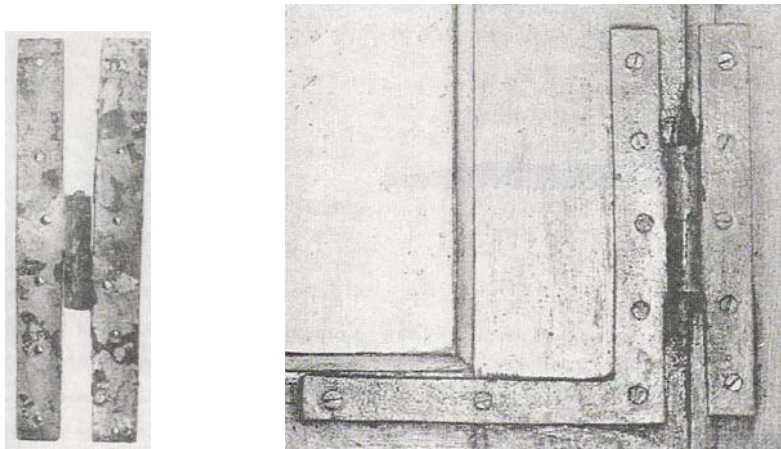
From left to right: "H" hinge and "H-L" hinge (Source: Worgan, 68)<sup>77</sup>

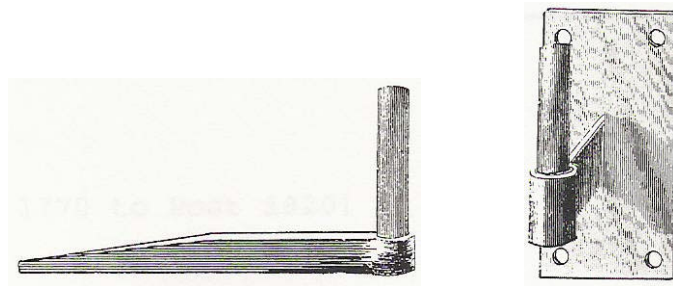
(Source: Habel, 49.)

**Pintel Hinge:** The fixed pin on which a removable shutter leaf hangs; its mate is a pintel sleeve.

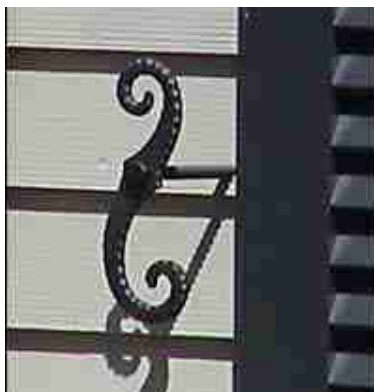
(Source: <http://www.bobvila.com/ArticleLibrary/Location/Exterior/Shutters.html> .)

**Shutter Dog, Turn, or Turn Buckle:** An S or dart-shaped fastener mounted to a wall or window sill to hold a shutter open, usually attached with a lag screw or drive nail.
