PRIVATE MANAGEMENT OF CULTURAL LANDSCAPES: CHALLENGES AT LAKE WINFIELD SCOTT RECREATION AREA

A Thesis Submitted to the Graduate Faculty of The University of Georgia in Partial Fulfillment

MASTER OF HISTORIC PRESERVATION

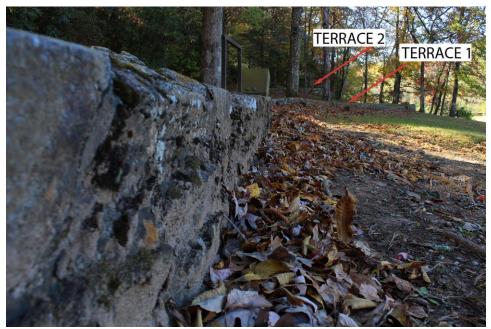
Figure 1.2. *Ground-level view looking south at the base of terrace one within the swimming area beach. The third terrace is located to the left, above terrace 2 and is not visually present in this photograph.* (Photo source, M. Scales English.)

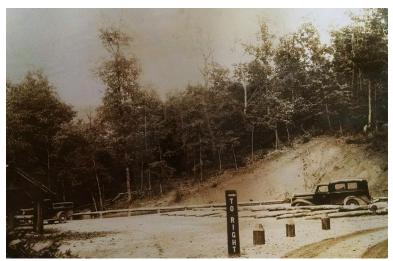
Figure 3.4. Original main parking lot located on the eastern ridge above the bathhouse. (Photo source, Blue Ridge Ranger District, Blairsville, GA.)

Camping and picnicking pads (sixteen in total), which were scattered along the terraced ridge with views and relatively easy access to the lake, consist of stone foundations with poured concrete surfaces. Each picnic pad consisted of lacked without picnic tables and were similarly placed on the terraced ridge on poured concrete platforms with stone surrounds. Specifications for the construction of these resources are outlined in the *Camp Ground Improvement Manual*.¹¹³ In addition to these resources, water fountains and trash incinerators were constructed at various locations. Basic plumbing allowed day-use visitors to access natural water systems constructed during this time and facilitated extended stays at Lake Winfield Scott. Two parking lots were constructed by grading the eastern ridge above the lake, and working with the natural slope on the western bank (Fig. 3.4).

Combined vehicle capacity was calculated at 90 in 1938. Reports of use at the site suggest that additional parking areas were necessary to accommodate a higher volume of visitors on weekends and holidays.¹¹⁴ The single fee-booth structure located at the main parking lot

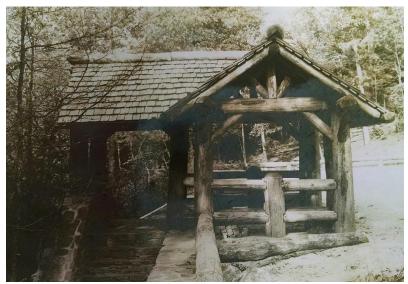
Figure 3.5. Original fee-booth structure located on the western side of the main parking lot and at the top of the stairs leading to the bathhouse. Wood shingles and rounded timbers were harvested on-site. (Photo source, Blue Ridge Ranger District Office, Blairsville, Georgia.)

consisted of large unfinished timbers and open-air rafters, and led visitors to descend the steep slope before arriving at the bathhouse (Fig. 3.5).

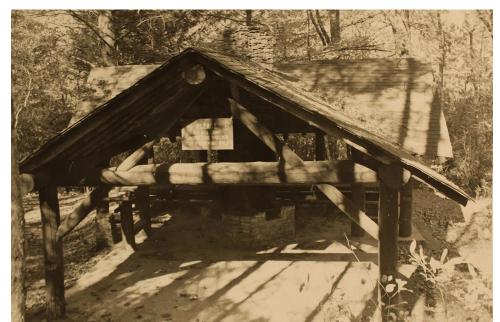
Figure 3.7. East elevation of day-use Shelter 1 (circa 1935); notice the round timbers compared to the squared timbers of Shelter 3 in Figure 3.9. (Photo source, Blue Ridge Ranger District, Blairsville, Georgia.)

Day-use shelters constructed at the site varied in size and materials. North of the bathhouse, two shelters were located on flattened portions of the ridge (see Figure 3.1). The first, Shelter 1, was located near the northeastern corner of the lake, above the gravel road that allowed access to a few camping and picnic pads. Round-cut timbers were used to create the support columns and exposed rafters. The east elevation had stylized vertical boards that came to triangular points at their lower ends (Fig. 3.7). A four-sided, centrally-located, rough-cut stone fireplace allowed simultaneous use by visitors. Benches and picnic tables were built into the exterior support columns which allowed for open and free movement beneath the gabled roof.

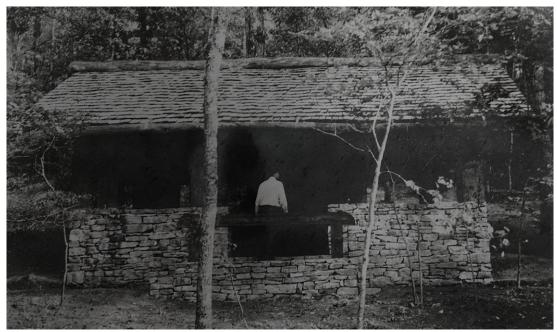
Figure 3.9. *Shelter 3 west elevation*. (Photo source, Blue Ridge Ranger District Office, Blairsville, Georgia.)

Shelter 3 is unique in both materials and placement. It was situated on a leveled portion of the eastern ridge above the lake south of the bathhouse. Squared timber columns supported the single-gable roof, and hewn logs created rusticated rafters. The foundation and surrounding three-feet-high walls were constructed of rough-cut stacked stone. Measuring approximately 15 feet by 10 feet, this was also the smallest shelter (Fig. 3.9). A single fireplace was constructed on the eastern wall using the same rough-cut stacked stone. Each shelter's roof was comprised of wood shingles with a timber cap that ran the length of the ridgeline.¹¹⁶

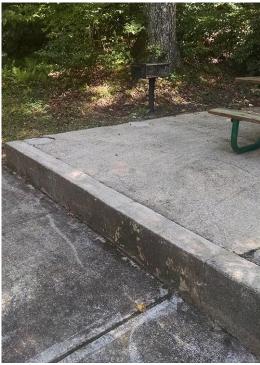
Figure 3.11. Remnant of the Shelter 2 concrete platform remains. Notice the timber post mold's shape (upper right-hand corner) is circular at this shelter (2016). (Photo source, M. Scales English.)

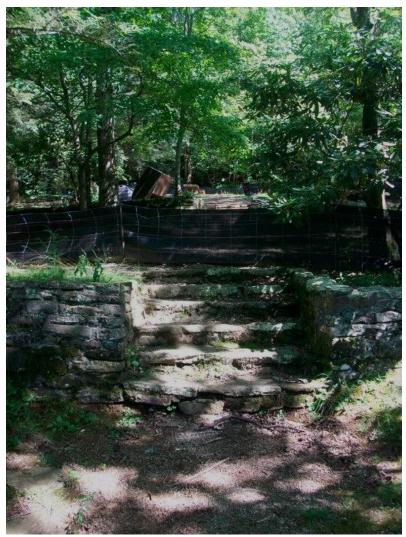
Figure 4.3. Stairs leading from the second terrace to the picnic area and further toward the third and final terraced section beyond the erosion screen, 2009. (Photo source, Darby Phillips Miller.)

walls used to create the terracing. Half-inch thick mortar secures the stones (Fig. 4.3). Additional stairways lead to the old paddleboat dock just south of the swimming area, and stairs lead into the swimming area as well. Additional stairs and navigation pathways are located at Shelter 1, where handicap accessibility has been extended.

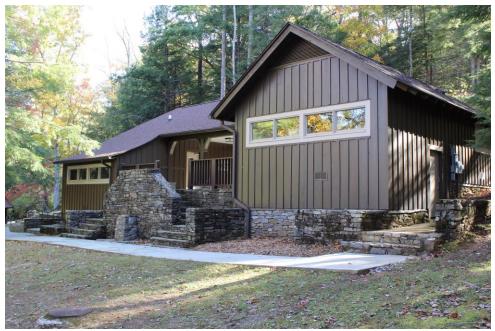
Figure 4.4. CCC-era bathhouse, existing conditions (2016); retention of the board-and-batten siding and stone foundation adds to the integrity of this resource. Despite changes to the breezeway and entrances, this building has been rehabilitated to maintain similar appearance of the original configuration. (Photo source, M. Scales English.)

The bathhouse, located just above the lake, has undergone extensive conservation and rehabilitation. Although the building's footprint has not changed, the function of the interior space has been altered at least twice, and it has been retrofitted with modern plumbing.¹³⁶ The foundation consists of rough-cut stone with half-inch grey mortar. Brown painted board-and-batten exterior walls enclose two sections of bath and shower facilities. The men's restroom is located on the north end, and the women's restroom is located to the south. They are separated by a breeze-way with rough-cut stone flooring and large square-cut timber columns (Fig. 4.4).

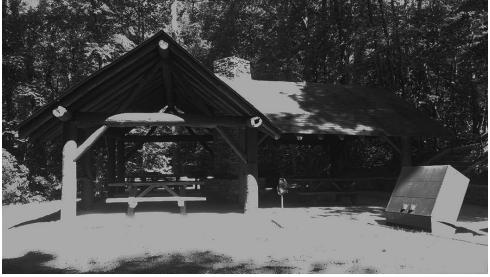
Figure 4.5. Shelter 1, south elevation (2016). (Photo by M. Scales English.)

Conservation efforts at Shelter 1 were also completed during the 2009 rehabilitation. This timber -ramed, shingle-roofed structure is painted dark brown, in compliance with USFS policies, and sits on a poured concrete pad. The central chimney has been closed, but two standing charcoal grills were added in 2009. The original, locally-sourced stone chimney extends from the ground to roughly three feet above the roof gable (see fig. 4.5 – shelter 1). Rounded timbers, painted brown, were utilized extensively throughout Lake Winfield Scott during the CCC/USFS period of development.¹³⁷

Further, the methods of construction regarding the chimney and structural components, were explicitly detailed in construction and design manuals produced by the National Park Service for use during the New Deal.¹³⁸

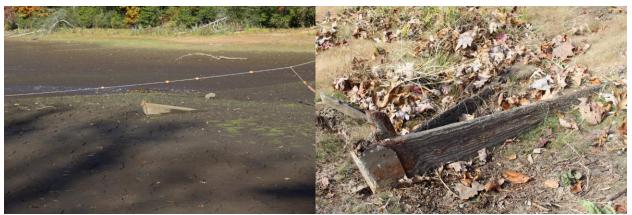
Figure 4.8. Left, first boat located within the northwest corner of the swimming area. Right, second boat discovered in the lakebed north of the swimming area. (Photos by M. Scales English.)

A canoe-style wooden boat is partially buried beneath lake sediment in the northwest corner of the swimming area. Approximately one-third of the boat's bow is visible above the sediment of the lakebed. Just north of this boat, embedded in the northern lakebed, the bow of a second boat was discovered. These wooden boats are known to have been used during the early 1940s through the early to mid-1950s, prior to the introduction of paddleboats by JAS (Figs.4.7 and 4.8). In addition to these boats, the dock that was once used to access them was located in a small cove near the mouth of East Seabolt Creek (Fig. 4.9). Investigations conducted in 2016 with Becky Bruce-Vaughters revealed the potential support columns from this dock. Two sets of square-framed forms, which may have surrounded the dock's columns, are located roughly 15 feet from the lake's bank on a large sediment deposit (Fig. 10). Based on information from one of the retired rangers experiences at the site, this dock was removed and the small cove was filled with dirt during the mid to late 1960s.¹⁴⁰ Located fifty-feet north of this former dock location, the remnants of a round and partially hand-hewn beam, likely associated with a footbridge, crosses East Seabolt Creek.

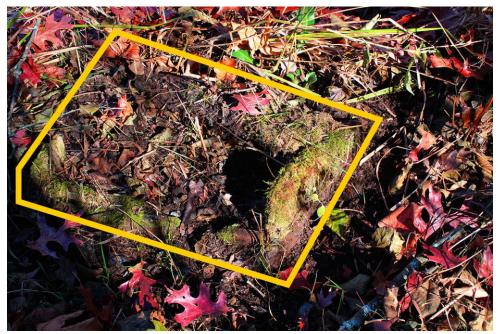
Figure 4.10. *Potential wooden dock pier support (located within the yellow box).* (Photo by M. Scales English.)

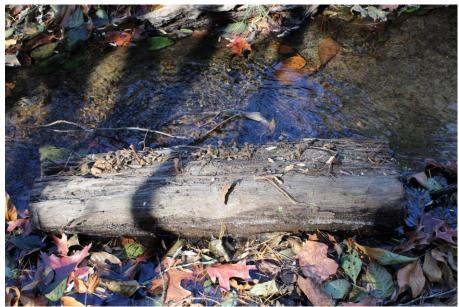
Figure 4.11. *Foot bridge timber, hand hewn with wire-cut nails where planks were attached.* (Photo by M. Scales English.)

Wire nails were used to secure planks across the log to create a walkable bridge for traversing this area of the lake (Fig. 4.11). No prior documentation of this bridge exists. When the lake is at normal water level, this bridge, dock remnants, and boats are undetectable.

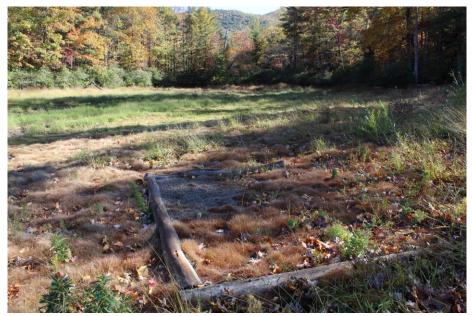
Figure 4.12. *Existing wading pool timbers, north of the swimming area.* (Photo by M. Scales English.)

timbered aligned by notched framing. These are located within and just north of the current swimming area's boundary posts (Fig. 4.12). Figure 4.12, shows the placement of these timbers in the context of the surrounding landscape. Although it was not located, a small dock and slide once existed in this location as well. Without conclusive evidence, the exact location of this features remains unknown.

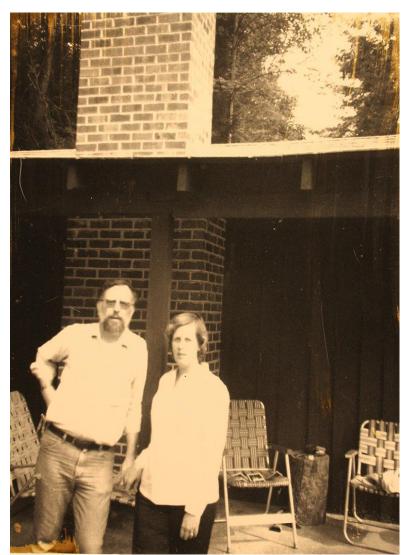
Figure 4.14. *Hosts standing in front of one of four cabins kept from the JAS period (circa 1987).* (Photo source, Blue Ridge Ranger District Office, Blairsville, Georgia.)

Regarding JAS archaeological resources, there are two areas of interest: (1) remains of the constructed and planned expansion of rental cabins on the site, and (2) submerged structural components associated with amenities at Lake Winfield Scott. As mentioned in Chapter 3, numerous stone, concrete, and brick foundations are located where the 26 rental cabins once stood. As part of the plan to expand the number of rental cabins, JAS graded roads to access these proposed areas. Many of these roads are no longer accessible and are overgrown with vegetation, but they are visible during winter months. Further, one of the original cabins remained on the landscape until the mid 1980s, when it was destroyed by fire (Fig. 4.14). The

foundation and location of this cabin is clearly visible near the southwestern corner of the lake at the large gravel parking lot.

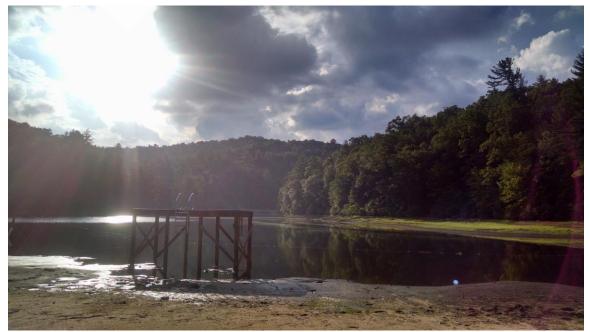
Figure 5.1. *This image illustrates the dramatic drop in water depth due to the fault drain pipe at Lake Winfield Scott. The height of this platform dock is roughly ten feet.* (Photo source, M. Scales English, August 2016.)

Physical changes to the natural environment are not of concern to the integrity of Lake Winfield Scott and its cultural resources. Increased sedimentation, however, has decreased the lake's depth at the mouth of each drainage. Thus, boats and water-based activities are significantly limited in these areas. When the lake's water level was severely diminished due to the faulty drain pipe, these areas were especially vibrant due to their enriched sediments and the grasses that sprouted from them (Fig. 5.1). Water levels have returned to normal following the construction of a new pipe. At the earliest point in this site's history, the first- and second-growth forests were a vital component to the natural environment. Currently, and greatly due to the protections of the USFS, second and tertiary forests continue to thrive within and surrounding the recreation area.
