AN ANALYSIS OF WOOD WINDOW RESTORATION AT THE
PRESIDENT LINCOLN AND SOLDIERS' HOME NATIONAL MONUMENT
WASHINGTON D.C.

PAIGE MICHELLE WOJCIK

A Thesis Submitted to the Graduate Faculty of The University of Georgia in Partial Fulfillment
of the Requirements for the Degree

MASTER OF HISTORIC PRESERVATION

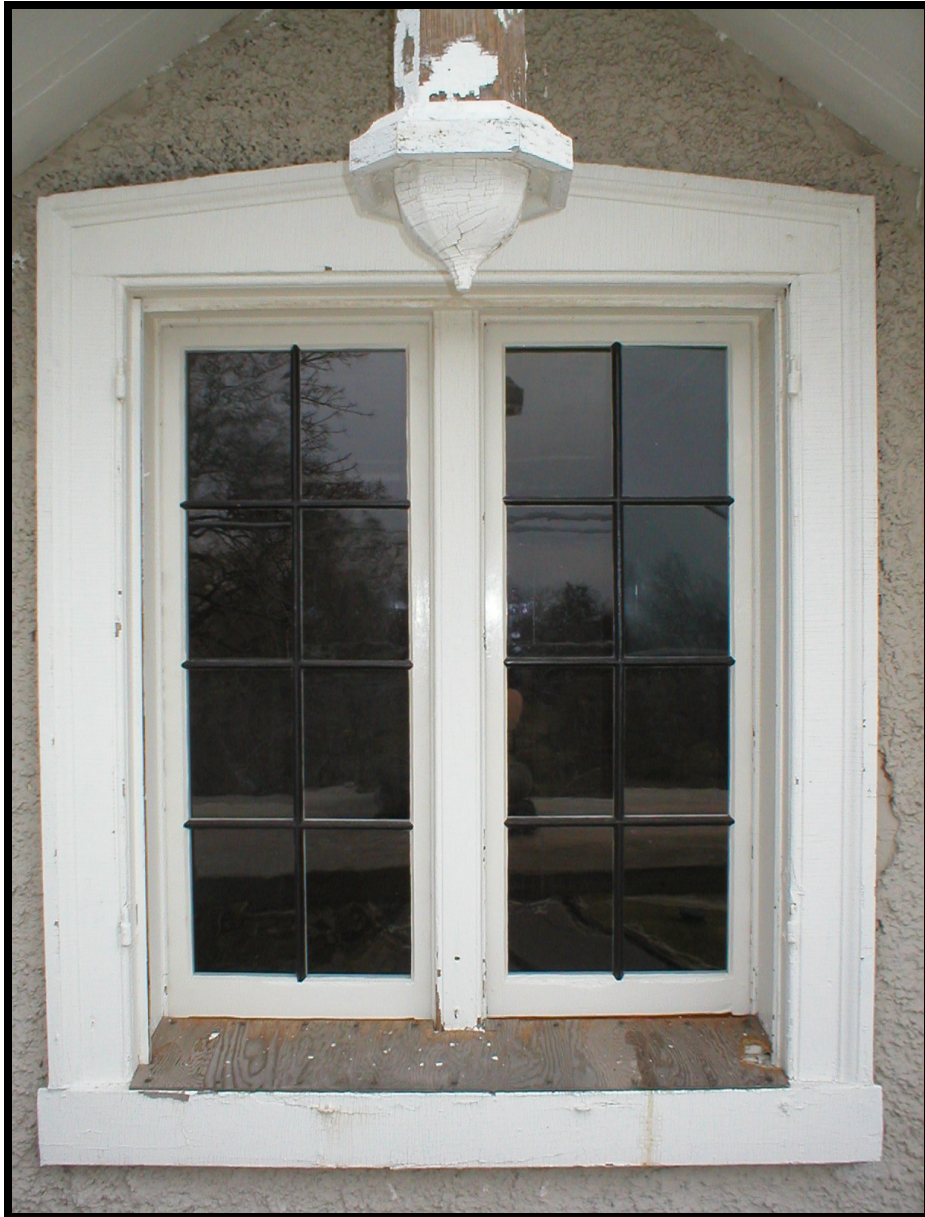
Figure 4.1 Casement Window, President Lincoln and Soldiers' Home National Monument

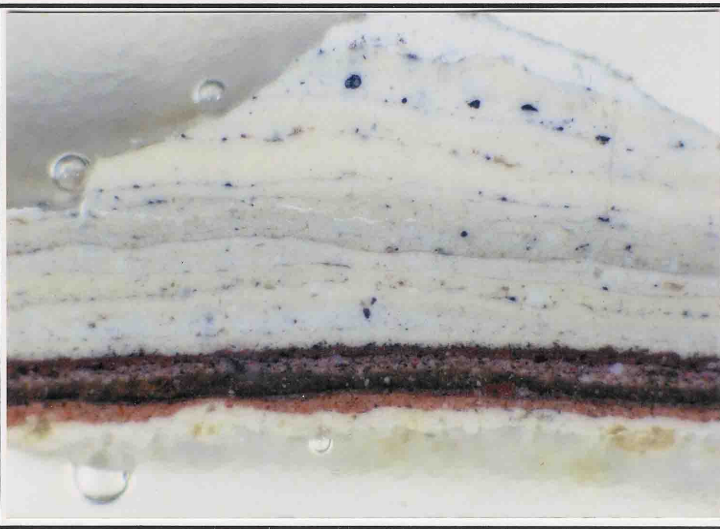
ROOM: <i>Exterior</i>	SAMPLE # <i>Ext-52</i>

<p data-bbox="1039 630 1234 693">} 20th c. Whites</p> <p data-bbox="1039 756 1266 798">} Late 19th c. Browns</p> <p data-bbox="1039 808 1299 850">} Lt. Brown: original finish</p> <p data-bbox="1039 850 1299 913">} White: original prime coat. (1857)</p>
<p data-bbox="300 934 1104 966">Sample Location: <i>North elevation, first floor bay window trim - ca. 1857.</i></p> <p data-bbox="300 955 779 987">Comments: <i>See page 6 for layer description</i></p>

Figure 4.8 Exterior Colors, President Lincoln and Soldiers' Home National Monument.
Welsh Color & Conservation, Inc. (copyright) 5/19/2003.

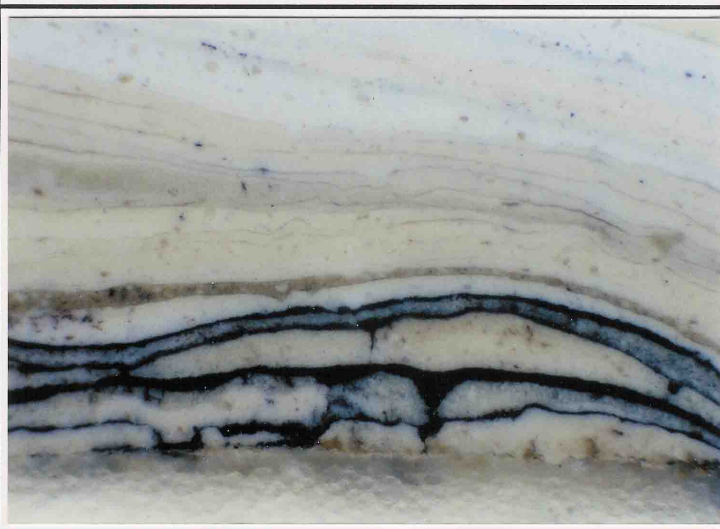
ROOM: <i>Exterior</i>	SAMPLE # <i>Ext-6</i>

<p data-bbox="1039 1260 1234 1323">} 20th c. Whites</p> <p data-bbox="1039 1428 1282 1491">} Lt. 19th c. White/Black finish coats</p> <p data-bbox="1039 1491 1299 1533">} Ca. 1857 Black finish coat</p> <p data-bbox="1039 1533 1299 1596">} Original (1843) White prime & finish coat.</p>
<p data-bbox="300 1585 1006 1617">Sample Location: <i>North front entry, west window muntins & putty.</i></p> <p data-bbox="300 1606 795 1638">Comments: <i>See page 6 for layer description</i></p>

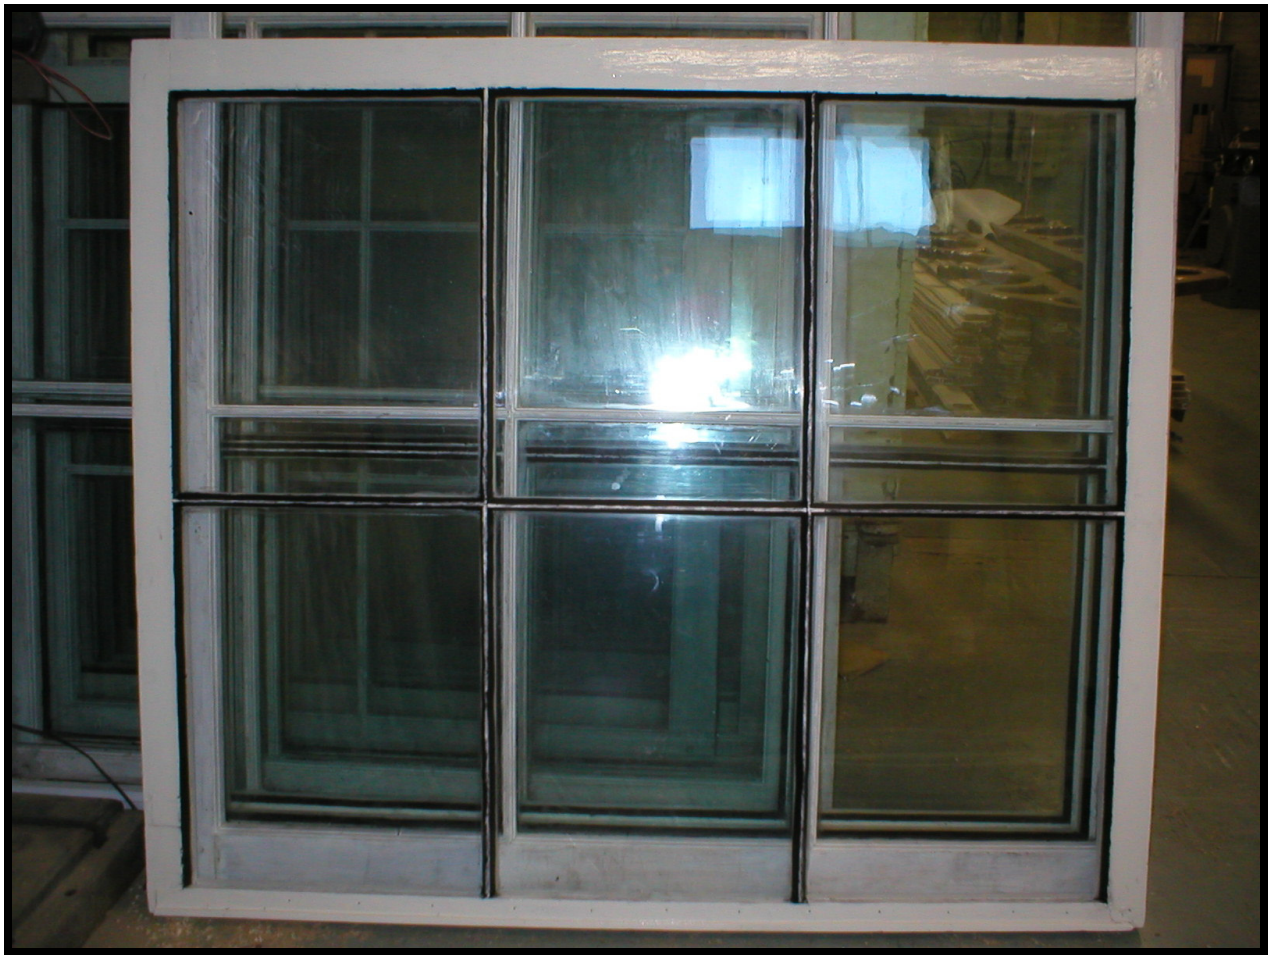
Figure 4.9 A stack of ‘almost’ restored windows - notice how the muntins almost disappear into the background when sun is shining on them

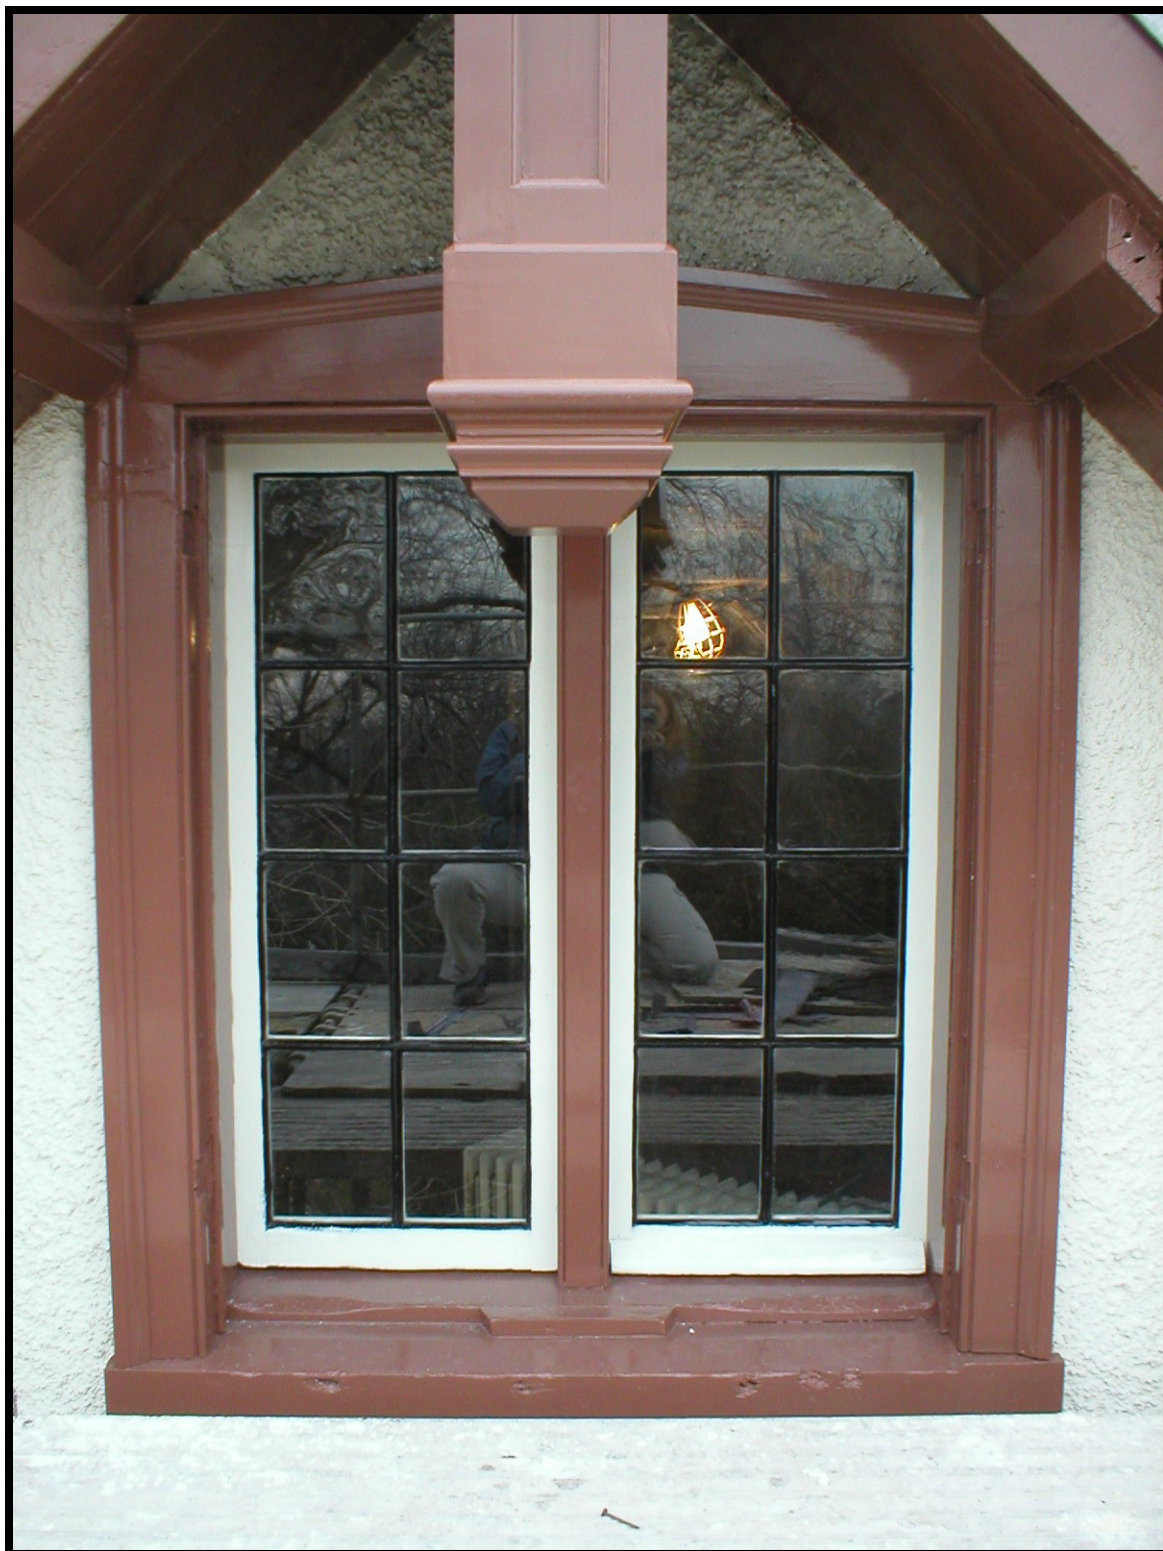
Figure 5.1 Restored Window
