THE IMPACT OF THE AMERICANS WITH DISABILITIES ACT ON HISTORIC

BUILDINGS

A Thesis Submitted to the Graduate Faculty of The University of Georgia in Partial Fulfillment of the Requirements for the Degree

MASTER OF HISTORIC PRESERVATION

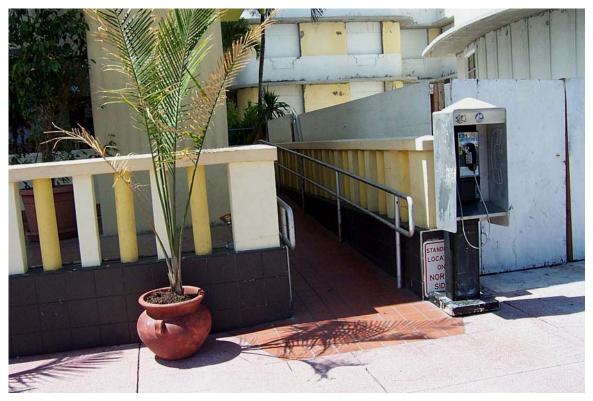
Photo 3: Close up of the ramp at the Leslie Hotel.

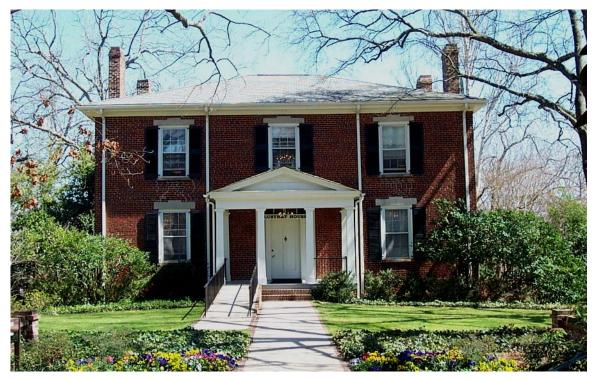
Photo 4: The Lustrat House, Athens, GA.

The ramp at the Lustrat House, on the University of Georgia campus, provides easy access to the front door, which faces the campus. This ramp utilizes the same concrete and brick as the front walk, and the rail matches that found on the porch. This ramp does

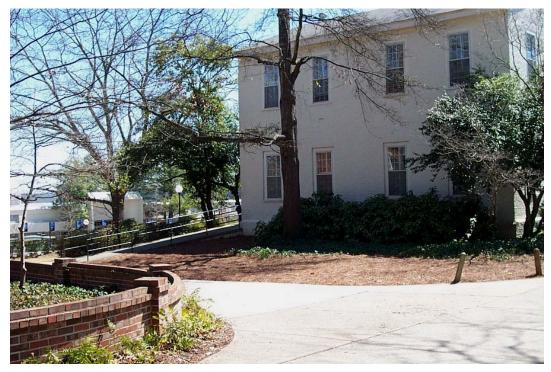
Photo 6: Waddell Hall ramp.

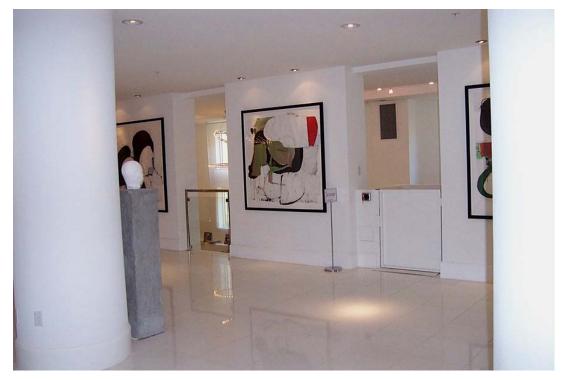
Photo 8: View of lift from rear lobby of the Sagamore, looking toward the library.

Vertical lifts are frequently installed along a porch or wall at a place where the standard means of ingress/egress is not disturbed. The Sagamore Hotel in Miami Beach installed such a lift along its porch during the recent rehabilitation. The installation of this lift required the removal of a piece of the banister. The historic significance of the Sagamore's façade is primarily found in the unique shape and fenestration pattern of the upper stories. (See Photo #7, pg. 88.) Thus the removal of a piece of the banister on the front façade does not significantly detract from the overall historic character. This solution allows people in wheelchairs to access the hotel from the front porch, the publicly used entrance.

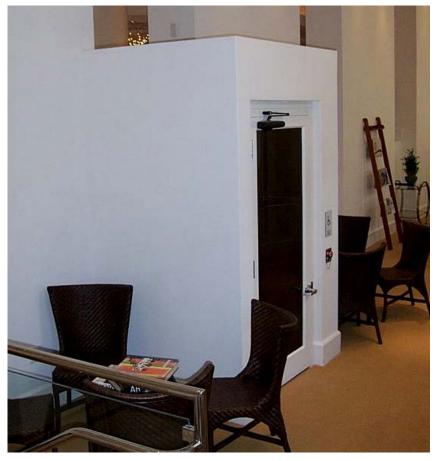
Photo 9: View of the lift from the library of the Sagamore.

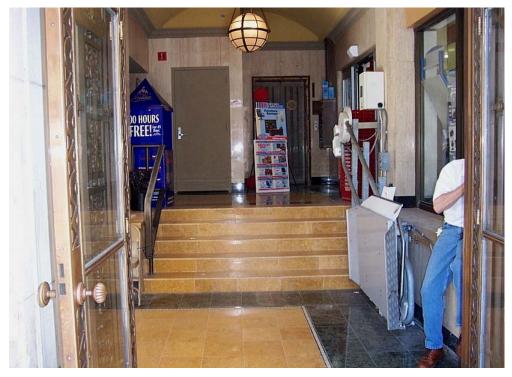
Photo 10: The lift of the Old Post Office Building, Miami, FL. Note the new railing.

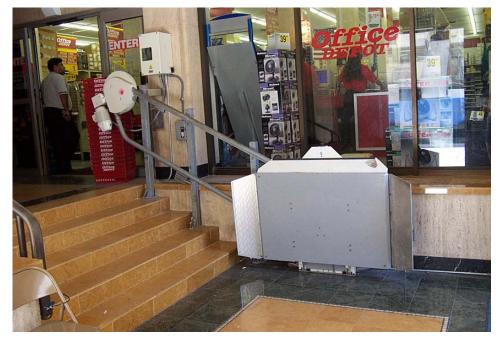
Photo 11: A side-view of the lift, while not in use.

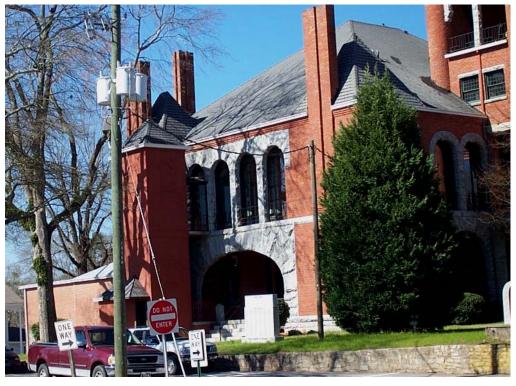
Photo 13: Close up of elevator tower.

<u>Elevator Towers</u>. Interior elevator towers are sometimes added to historic buildings to provide access to all levels of the building. As noted above, ADAAG does not require

elevators in any building that is less than three stories or has less than 3000 square feet per story.¹⁰¹ Many historic buildings qualify for this exemption; however, where an elevator can be added without causing significant damage to historic features it is often the best means of providing access to all levels and all significant spaces.
